**55-57 Devonshire Rd, Bexhill-on-Sea**

**Schedule of Condition UK**

**Inspected by: Philip Cushion**

**Inspection Date: 03 July 2023**

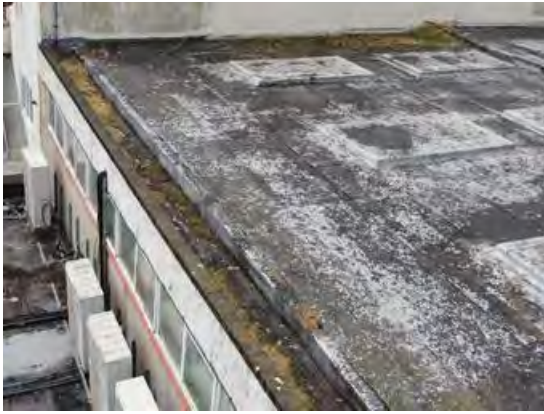
9

**Location:** Upper Roof

**Condition:** Poor

**Comments:** View along the rear gutter - the felt is weathered and in poor condition throughout. Solar reflective coatings are almost completely weathered away. The felt weatherproofing system is considered to be at the end of its serviceable life

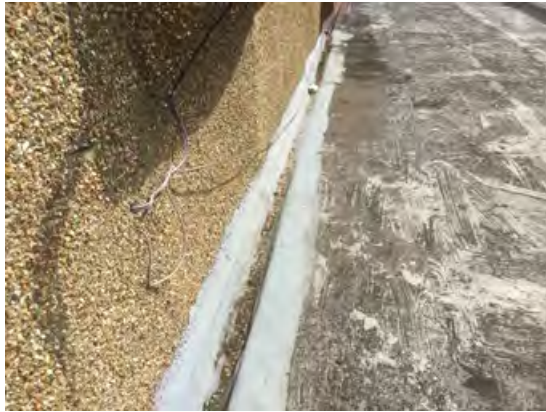
25

**Location:** Lower Roof

**Condition:** Poor

**Comments:** Liquid sealant applied along the side gutter

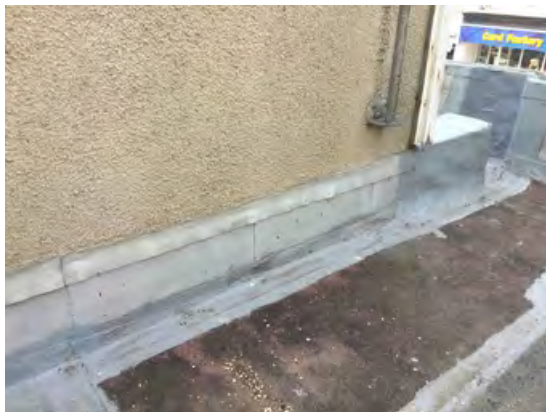
26

**Location:** Lower Roof

**Condition:** Poor

**Comments:** Liquid sealant applied to the upstand against the side elevation

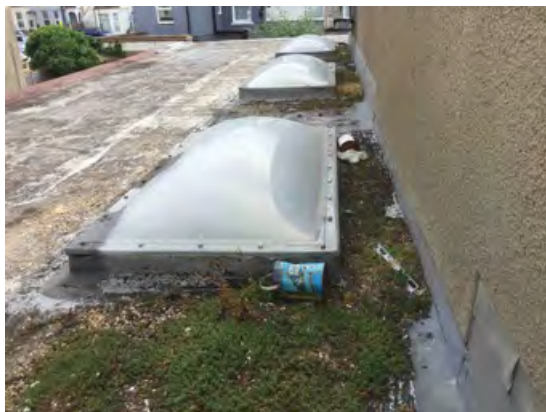
27

**Location:** Lower Roof

**Condition:** Poor

**Comments:** Silt and vegetation accumulating alongside the rooflights

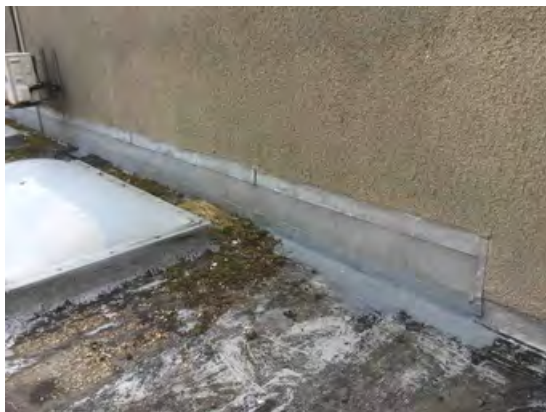
28

**Location:** Lower Roof

**Condition:** Poor

**Comments:** Sealant applied along the upstand with the side elevation

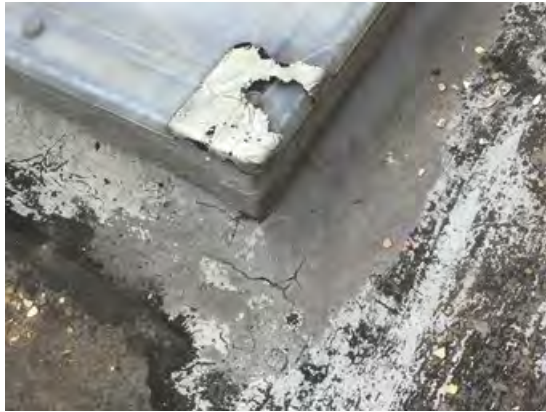
29

**Location:** Lower Roof

**Condition:** Poor

**Comments:** Front rooflight - patch repair, split felt upstand

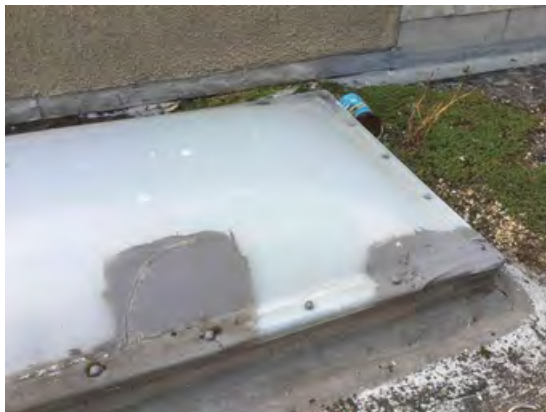
30

**Location:** Lower Roof

**Condition:** Poor

**Comments:** Front rooflight - liquid applied sealant, patch repair

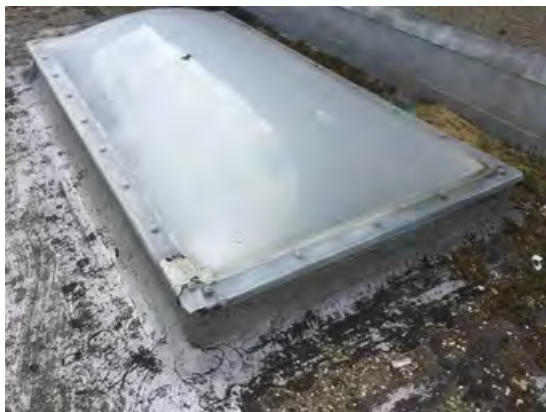
31

**Location:** Lower Roof

**Condition:** Poor

**Comments:** Middle rooflight - patch repair, split upstands

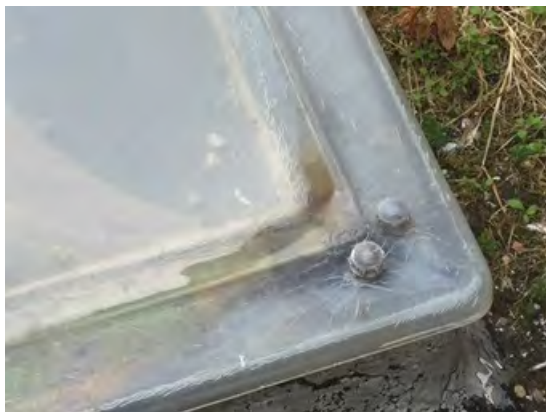
32

**Location:** Lower Roof

**Condition:** Poor

**Comments:** Solar degraded polycarbonate rooflight

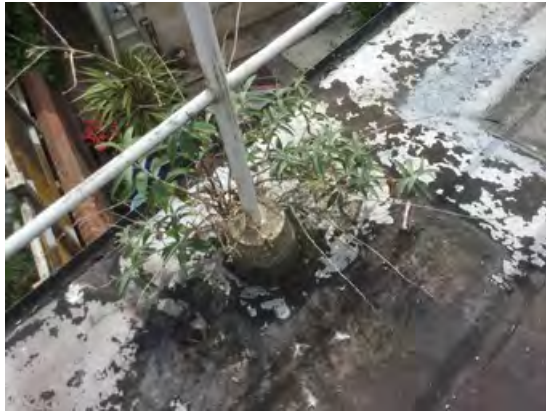
45

**Location:** Lower Roof

**Condition:** Poor

**Comments:** Vegetation growth

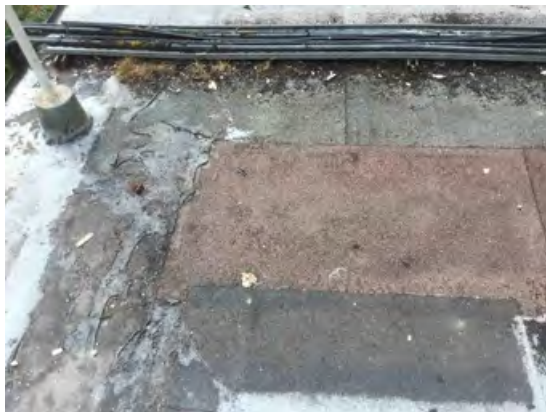
46

**Location:** Lower Roof

**Condition:** Poor

**Comments:** Path repairs and lifting sealant

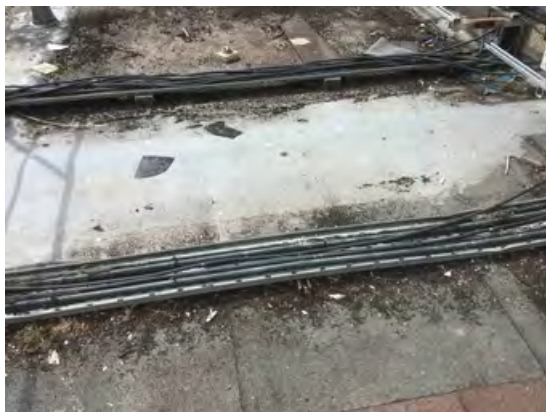
47

**Location:** Lower Roof

**Condition:** Very poor

**Comments:** AC pipework insulation has perished and weathered away

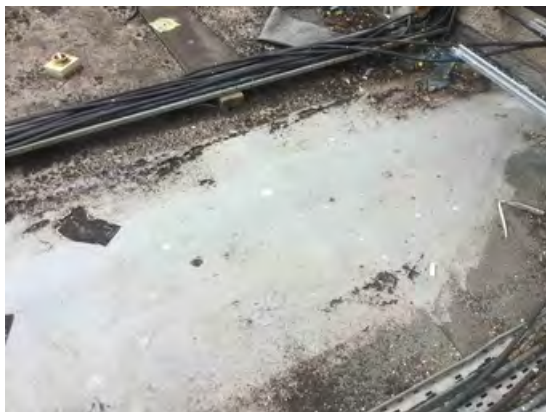
48

**Location:** Lower Roof

**Condition:** Poor

**Comments:** Attempted sealant repair

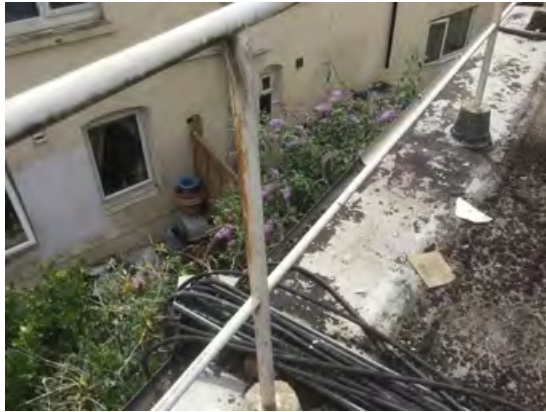
49

**Location:** Lower Roof

**Condition:** Fair

**Comments:** Corroding handrails

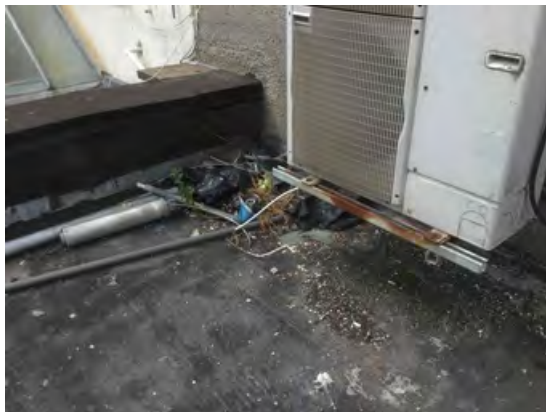
50

**Location:** Lower Roof

**Condition:** Poor

**Comments:** Accumulation of waste and debris

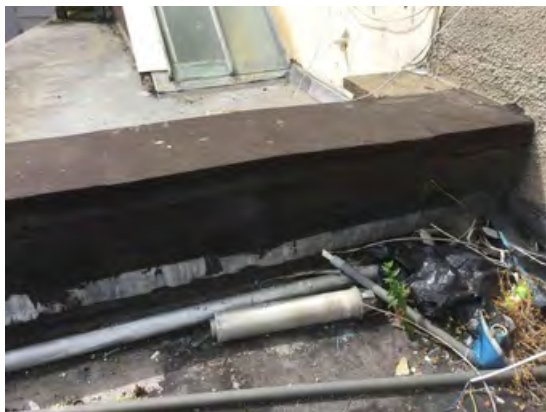
51

**Location:** Lower Roof

**Condition:** Poor

**Comments:** Untidy sealant applied to weathered the upstand

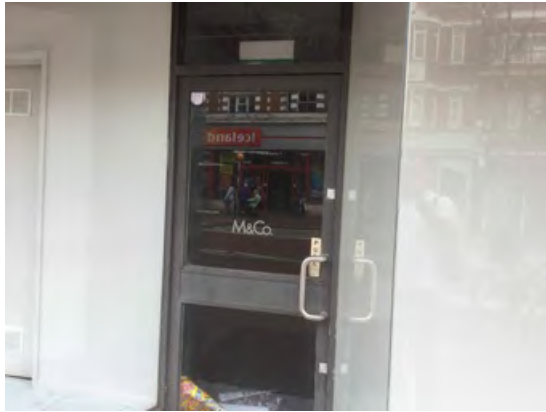
77

**Location:** Front Elevation

**Condition:** Fair

**Decorative Condition:** Poor

**Comments:** Left entrance door - flaking paintwork, former tenants graphics remain

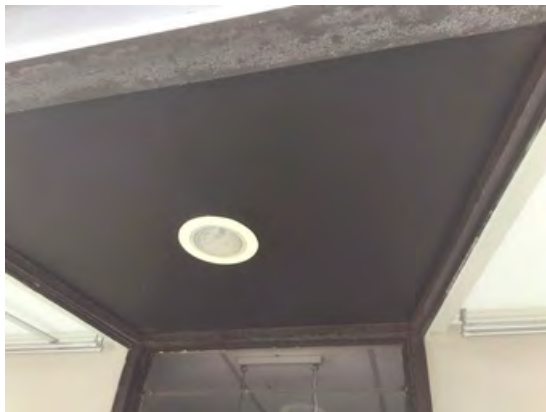
78

**Location:** Front Elevation

**Comments:** Defective soffit light, soiled soffit panel

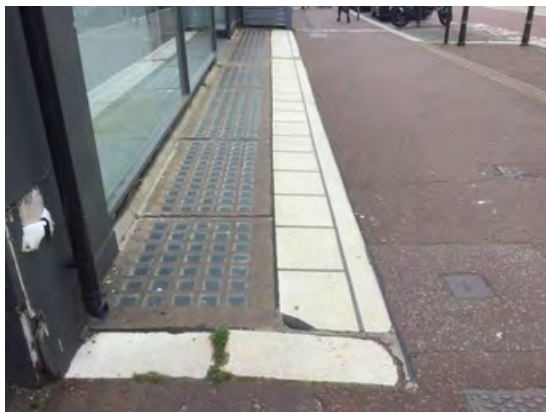
80

**Location:** Front Elevation

**Condition:** Poor

**Comments:** Various cracked and displaced paving slabs

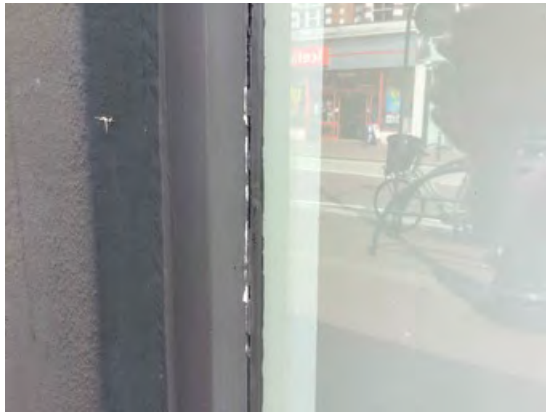
94

**Location:** Front Elevation

**Condition:** Poor

**Comments:** Split and delaminating perimeter frame seals

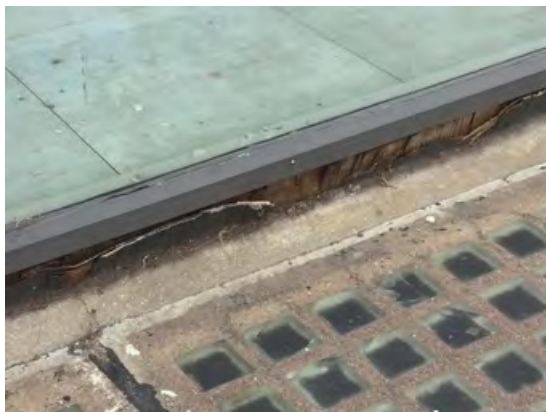
95

**Location:** Front Elevation

**Condition:** Very poor

**Comments:** Rotten stall riser panels

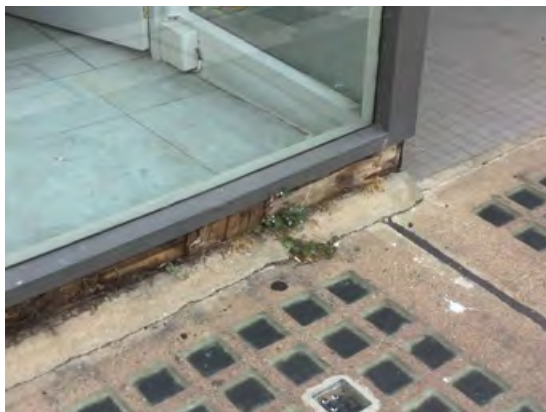
96

**Location:** Front Elevation

**Condition:** Very poor

**Comments:** Rotten stall riser panels

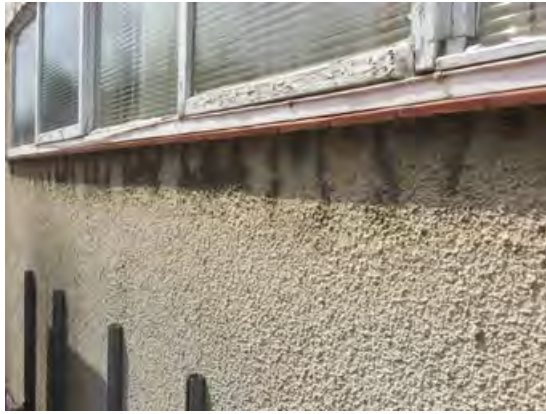
109

**Location:** Rear Elevation

**Condition:** Fair

**Comments:** Water stained render, generally fair condition

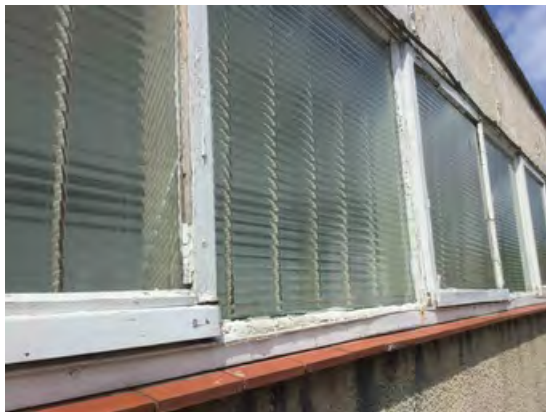
110

**Location:** Rear Elevation

**Condition:** Very poor

**Comments:** Rotten windows at first floor level

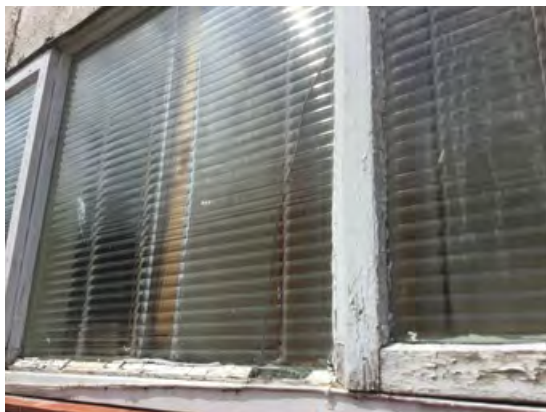
111

**Location:** Rear Elevation

**Comments:** Total of 2no cracked glazing panes - first floor windows

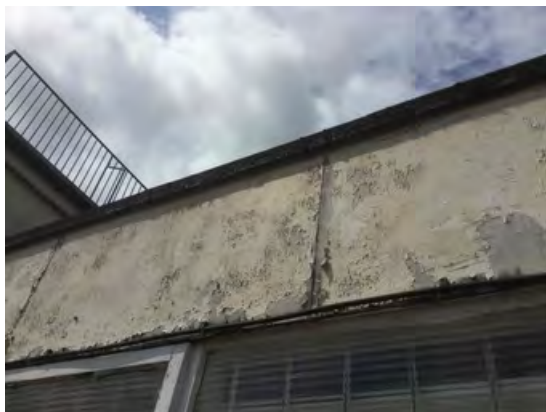
112

**Location:** Rear Elevation

**Condition:** Poor

**Comments:** Aged and weathered fascia panels. Delaminating plywood

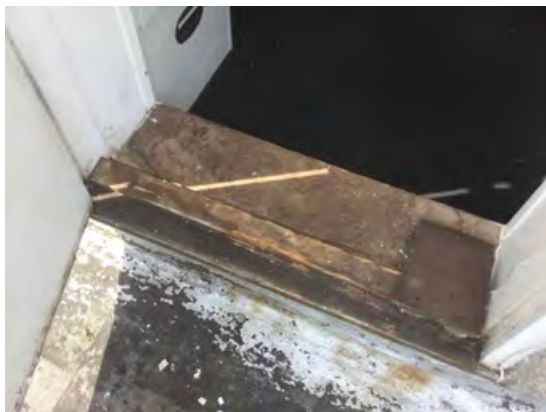
115

**Location:** Rear Elevation

**Condition:** Poor

**Comments:** Weathered sill to the roof access door, water ingress noted

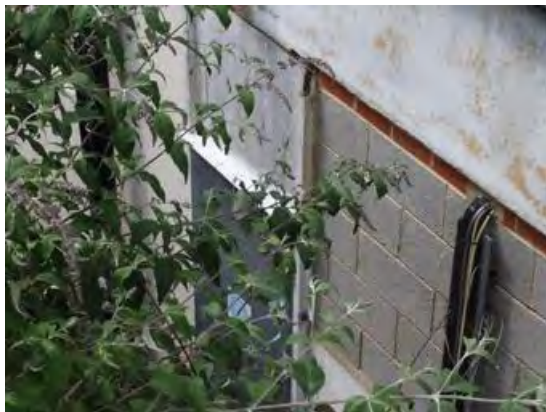
130

**Location:** Rear Elevation

**Condition:** Poor

**Comments:** Rear door - not tested at the time of inspection.  
Poor decorative order, localised decay

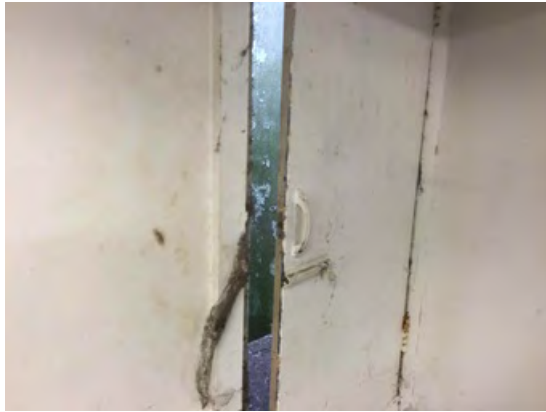
157

**Location:** Front stockroom

**Condition:** Very poor

**Comments:** Door not closing

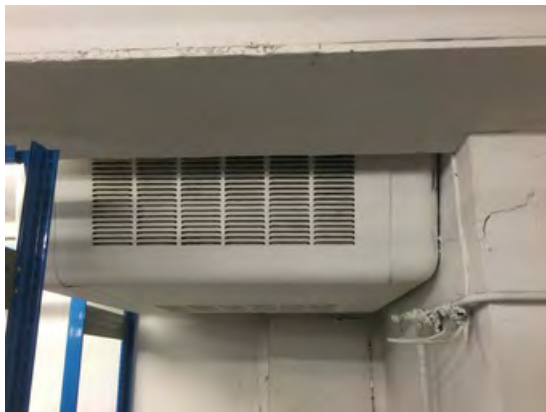
158

**Location:** Front stockroom

**Condition:** Very poor

**Comments:** Redundant ventilation systems remain

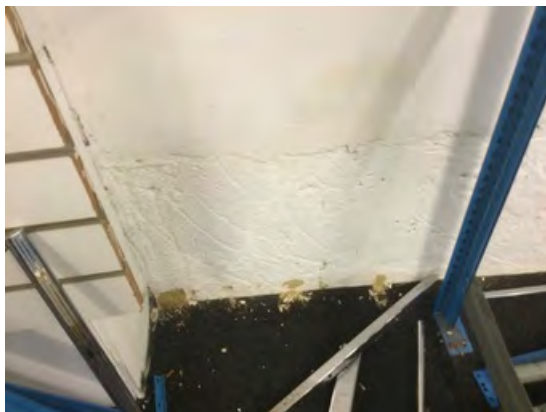
159

**Location:** Front stockroom

**Condition:** Poor

**Comments:** Penetrating dampness along the side elevation

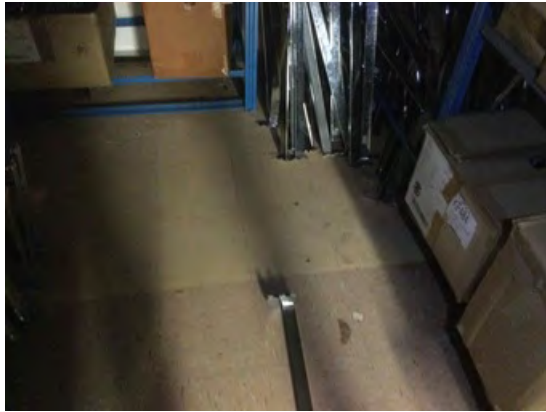
213

**Location:** Rear stockroom

**Condition:** Poor

**Comments:** Patchy miss-matching vinyl flooring, aged and worn vinyl tiles

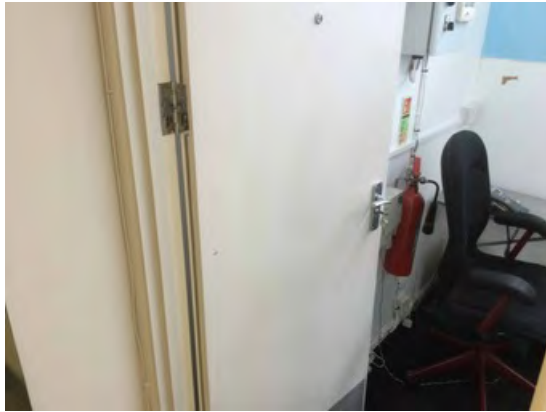
237

**Location:** Office

**Comments:** Entrance door - soiled and scuffed

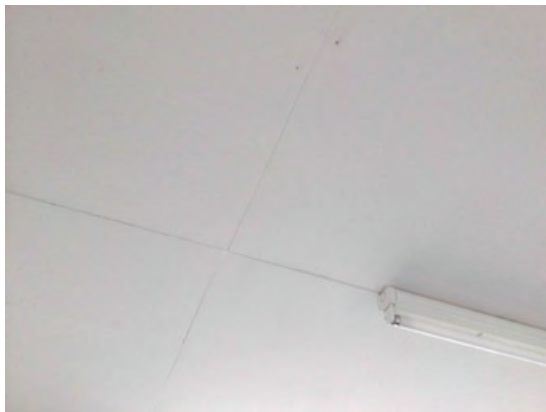
238

**Location:** Office

**Comments:** Ceilings - visible board joints

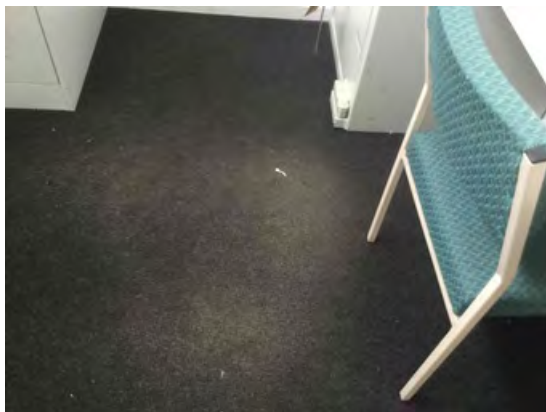
239

**Location:** Office

**Condition:** Poor

**Comments:** Worn carpets
