## WAREHOUSE, TRENT LANE INDUSTRIAL EST, CASTLE DONNINGTON - Schedule of Condition

Trent Lane Ind Est, Castle Donnington. DE742NP

**Inspected by: Philip Cushion**

Report Date: 07 August 2023

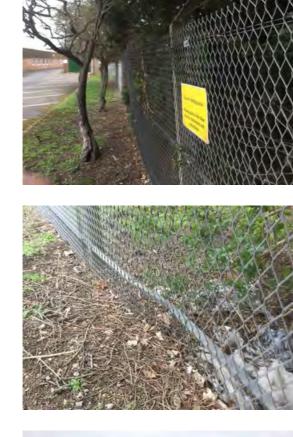
Location: Eastern Boundary Condition: Poor Decorative Condition: N/a Comments: Leaning fence posts - 20m section of fencing

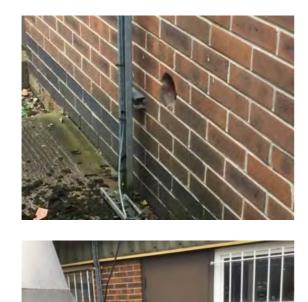
151

Location: West elevation

Condition: N/a

Decorative Condition: N/a

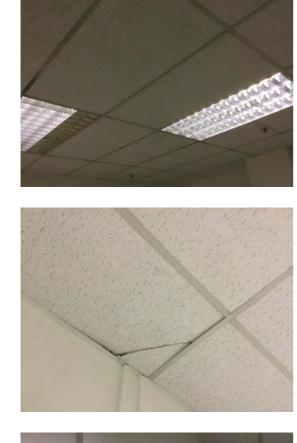
279

Location: Office 2

Condition: Poor

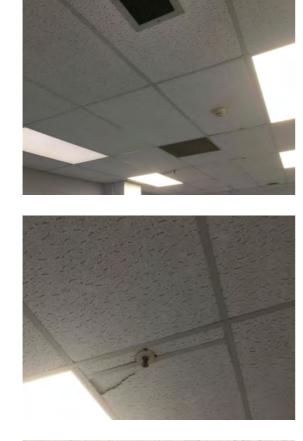
430

Location: Kitchen

Condition: Fair
