UNIT 7 GREENHILLS BUSINESS CENTRE - Schedule of Condition

Unit 7 Greenhills Business Ctr, Spennymoor

Inspection Date: 28 March 2023

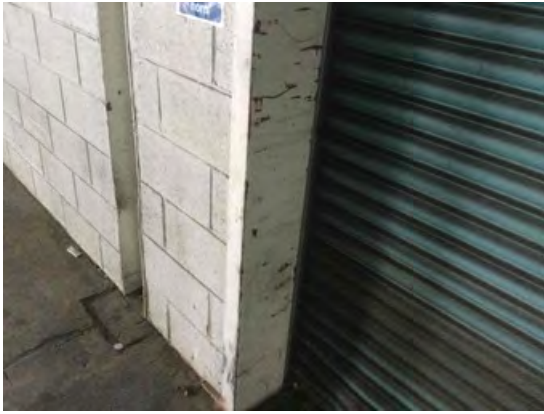
5

Location: Elevation 1

Condition: Fair

Decorative Condition: Poor

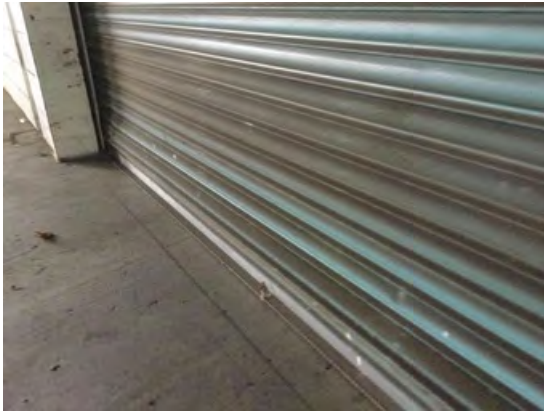
9

Location: Elevation 1

Condition: Fair

Decorative Condition: Poor

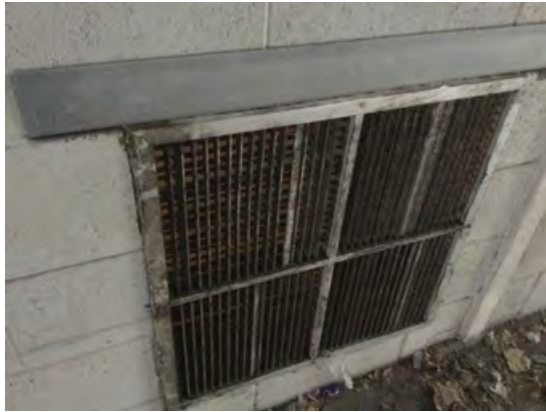
17

Location: Elevation 1

Condition: Poor

Comments: Aged, corroded and soiled vent

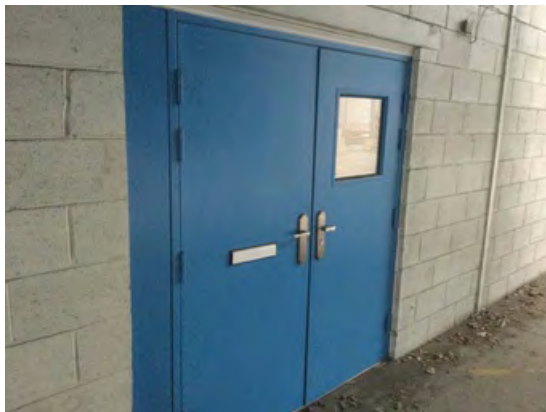
18

Location: Elevation 1

Condition: Fair

Decorative Condition: Fair

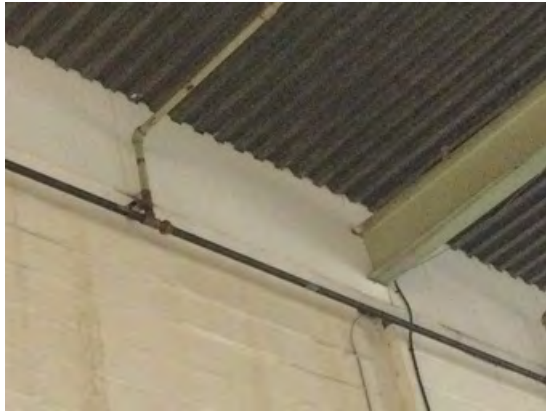
25

Location: Elevation 2

Condition: Fair

Comments: Fire cladding in fair condition

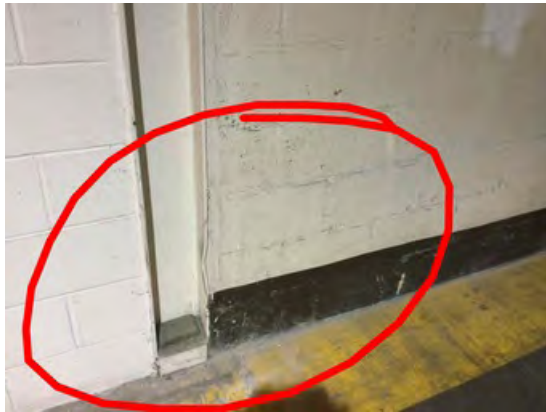
26

Location: Elevation 2

Condition: Fair

Comments: Minor impact damage to the column to the left of the double doors

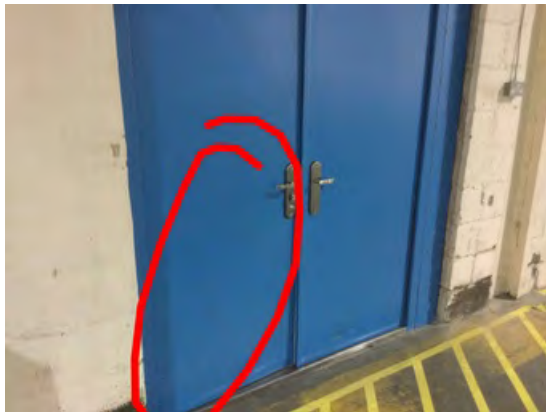
27

Location: Elevation 2

Condition: Fair

Comments: Distorted left door leaf

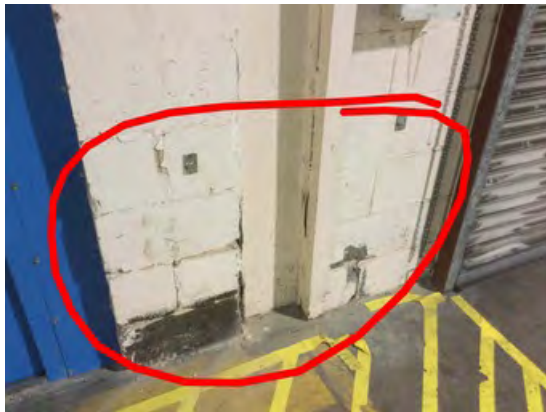
28

Location: Elevation 2

Condition: Poor

Comments: Impact damage

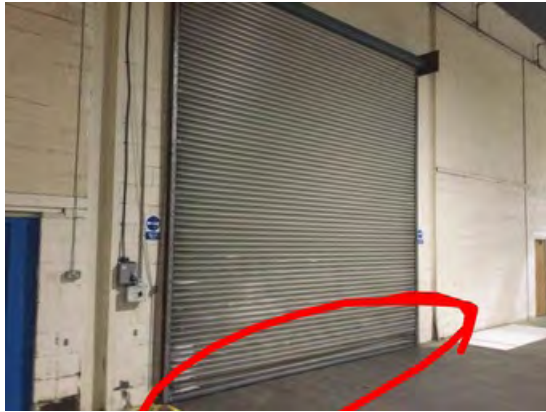
29

Location: Elevation 2

Condition: Fair

Comments: Soiled shutter door, impact damage at low level

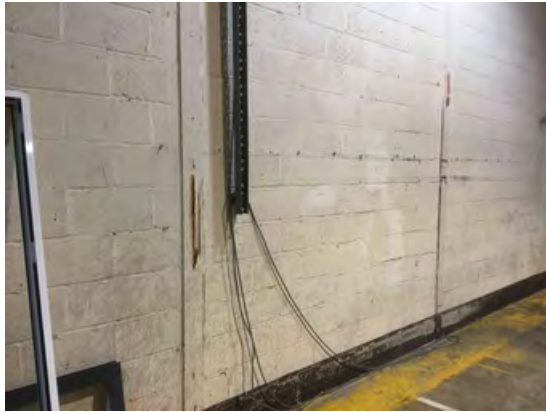
41

Location: Elevation 3

Decorative Condition: Poor

Comments: Redundant metal containment, unclipped cable, fixing holes in the blockwork, soiled decorations

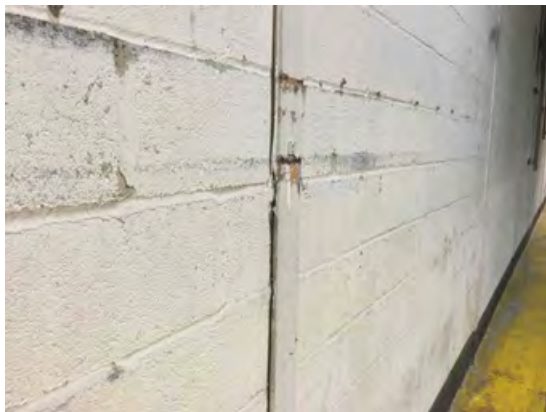
42

Location: Elevation 3

Condition: Fair

Comments: Minor impact damage

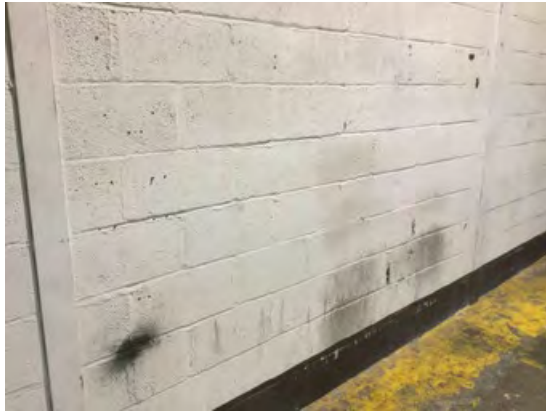
45

Location: Elevation 3

Decorative Condition: Poor

Comments: Soiled decorations

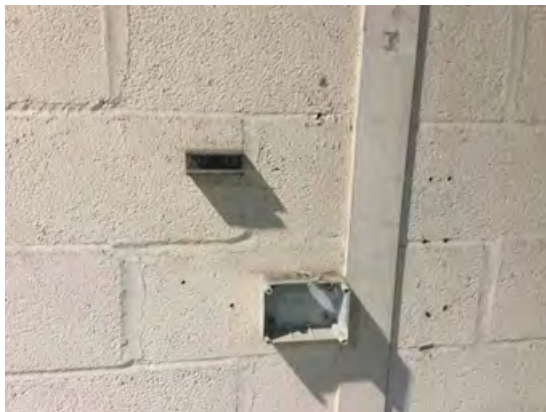
46

Location: Elevation 3

Comments: Remnants of electrical fittings

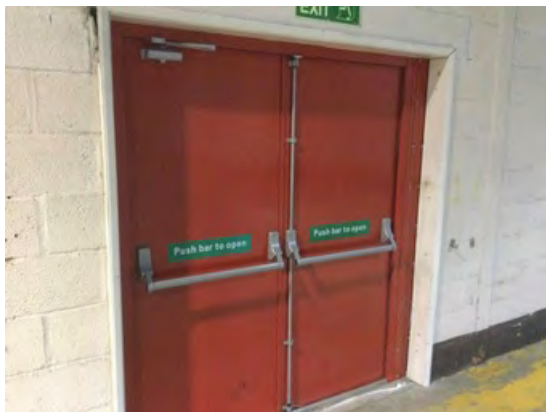
47

Location: Elevation 3

Condition: Fair

Comments: Metal exit doors - lightly soiled and scuffed

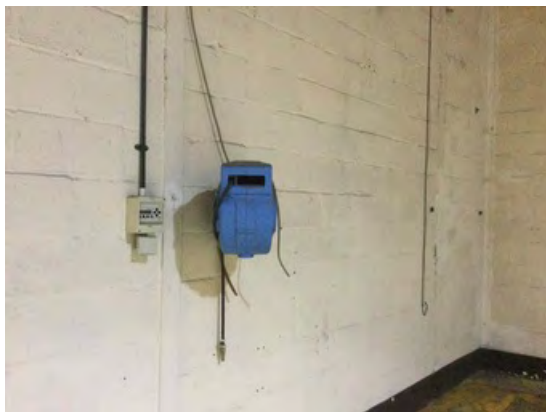
48

Location: Elevation 3

Condition: Poor

Comments: Redundant service hose

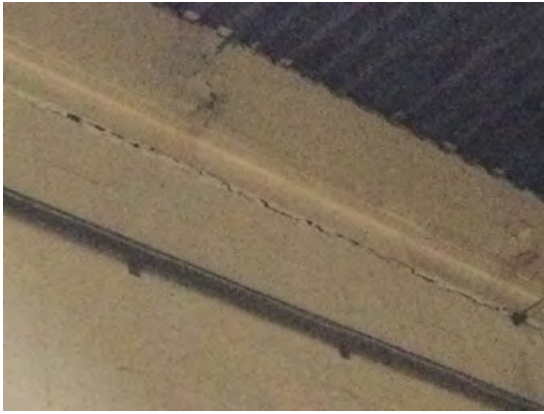
57

Location: Elevation 4

Comments: Cracking under the ring beam at high level

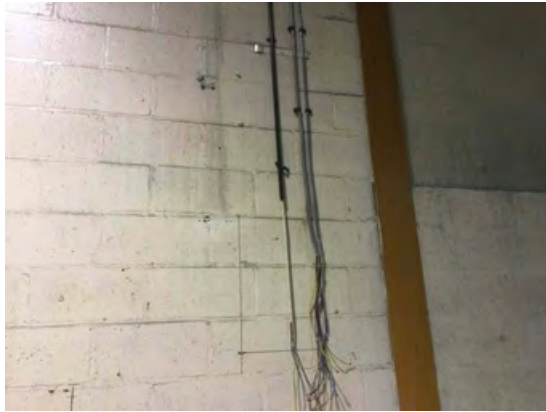
65

Location: Elevation 5

Condition: Very poor

Comments: Redundant cabling

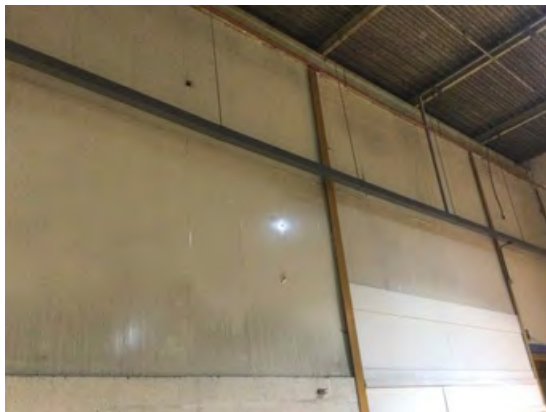
66

Location: Elevation 5

Decorative Condition: Very poor

Comments: Heavily soiled partition, minor damage

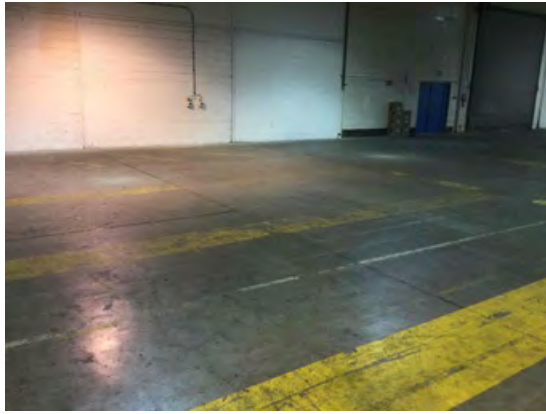
77

Location: Bay 1

Condition: Fair

Comments: Floor slab - worn paint markings, soiled, minor pitting

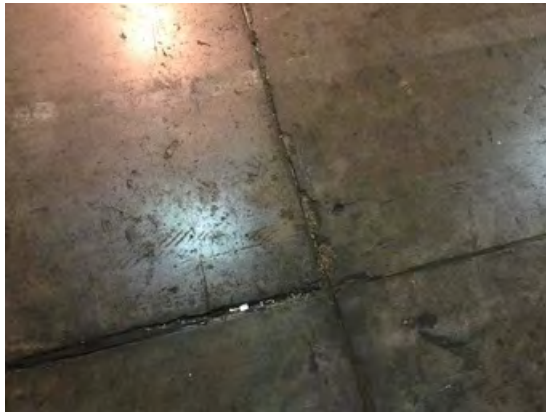
78

Location: Bay 1

Comments: Frayed bay joints

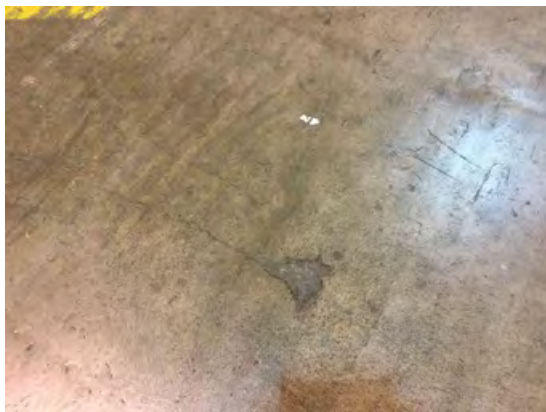
79

Location: Bay 1

Comments: Minor imperfections

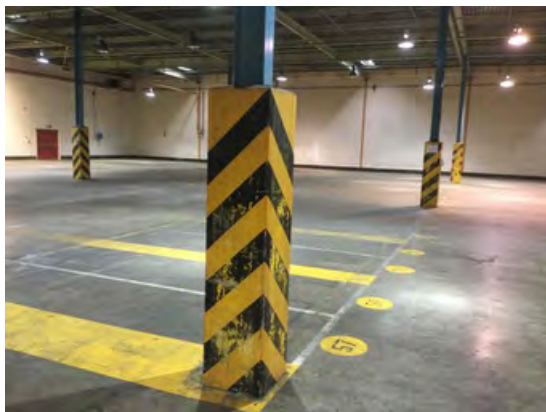
80

Location: Bay 1

Decorative Condition: Poor

Comments: Column casings - scuffed and affected by minor damage generally

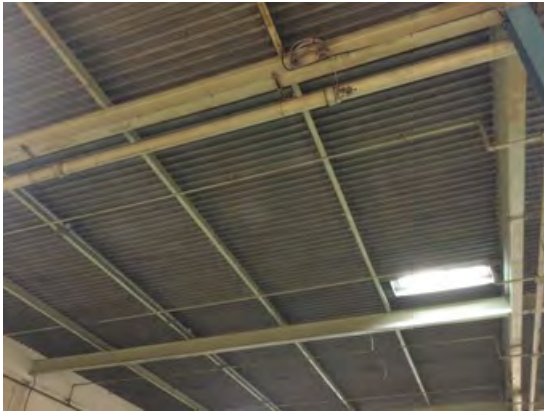
81

Location: Bay 2

Decorative Condition: Poor

Comments: Roof cladding is heavily soiled, steelwork affected by surface corrosion

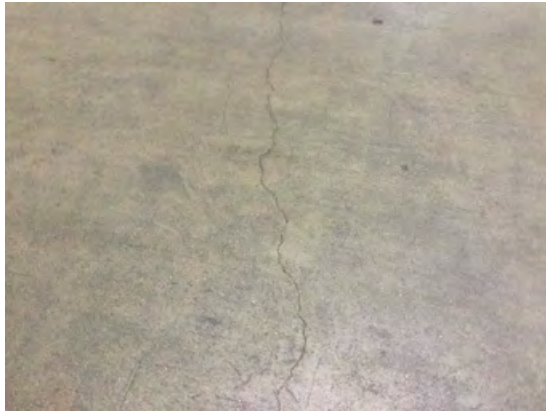
85

Location: Bay 2

Comments: Non structural cracks

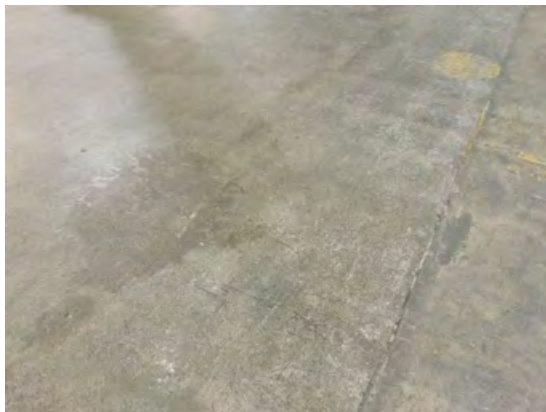
86

Location: Bay 2

Comments: General wear

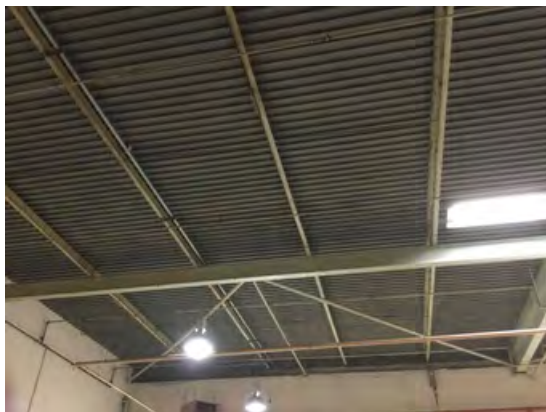
87

Location: Bay 3

Decorative Condition: Poor

Comments: Roof cladding is heavily soiled, steelwork affected by surface corrosion

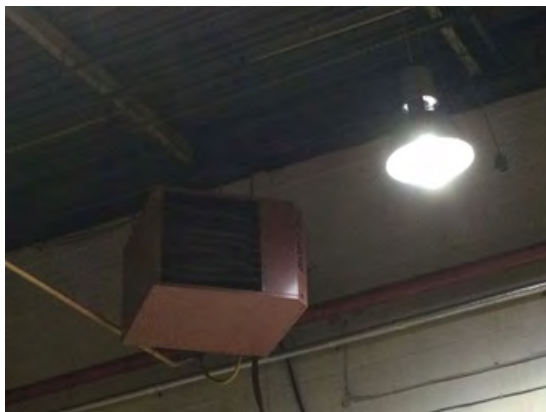
88

Location: Bay 3

Comments: Gas heater - not tested

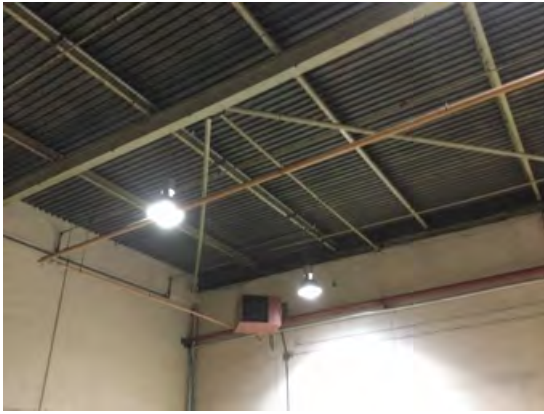
89

Location: Bay 3

Comments: 2no lamps - fair condition

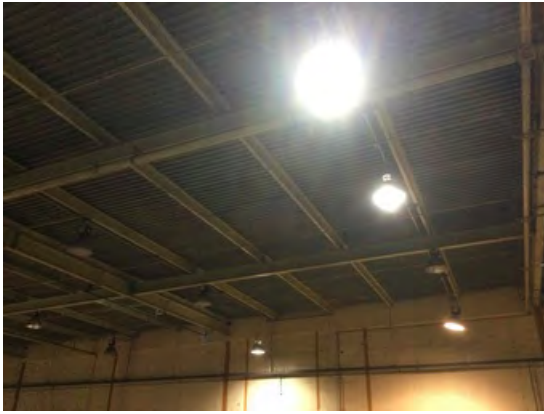
93

Location: Bay 4

Decorative Condition: Poor

Comments: Roof cladding is heavily soiled, steelwork affected by surface corrosion

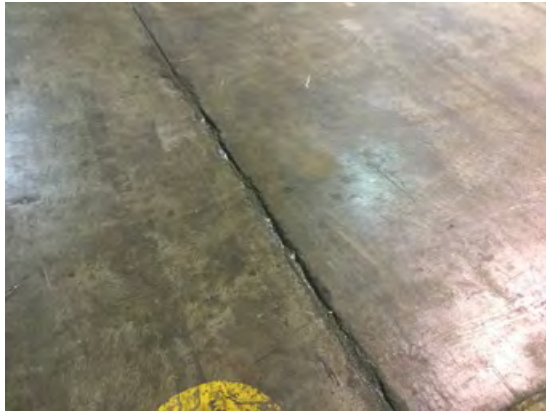
97

Location: Bay 4

Comments: Frayed bay joints

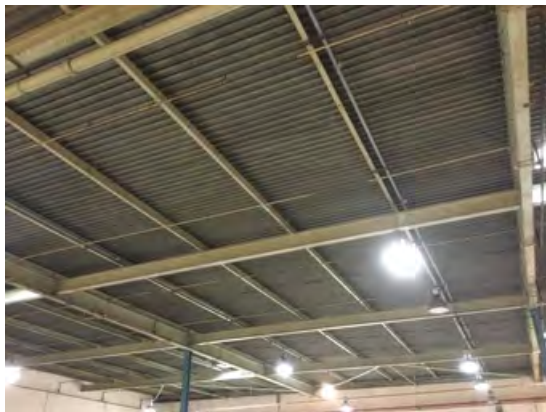
98

Location: Bay 5

Decorative Condition: Poor

Comments: Roof cladding is heavily soiled, steelwork affected by surface corrosion. 1no defective lamp

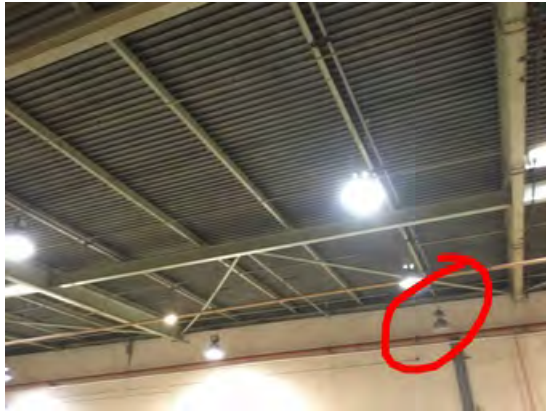
101

Location: Bay 6

Decorative Condition: Poor

Comments: Roof cladding is heavily soiled, steelwork affected by surface corrosion. 1no defective lamp

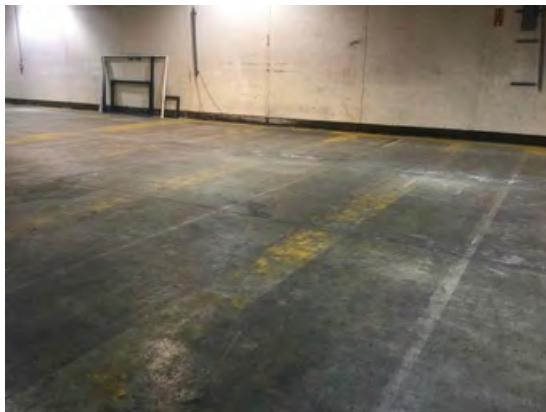
102

Location: Bay 6

Decorative Condition: Poor

Comments: Slab subject to general wear, minor cracks and surface damage

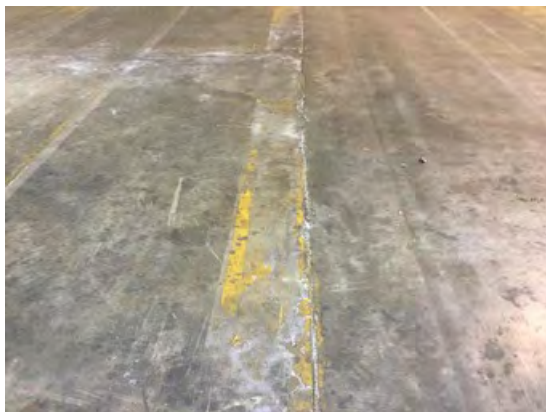
103

Location: Bay 6

Comments: Frayed bay joints

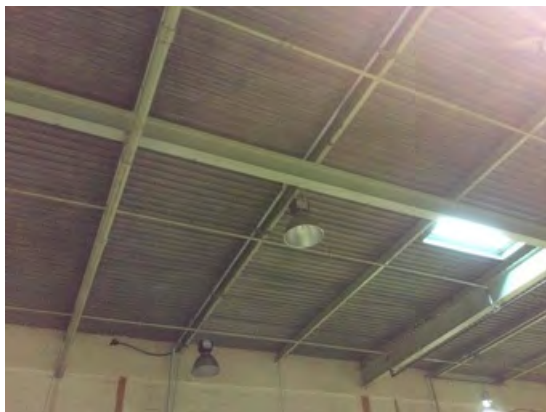
104

Location: Bay 7

Decorative Condition: Poor

Comments: Roof cladding is heavily soiled, steelwork affected by surface corrosion. 2 no defective lamps

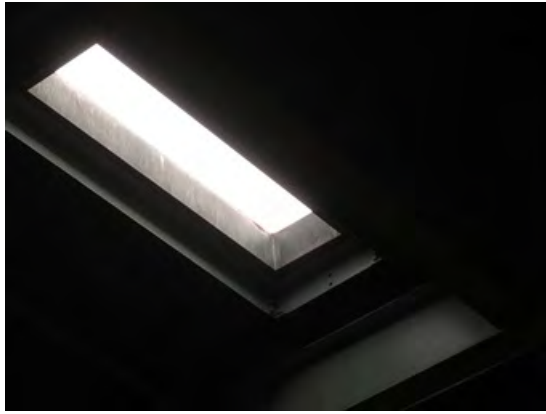
105

Location: Bay 7

Comments: Light corrosion to the rooflight surround

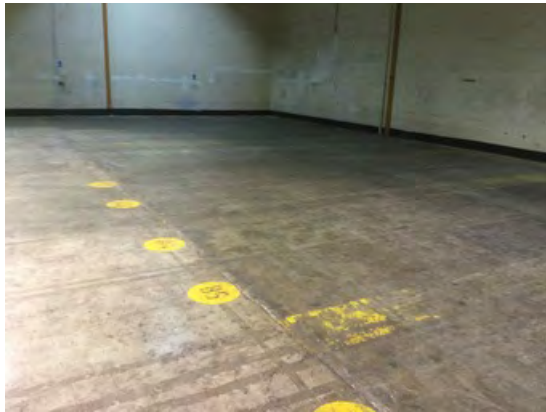
106

Location: Bay 7

Decorative Condition: Poor

Comments: Slab subject to general wear, minor cracks and surface damage, worn paint markings

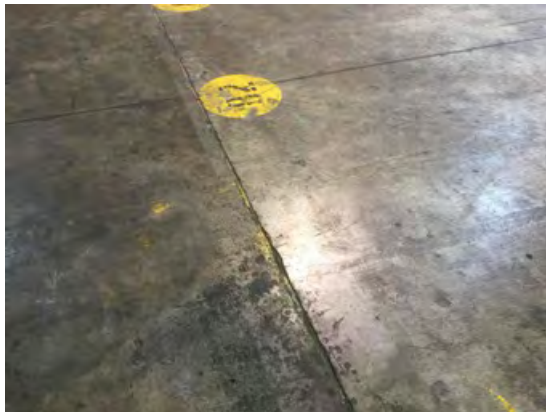
107

Location: Bay 7

Comments: Frayed bay joints

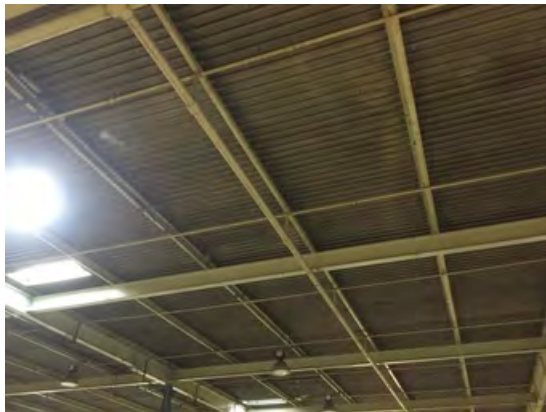
108

Location: Bay 8

Decorative Condition: Poor

Comments: Roof cladding is heavily soiled, steelwork affected by surface corrosion. 1no defective lamp

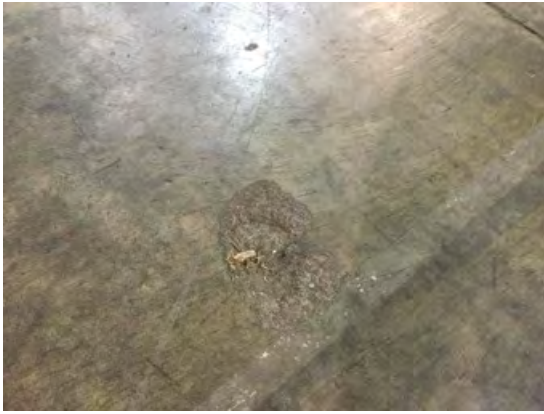
113

Location: Bay 9

Comments: Localised damage

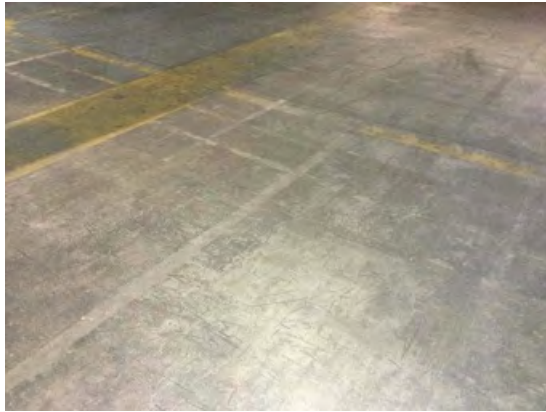
121

Location: Bay 11

Decorative Condition: Poor

Comments: Slab - general wear, soiling and worn paint markings

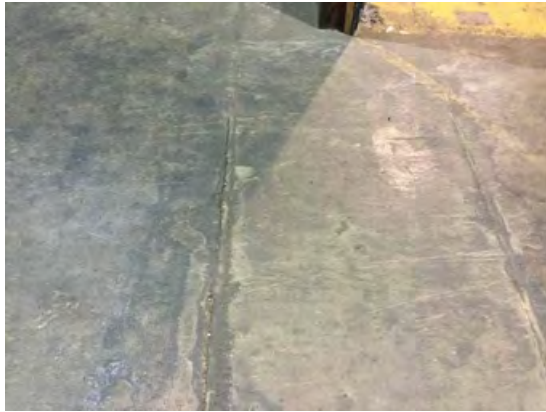
129

Location: Bay 13

Condition: Poor

Comments: Damaged screed at the entrance threshold

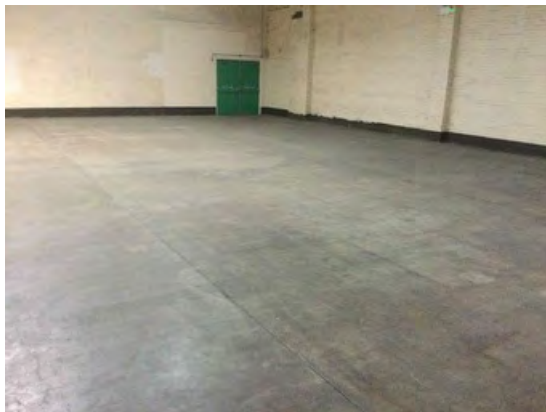
130

Location: Bay 13

Comments: The floor slab is in fair condition, subject to general hard wear and soiling. Sporadic cracks and surface damage, many fixing bolts remain

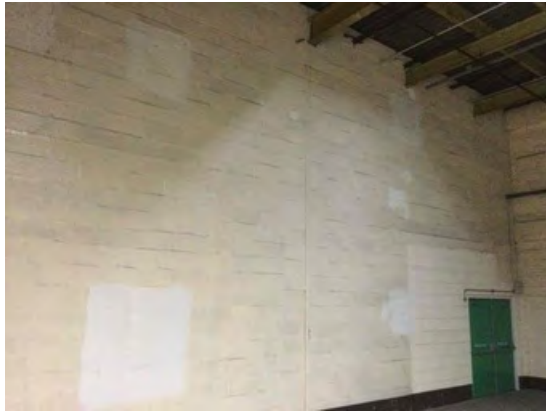
141

Location: Bay 13

Decorative Condition: Poor

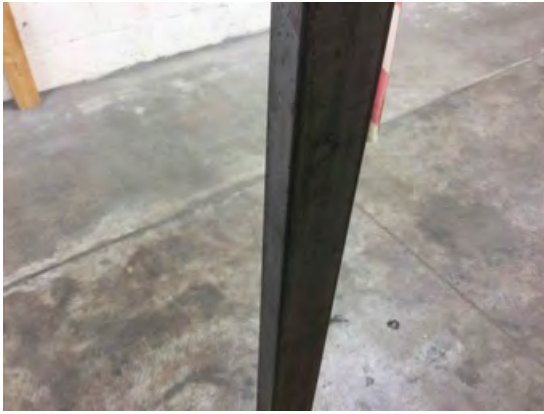
157

Location: Office 1

Comments: Corroded steel support post

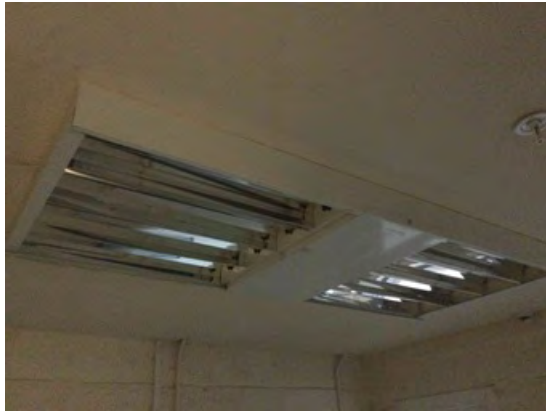
161

Location: Office 2

Comments: Ceilings and lighting - fair condition

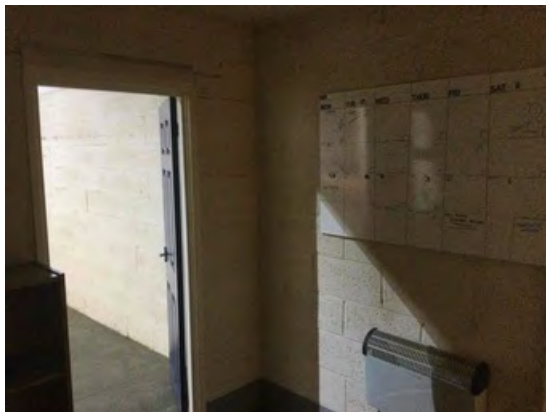
162

Location: Office 2

Comments: Fair decorative order

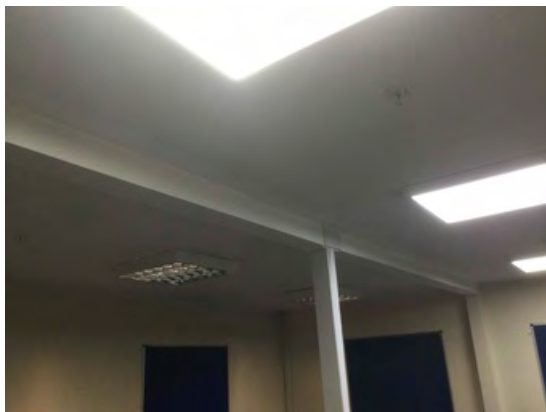
163

Location: Office 3

Comments: Ceilings - no defects, bank of 3 no defective lights

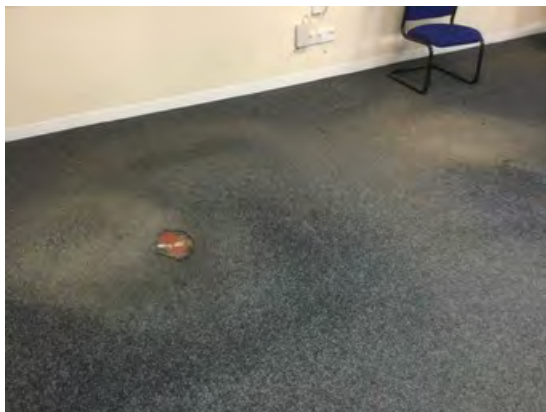
164

Location: Office 3

Condition: Very poor

Comments: Worn carpets

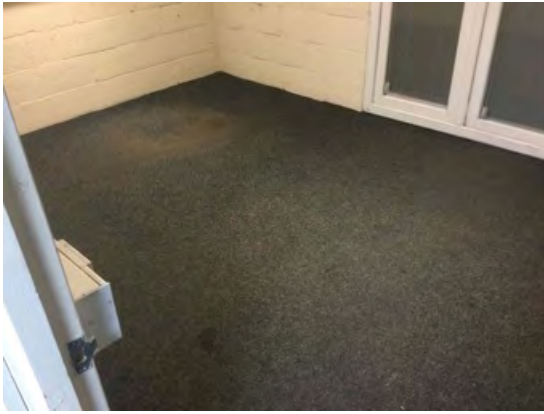
173

Location: Office 5

Condition: Poor

Comments: Worn and soiled carpets

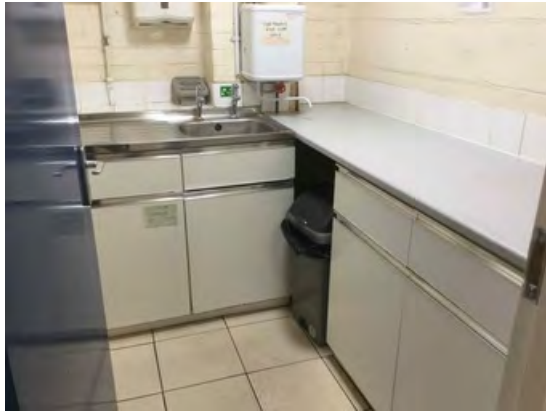
193

Location: Tea room

Condition: Poor

Comments: Aged, soiled and worn kitchen units - displaced doors and drawers

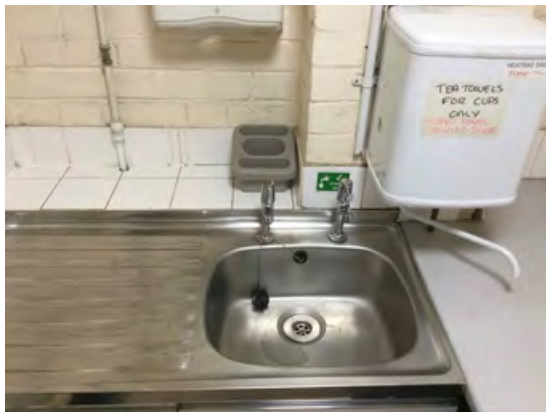
194

Location: Tea room

Comments: Sink and water heater - fair visual condition

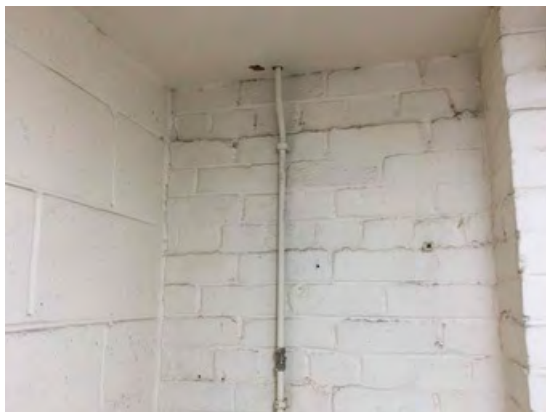
195

Location: Tea room

Decorative Condition: Poor

Comments: Soiled decorations

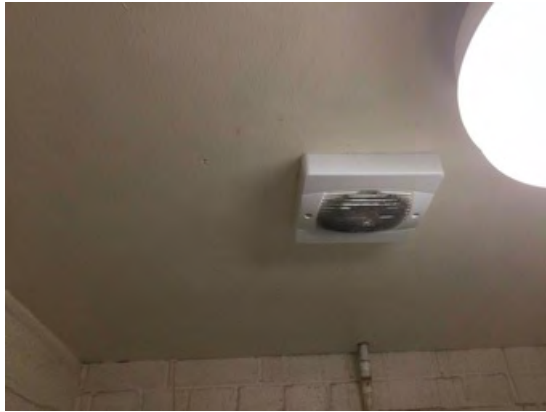
201

Location: Dis WC

Condition: Poor

Comments: Defective extractor

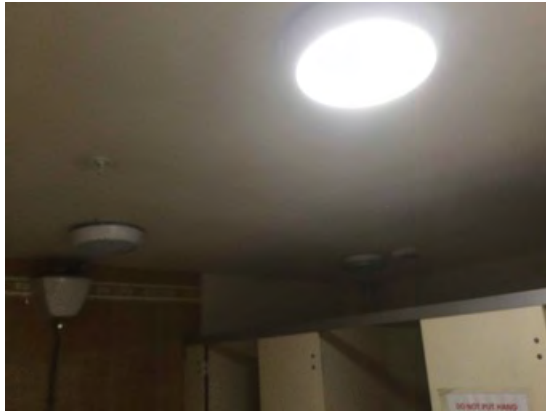
209

Location: Male WC

Condition: Poor

Comments: 3no defective lamps

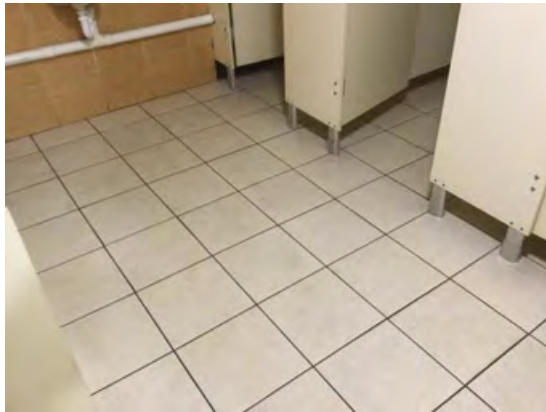
210

Location: Male WC

Comments: Floor tiles - general wear and soiling

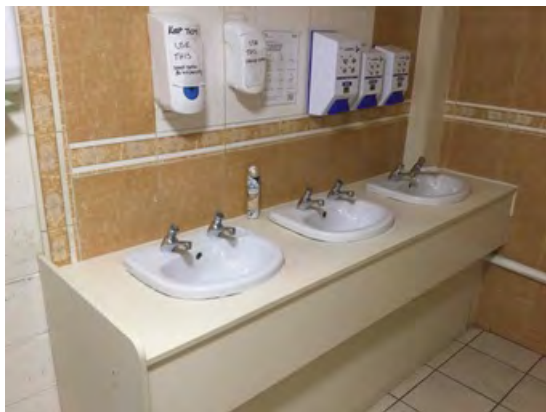
211

Location: Male WC

Comments: Worn top to the vanity unit
