**55-57 Devonshire Rd, Bexhill-on-Sea**

**Schedule of Condition UK**

**Inspected by: Philip Cushion**

**Inspection Date: 03 July 2023**

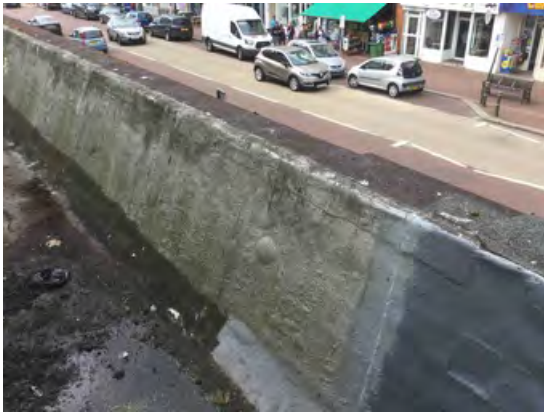
2

**Location:** Canopy Roof

**Condition:** Poor

**Comments:** Blistered upstand along the shop front

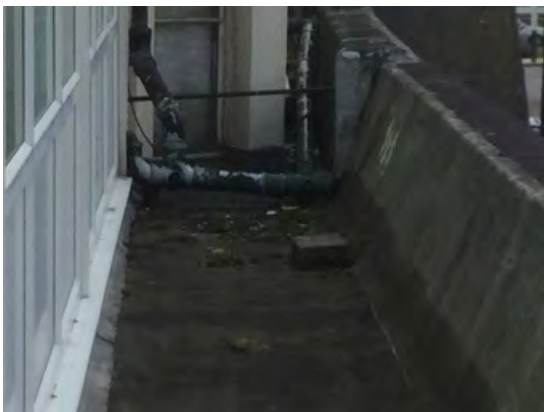
3

**Location:** Canopy Roof

**Condition:** Poor

**Comments:** Accumulation of silt and weed growth

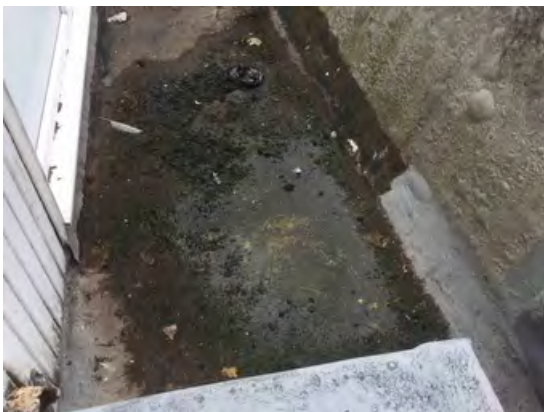
4

**Location:** Canopy Roof

**Condition:** Poor

**Comments:** Standing water and accumulating silt

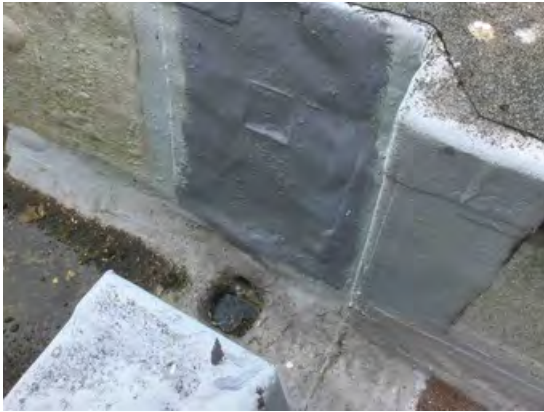
5

**Location:** Canopy Roof

**Condition:** Poor

**Comments:** Temporary repair with liquid sealant

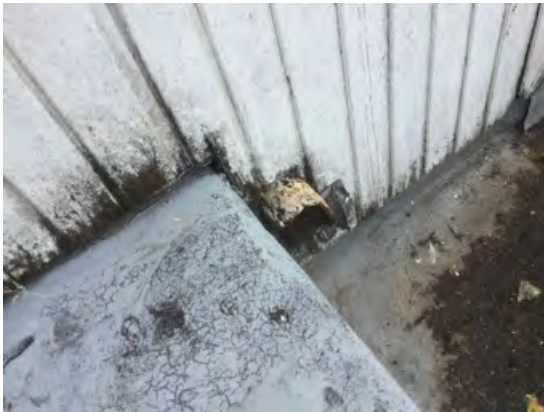
6

**Location:** Canopy Roof

**Condition:** Poor

**Decorative Condition:** Poor

**Comments:** Corroding outlet from the upper roof

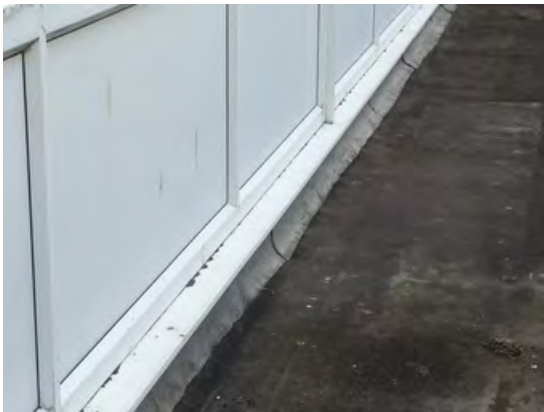
7

**Location:** Canopy Roof

**Comments:** Undulating leadwork

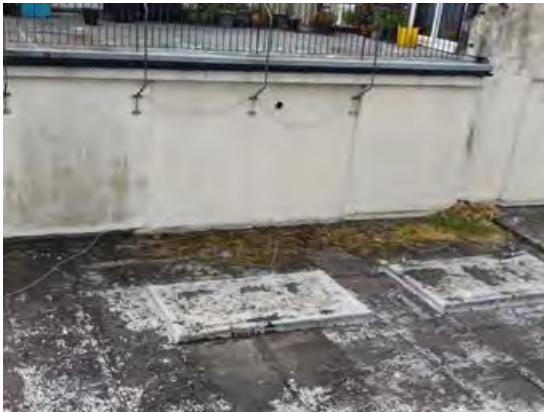
10

**Location:** Upper Roof

**Condition:** Poor

**Comments:** Accumulation of silt and vegetation alongside the right hand party wall

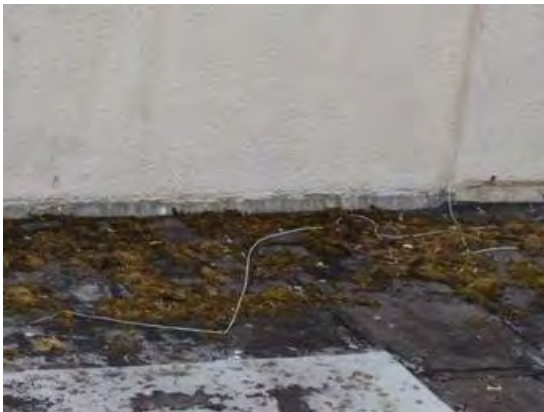
11

**Location:** Upper Roof

**Condition:** Poor

**Comments:** Moss and silt accumulating along the right hand party wall. Undulating leadwork to the upstand

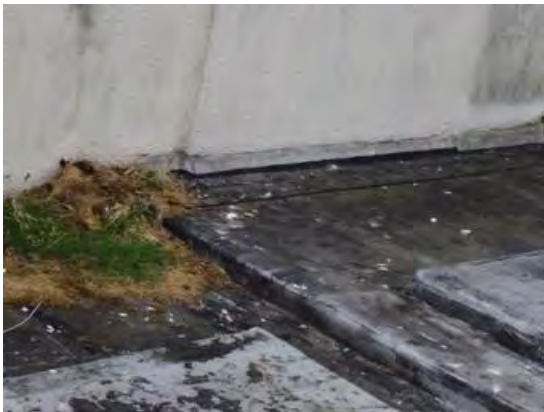
12

**Location:** Upper Roof

**Condition:** Poor

**Comments:** Mass of silt and vegetation - undulating lead flashings

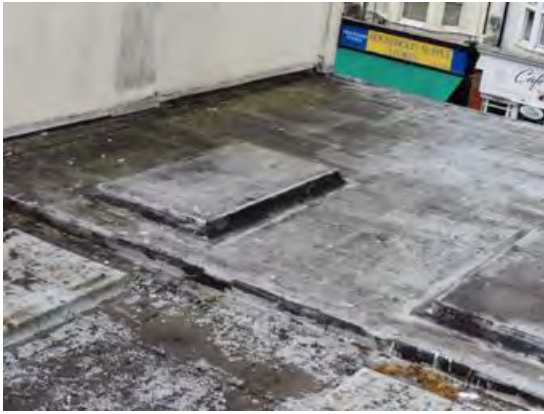
13

**Location:** Upper Roof

**Condition:** Poor

**Decorative Condition:** Very poor

**Comments:** View towards the front of the roof - rooflights have been felted over

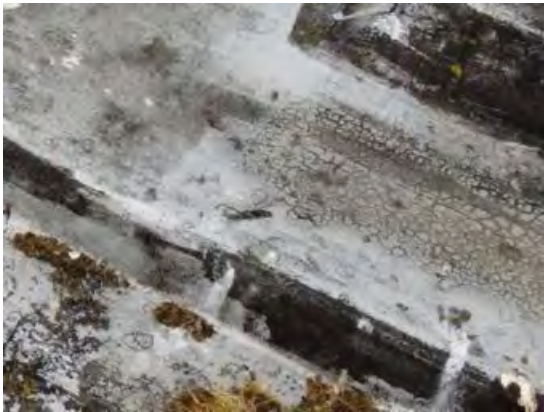
14

**Location:** Upper Roof

**Condition:** Poor

**Comments:** Split and cracked felt cap sheet, felt to the central channel gutter is aged and weathered

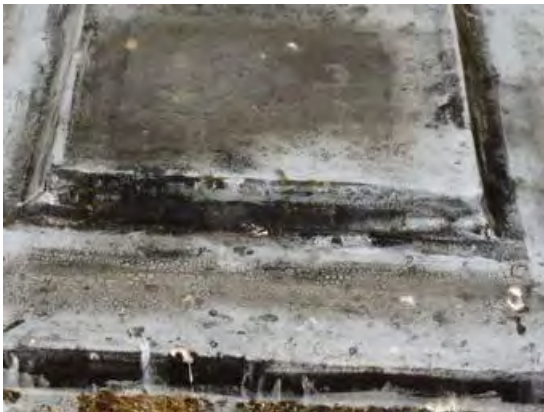
15

**Location:** Upper Roof

**Condition:** Poor

**Decorative Condition:** Very poor

**Comments:** Blistered felt and cracked solar coating

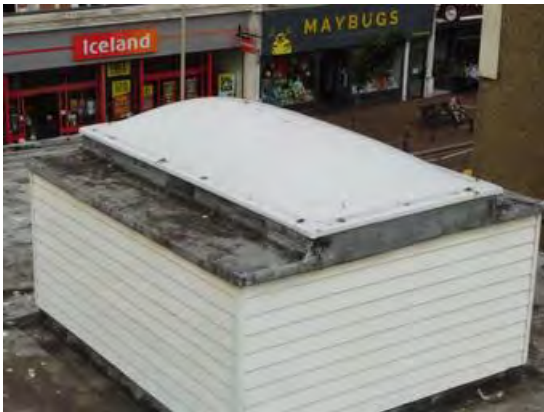
16

**Location:** Upper Roof

**Condition:** Poor

**Comments:** Lift shaft enclosure - leaking, water ingress around the perimeter of the lift shaft

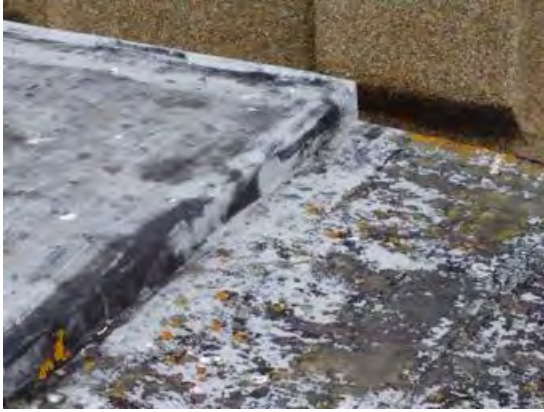
17

**Location:** Upper Roof

**Condition:** Poor

**Decorative Condition:** Very poor

**Comments:** Accumulation of lichen growth and moss, felt and solar reflective coatings are heavily weathered

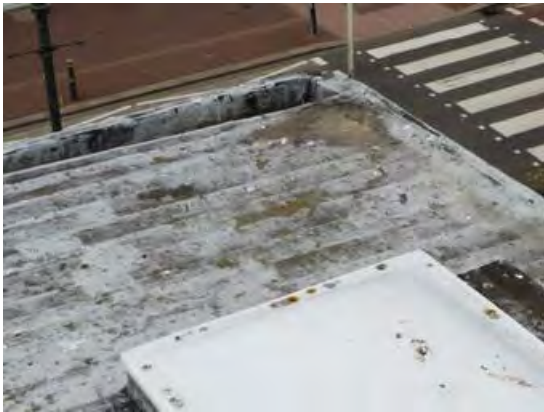
18

**Location:** Upper Roof

**Condition:** Poor

**Decorative Condition:** Very poor

**Comments:** Undulations along the front of the roof - significant leaks noted internally

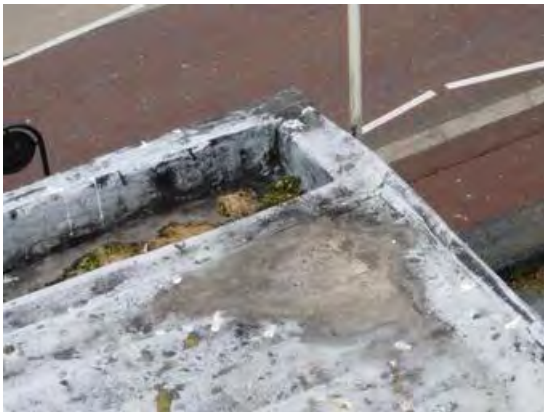
19

**Location:** Upper Roof

**Condition:** Poor

**Decorative Condition:** Very poor

**Comments:** Evidence of ponding to the front left corner, leaks noted internally

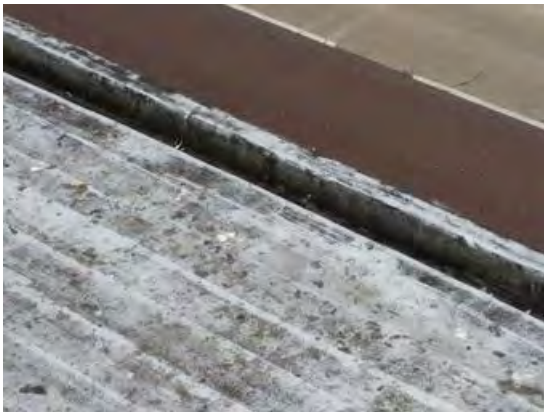
20

**Location:** Upper Roof

**Condition:** Poor

**Decorative Condition:** Very poor

**Comments:** Leaks evident along the front of the roof

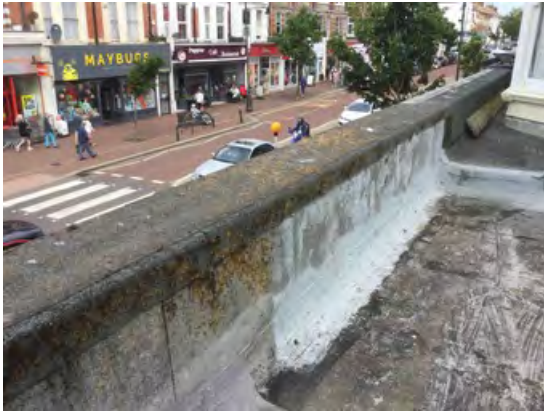
21

**Location:** Lower Roof

**Condition:** Poor

**Comments:** Undulating and weathered felt to the front upstand, liquid sealant applied to the felt

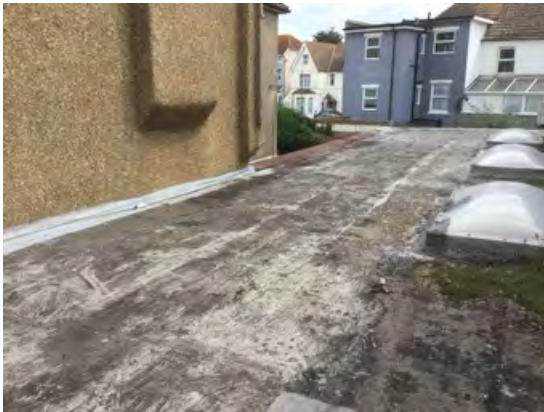
22

**Location:** Lower Roof

**Condition:** Poor

**Decorative Condition:** Very poor

**Comments:** Aged and weathered felt, solar coating weathered away

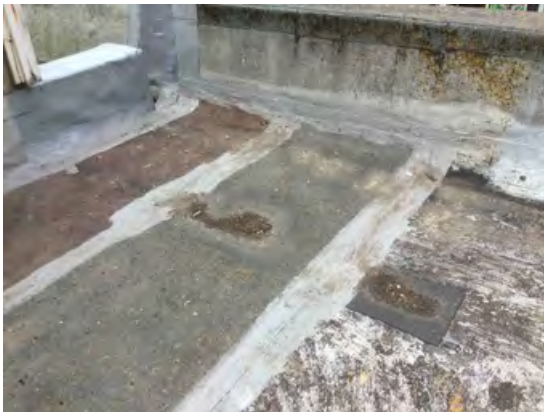
23

**Location:** Lower Roof

**Condition:** Poor

**Comments:** Blistered, undulating felt

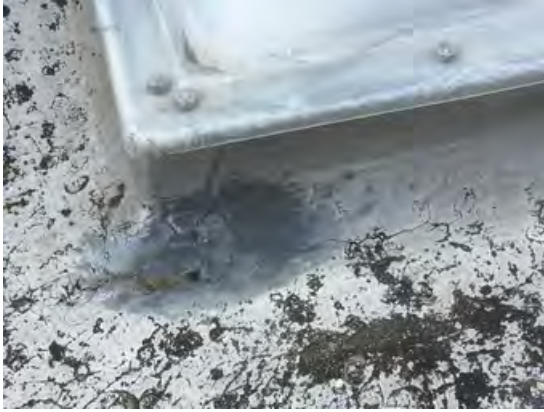
33

**Location:** Lower Roof

**Condition:** Poor

**Comments:** Split upstands, sealant applied to the upstands

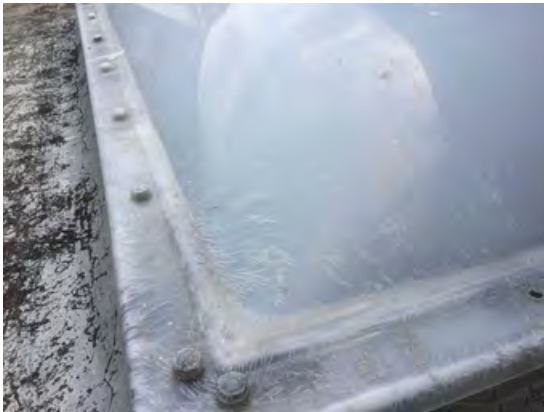
34

**Location:** Lower Roof

**Condition:** Poor

**Comments:** Rear rooflight - solar degraded polycarbonate material

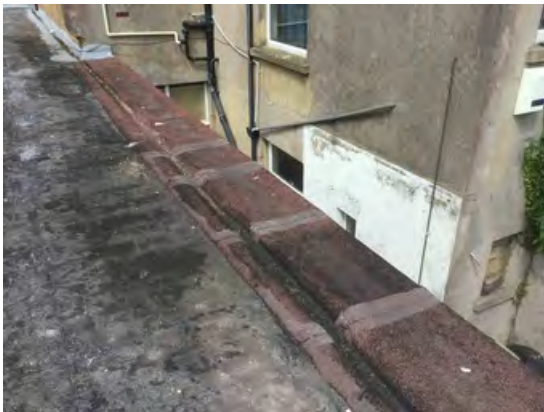
35

**Location:** Lower Roof

**Condition:** Poor

**Comments:** Patch repaired felt edging

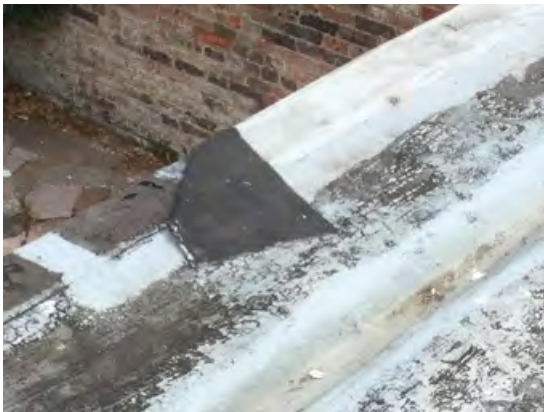
36

**Location:** Lower Roof

**Condition:** Poor

**Comments:** Lifting felt edging

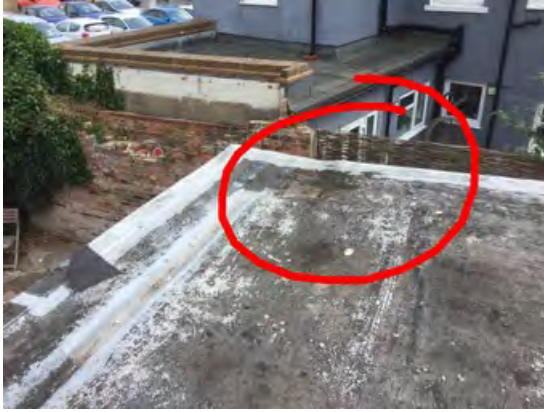
37

**Location:** Lower Roof

**Condition:** Poor

**Comments:** Sealant applied to address roof leaks, undulating felt

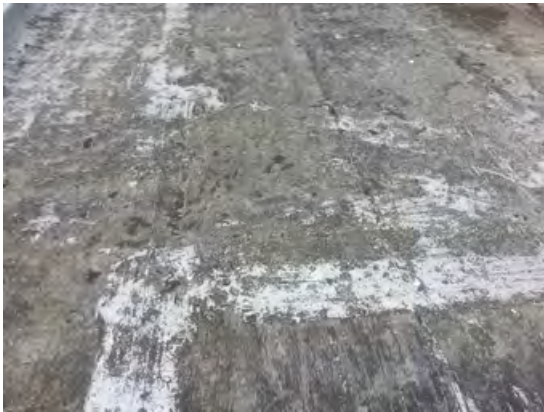
38

**Location:** Lower Roof

**Condition:** Poor

**Comments:** Weathered felt cap sheet

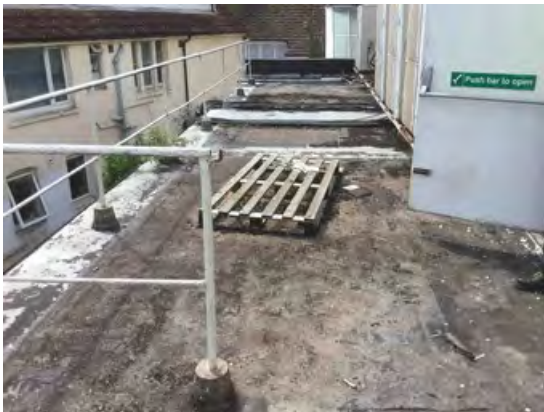
39

**Location:** Lower Roof

**Condition:** Poor

**Comments:** General view - aged, weathered felt. End of life

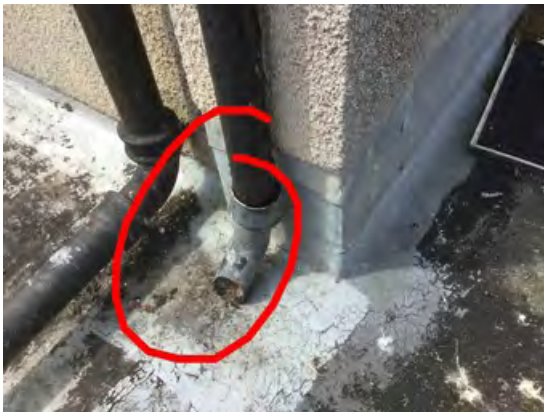
40

**Location:** Lower Roof

**Condition:** Poor

**Decorative Condition:** Poor

**Comments:** Detached shoe to the rear left downpipe

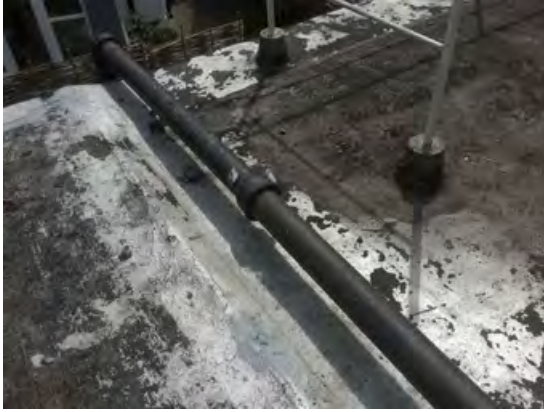
41

**Location:** Lower Roof

**Condition:** Fair

**Decorative Condition:** Poor

**Comments:** Soil vent pipe and downpipes - poor decorative condition

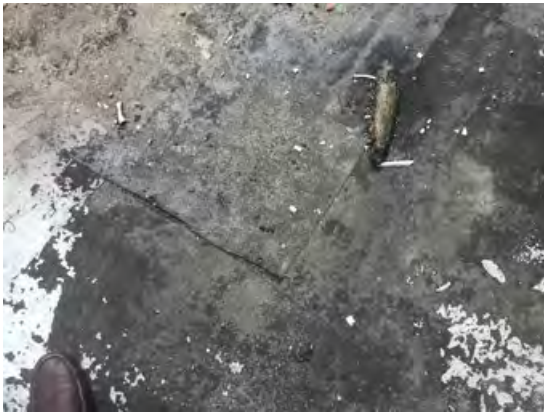
42

**Location:** Lower Roof

**Condition:** Poor

**Comments:** Weathered and lifting felt

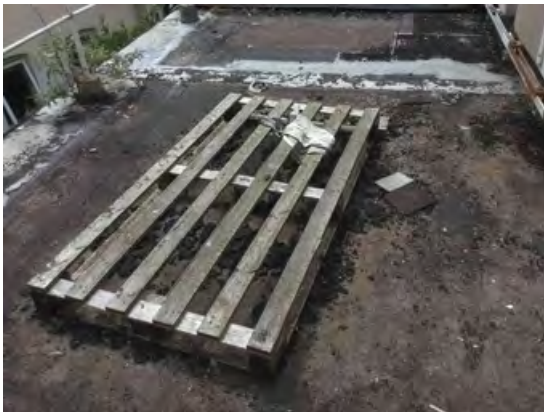
43

**Location:** Lower Roof

**Condition:** Poor

**Comments:** Accumulation of debris on the roof

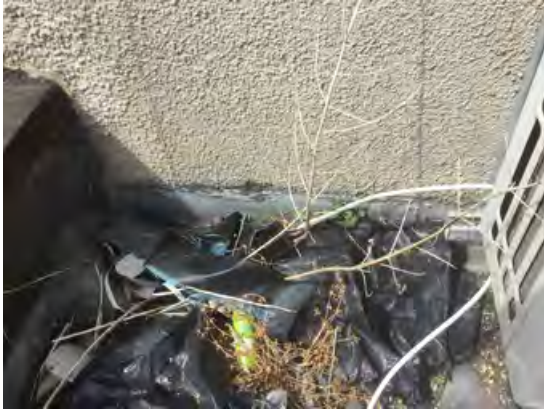
53

**Location:** Lower Roof

**Condition:** Poor

**Comments:** Liquid sealant applied along the rear upstand

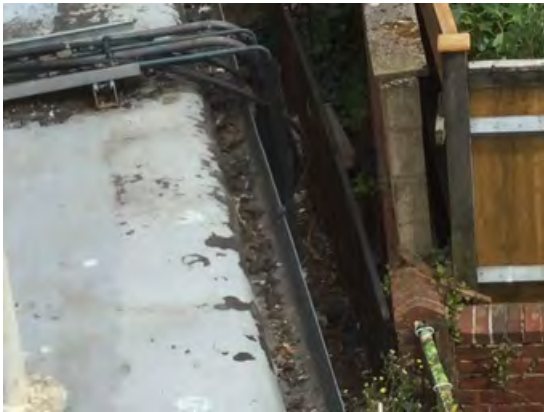
54

**Location:** Lower Roof

**Condition:** Poor

**Comments:** Silted and aged UpVC guttering

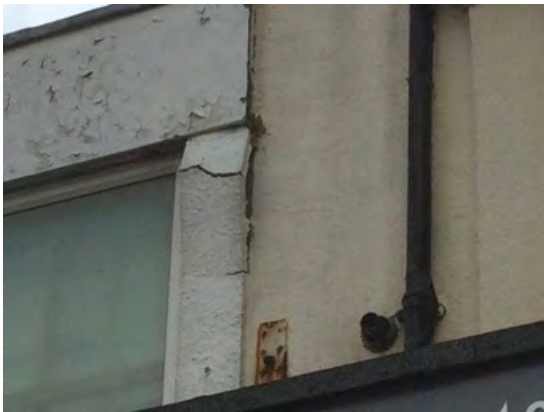
56

**Location:** Front Elevation

**Condition:** Very poor

**Comments:** Spalling render - right column

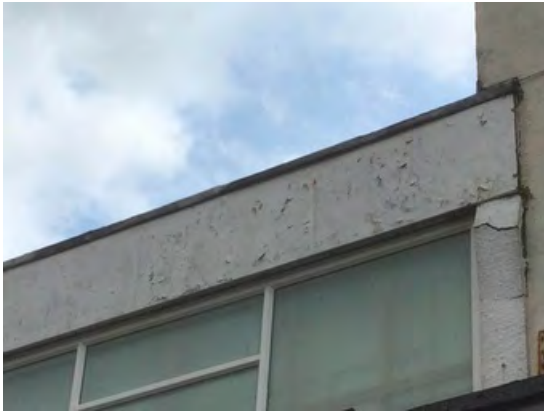
58

**Location:** Front Elevation

**Condition:** Poor

**Decorative Condition:** Very poor

**Comments:** Weathered fascia, flaking paintwork

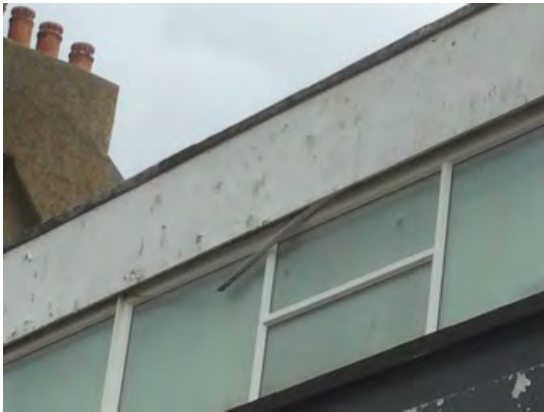
59

**Location:** Front Elevation

**Condition:** Poor

**Comments:** Displaced trim to the centre of the elevation

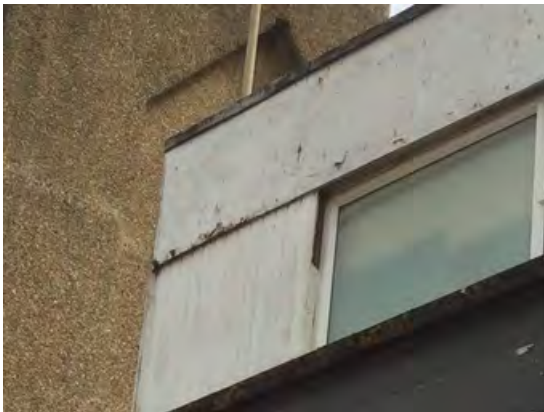
60

**Location:** Front Elevation

**Condition:** Poor

**Decorative Condition:** Very poor

**Comments:** Weathered and delaminating plywood fascia, missing trim to reveal of the cladding panel, upper left corner

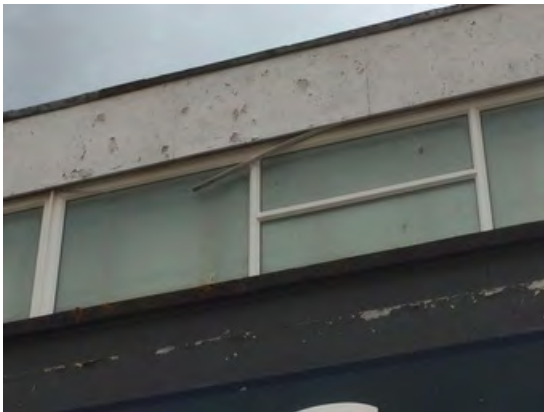
61

**Location:** Front Elevation

**Condition:** Fair

**Comments:** Upper UPVC windows - film applied to the glazing

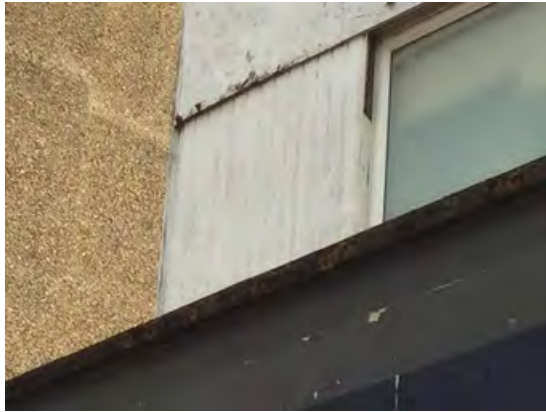
62

**Location:** Front Elevation

**Condition:** Fair

**Decorative Condition:** Poor

**Comments:** Weathered cladding to the upper left corner

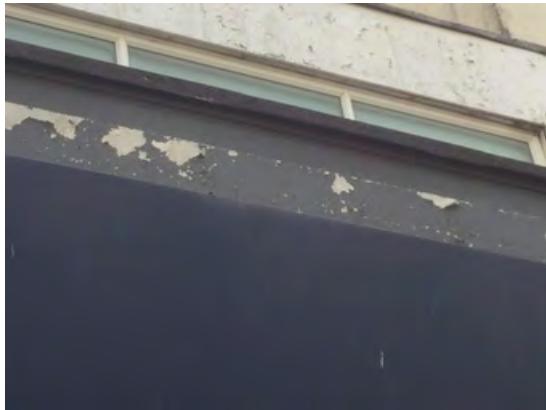
63

**Location:** Front Elevation

**Condition:** Poor

**Decorative Condition:** Poor

**Comments:** Delaminating paintwork to the sign facia

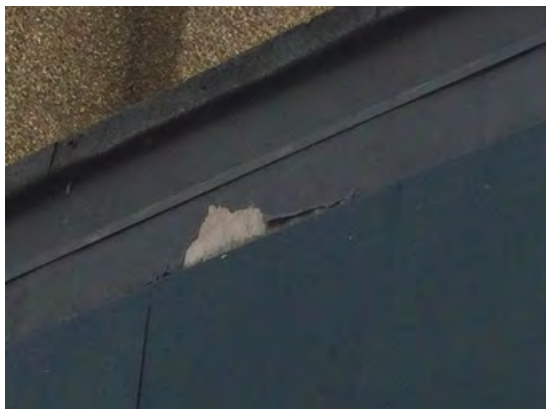
64

**Location:** Front Elevation

**Condition:** Poor

**Decorative Condition:** Poor

**Comments:** Delaminating ply facia over the left hand sign / entrance

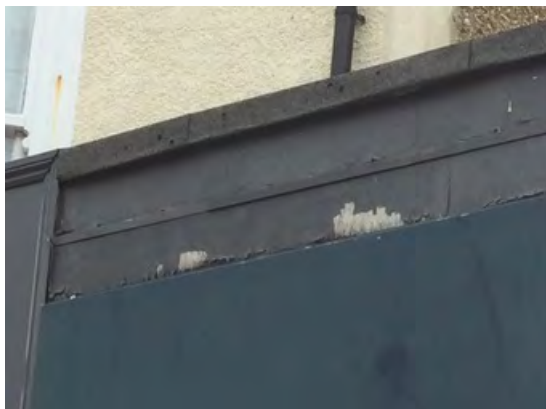
65

**Location:** Front Elevation

**Condition:** Poor

**Decorative Condition:** Poor

**Comments:** Delaminating ply facia

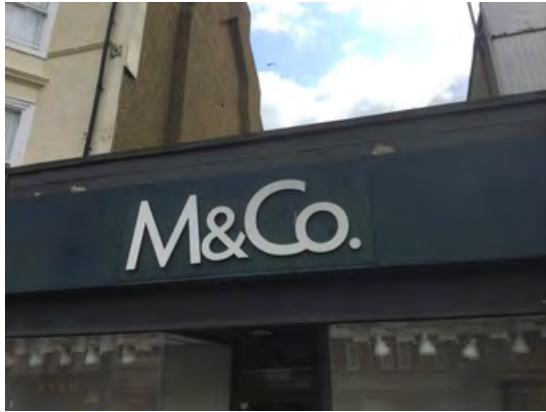
66

**Location:** Front Elevation

**Condition:** Poor

**Comments:** Former tenant signage remain, faded fascia panels

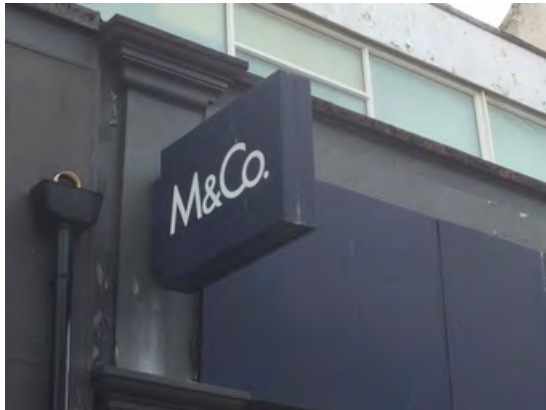
67

**Location:** Front Elevation

**Comments:** Former tenants bus stop sign remains

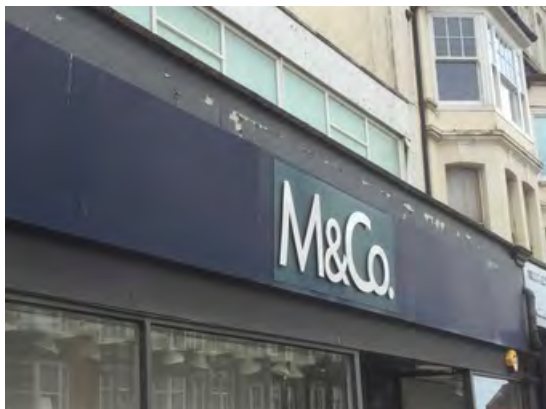
68

**Location:** Front Elevation

**Comments:** Former tenant signage remains, fascia panels are solar faded.

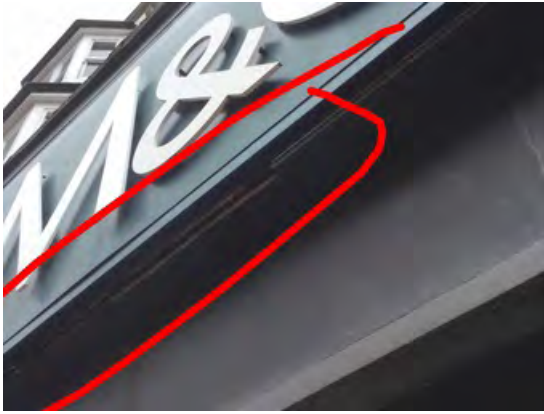
70

**Location:** Front Elevation

**Condition:** Poor

**Comments:** Water damage and missing trim below the signage fascia

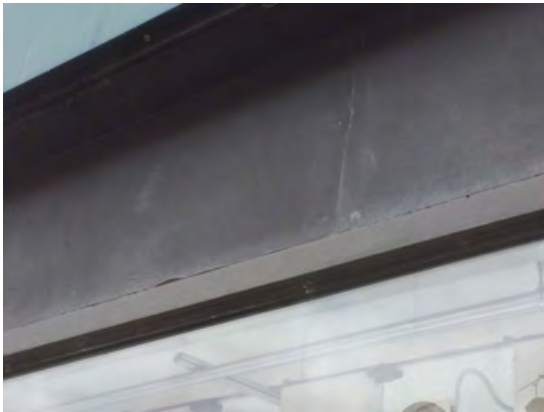
71

**Location:** Front Elevation

**Condition:** Poor

**Decorative Condition:** Poor

**Comments:** Faded and delaminating plywood over the shop windows

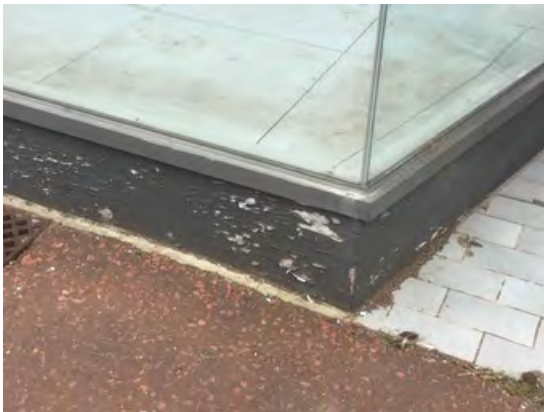
72

**Location:** Front Elevation

**Condition:** Poor

**Decorative Condition:** Poor

**Comments:** Delaminating plywood stall riser

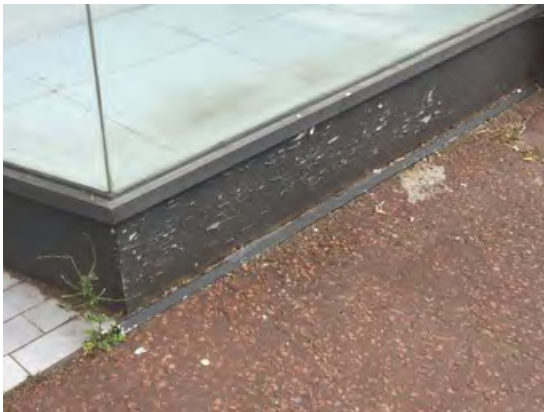
73

**Location:** Front Elevation

**Condition:** Poor

**Decorative Condition:** Very poor

**Comments:** Delaminating stall riser panels

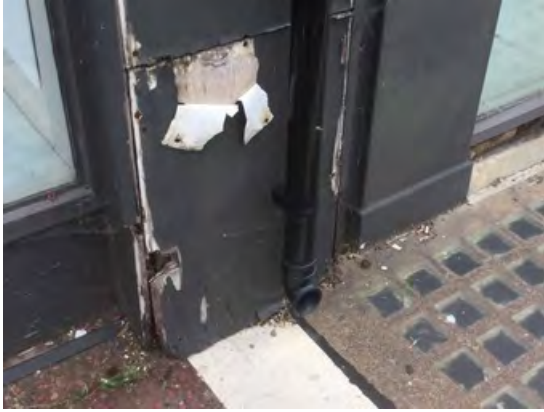
74

**Location:** Front Elevation  
**Condition:** Very poor  
**Decorative Condition:** Very poor  
**Comments:** Decayed plywood column facing

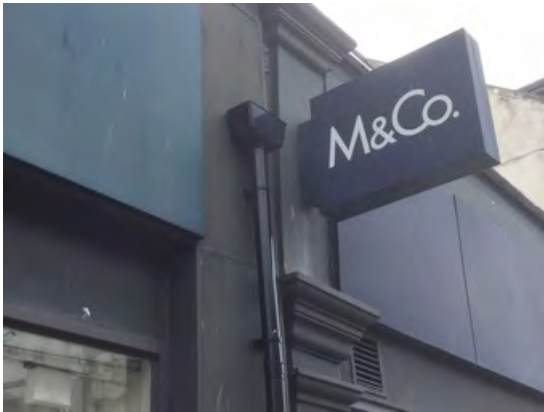
75

**Location:** Front Elevation  
**Condition:** Fair  
**Decorative Condition:** N/a  
**Comments:** UPVC downpipe - fair condition

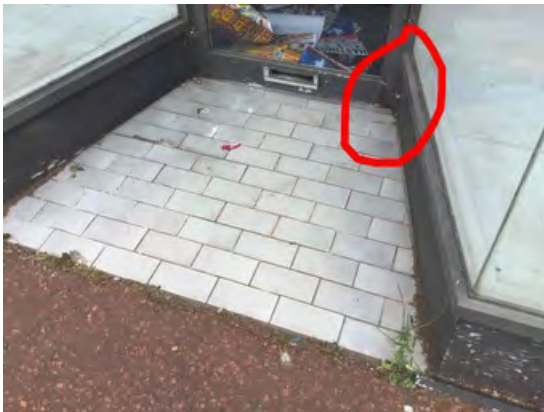
76

**Location:** Front Elevation  
**Condition:** Fair  
**Decorative Condition:** N/a  
**Comments:** Weed growth and soiling affecting the tiled threshold, 1no cracked tile

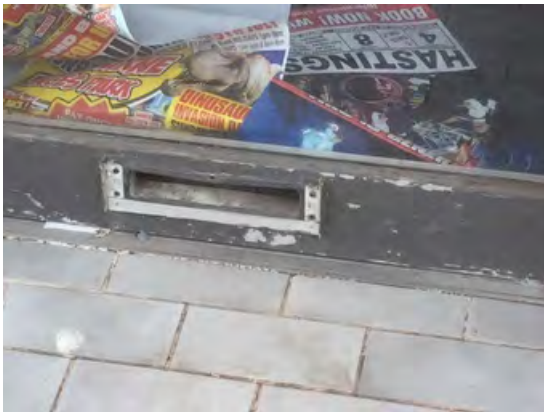
77

**Location:** Front Elevation  
**Condition:** Poor  
**Decorative Condition:** Poor  
**Comments:** Missing letter box cover, flaking paintwork

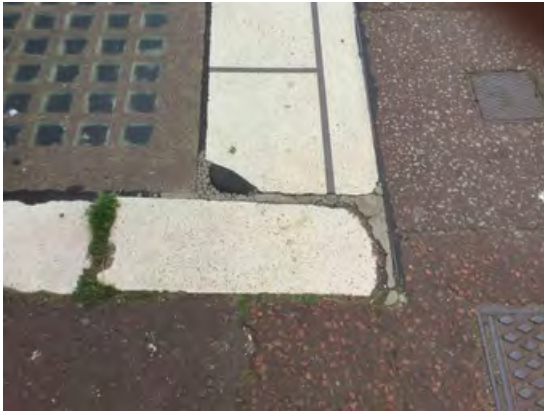
82

**Location:** Front Elevation

**Condition:** Poor

**Comments:** Displaced paving

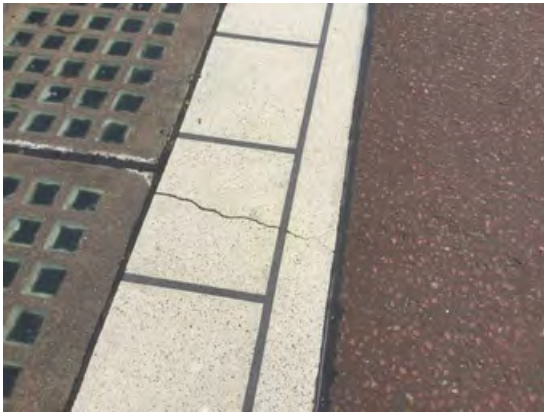
83

**Location:** Front Elevation

**Condition:** Poor

**Comments:** Cracked paving

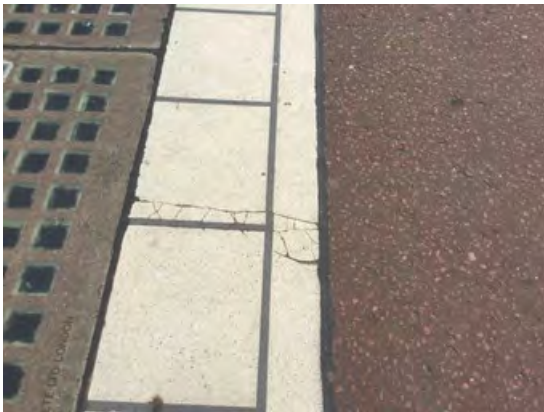
84

**Location:** Front Elevation

**Condition:** Poor

**Comments:** Cracked paving

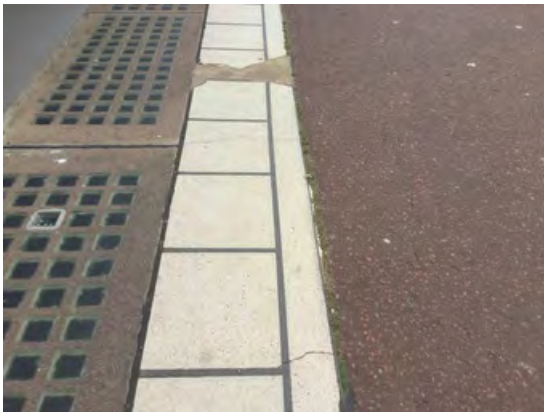
85

**Location:** Front Elevation

**Condition:** Poor

**Comments:** Cracked and patch repaired paving

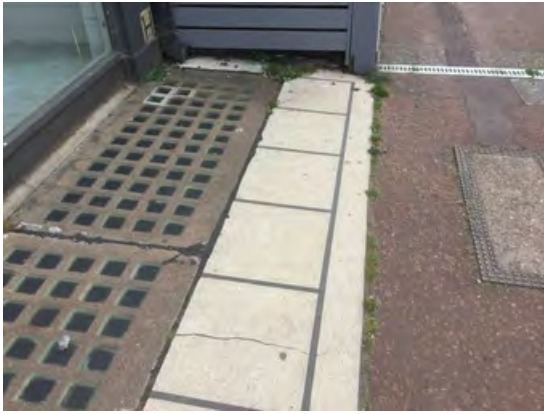
86

**Location:** Front Elevation

**Condition:** Poor

**Comments:** Cracked paving - weed growth and general soiling

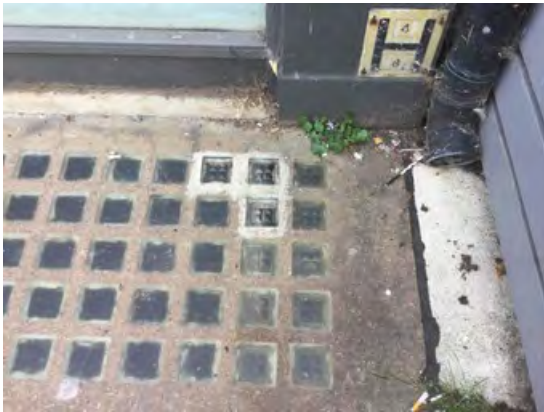
87

**Location:** Front Elevation

**Condition:** Fair

**Comments:** Repaired glazing to the basement lights

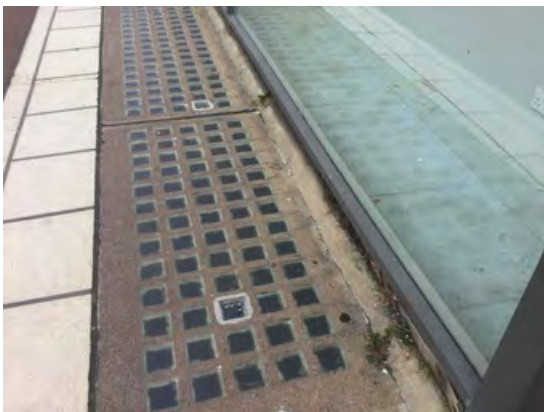
88

**Location:** Front Elevation

**Condition:** Fair

**Comments:** Repaired glazing to the basement lights

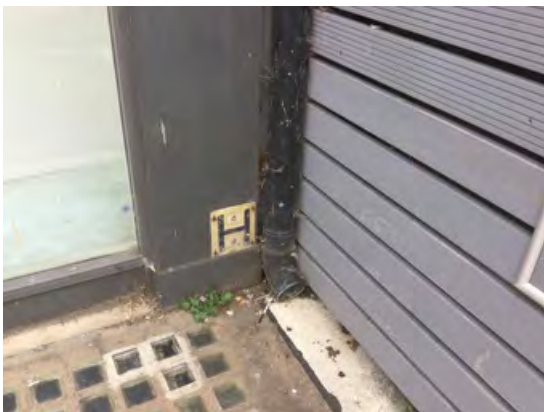
89

**Location:** Front Elevation

**Condition:** Fair

**Decorative Condition:** Poor

**Comments:** Right hand downpipe - flaking paintwork

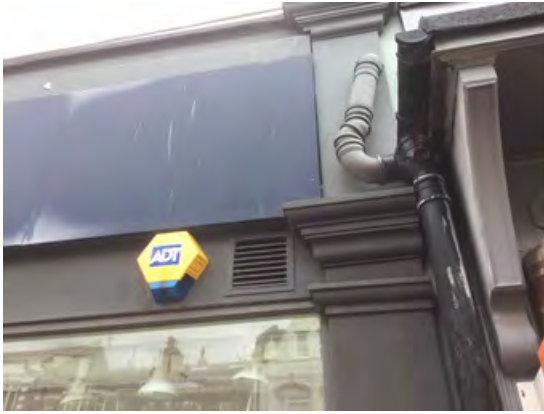
90

**Location:** Front Elevation

**Comments:** Former tenants security systems remain

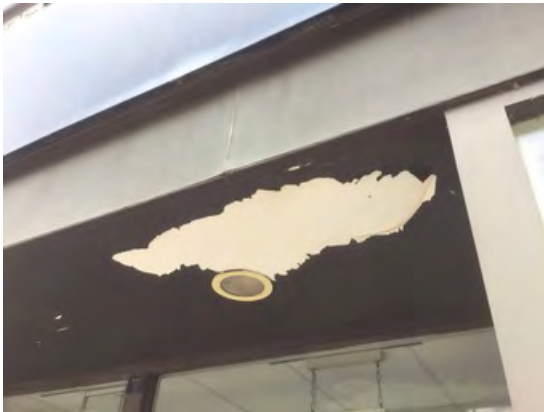
91

**Location:** Front Elevation

**Condition:** Poor

**Decorative Condition:** Poor

**Comments:** Facia and soffit panels - affected by weathering, leaks from the canopy roof

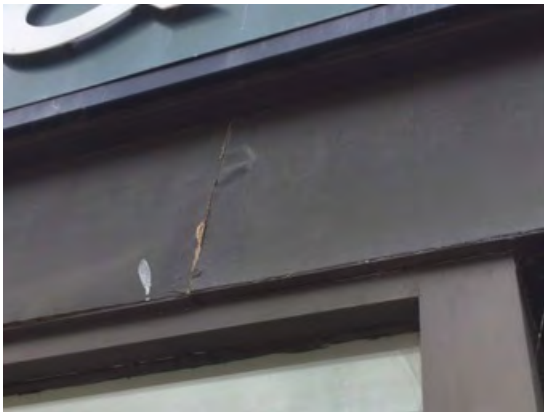
92

**Location:** Front Elevation

**Condition:** Poor

**Decorative Condition:** Poor

**Comments:** Delaminating ply facia

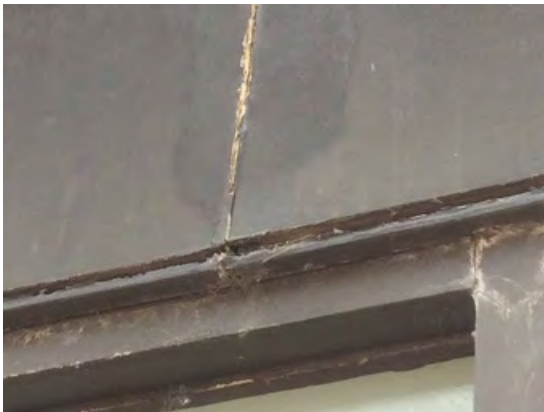
93

**Location:** Front Elevation

**Condition:** Poor

**Decorative Condition:** Poor

**Comments:** Delaminating ply facia, missing sealant to joint between facia and frame. Displaced beading

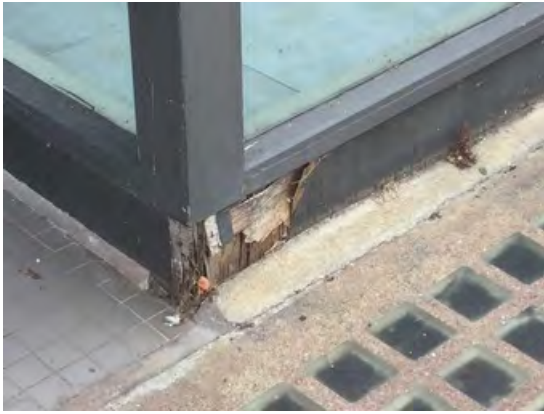
98

**Location:** Front Elevation

**Condition:** Very poor

**Decorative Condition:** Very poor

**Comments:** Rotten stall riser

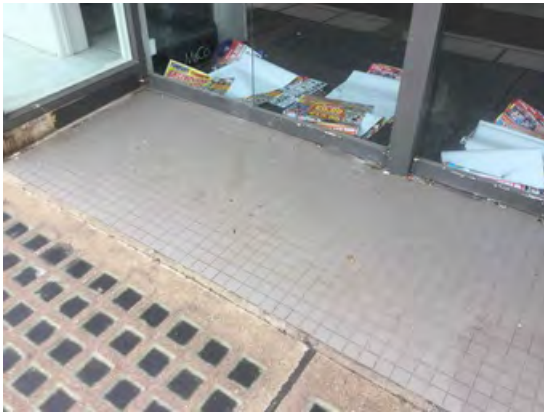
99

**Location:** Front Elevation

**Condition:** Fair

**Comments:** Tiled threshold - soiled, fair condition

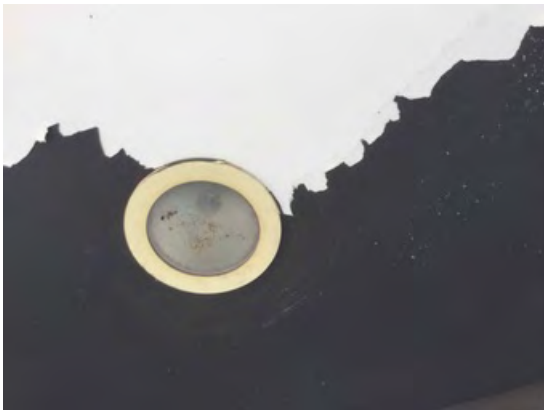
100

**Location:** Front Elevation

**Condition:** Poor

**Comments:** Defective soffit lights

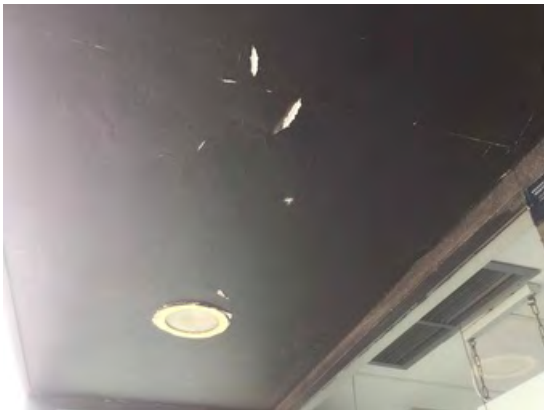
101

**Location:** Front Elevation

**Condition:** Poor

**Decorative Condition:** Poor

**Comments:** Lifting paint finish to the soffit panel

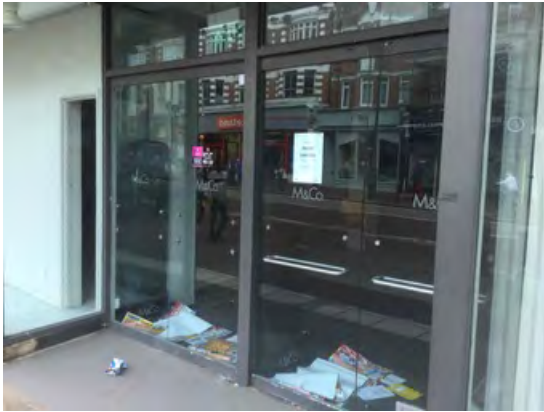
102

**Location:** Front Elevation

**Condition:** Fair

**Decorative Condition:** Poor

**Comments:** Entrance door - operational, scuffed and weathered paintwork

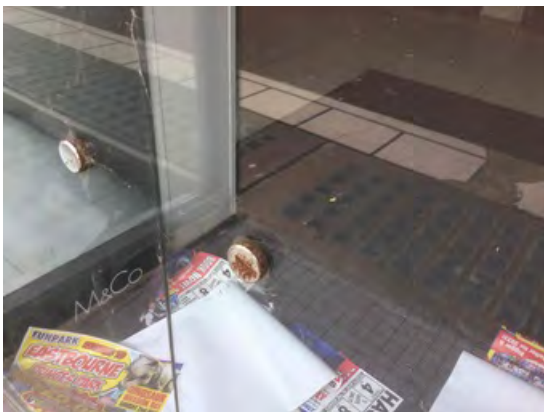
103

**Location:** Front Elevation

**Condition:** Poor

**Comments:** Corroding glazing fixings

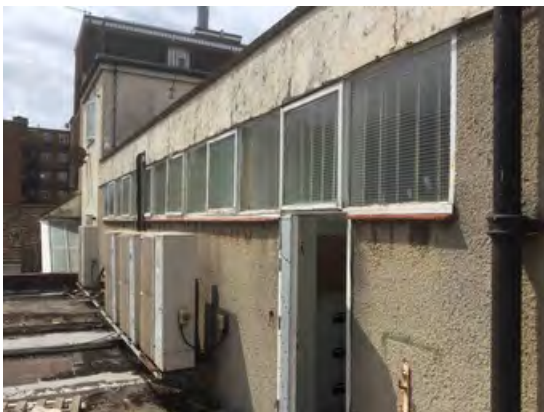
104

**Location:** Rear Elevation

**Decorative Condition:** Poor

**Comments:** General view, poor decorative condition throughout

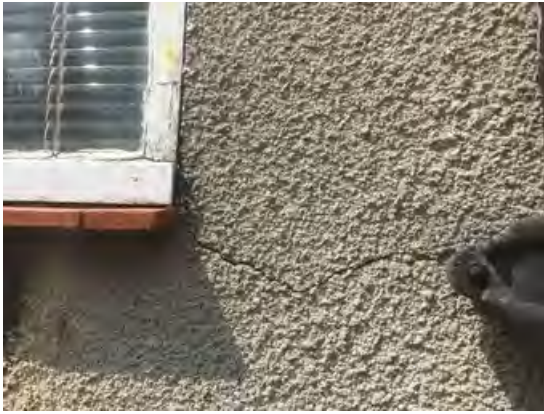
105

**Location:** Rear Elevation

**Condition:** Poor

**Comments:** Cracking - lower right corner of the windows

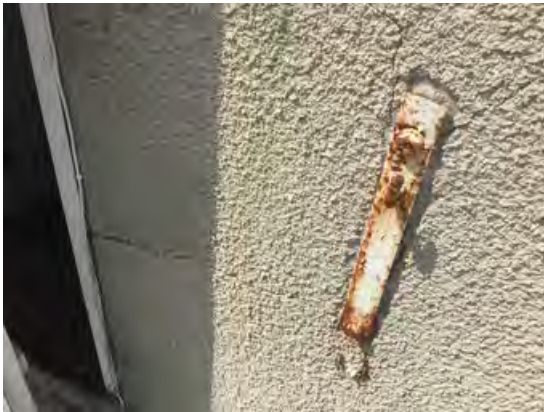
106

**Location:** Rear Elevation

**Condition:** Poor

**Comments:** Cracking to the right of the roof access door

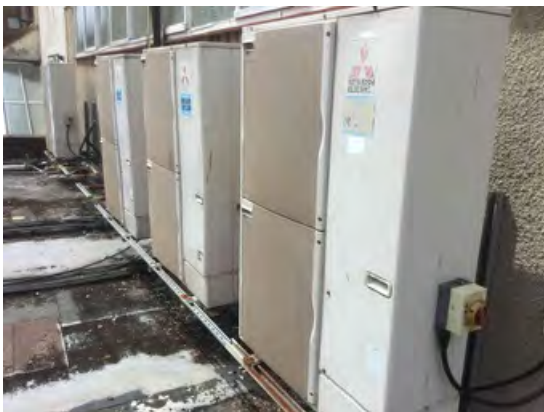
107

**Location:** Rear Elevation

**Condition:** Poor

**Comments:** Aged AC units, 'end of life'

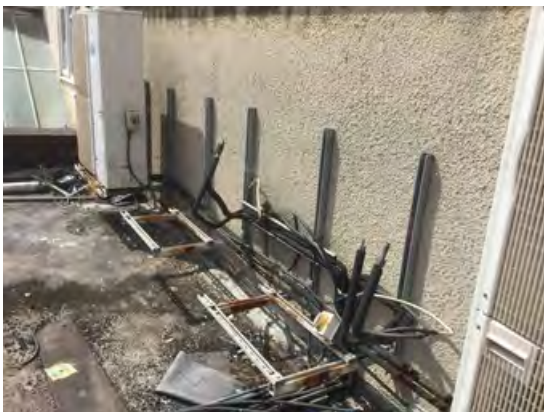
108

**Location:** Rear Elevation

**Condition:** Poor

**Comments:** Remnants of old AC units, corroding brackets

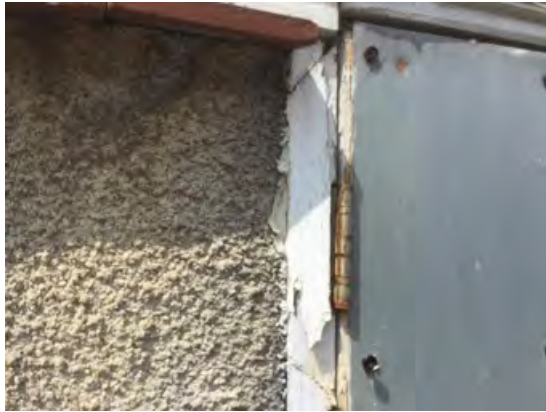
113

**Location:** Rear Elevation

**Condition:** Poor

**Decorative Condition:** Poor

**Comments:** Split door frame

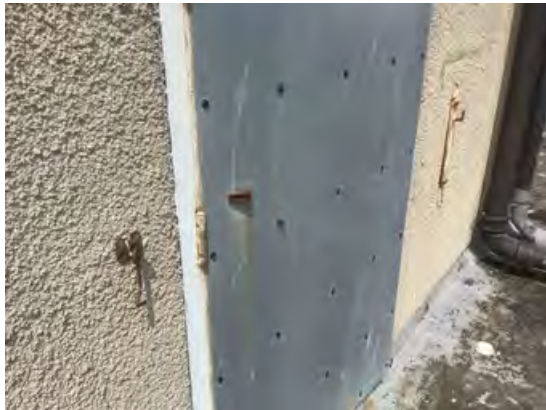
114

**Location:** Rear Elevation

**Condition:** Poor

**Decorative Condition:** Poor

**Comments:** Roof access door - corroding hinges and fixings, door is sticking

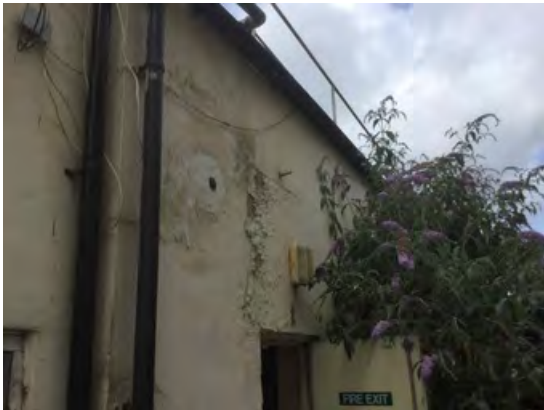
119

**Location:** Rear Elevation

**Condition:** Poor

**Decorative Condition:** Very poor

**Comments:** Weathered and spalling render

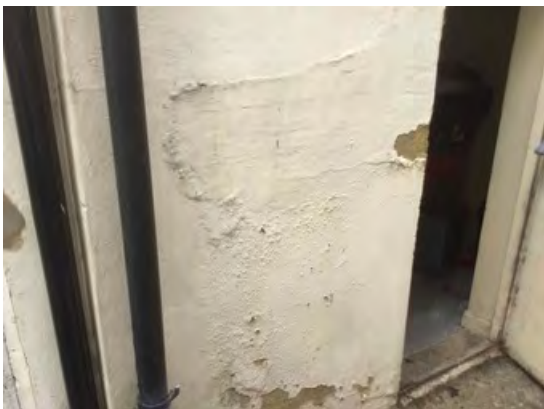
120

**Location:** Rear Elevation

**Condition:** Poor

**Decorative Condition:** Very poor

**Comments:** Cracked, weathered render. Spalling paintwork

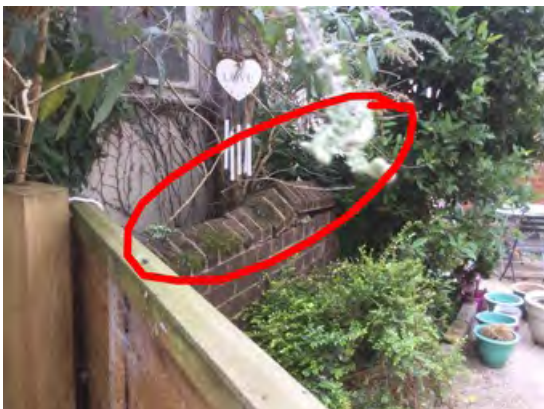
124

**Location:** Rear Elevation

**Condition:** Poor

**Comments:** Vegetation growth along the rear elevation

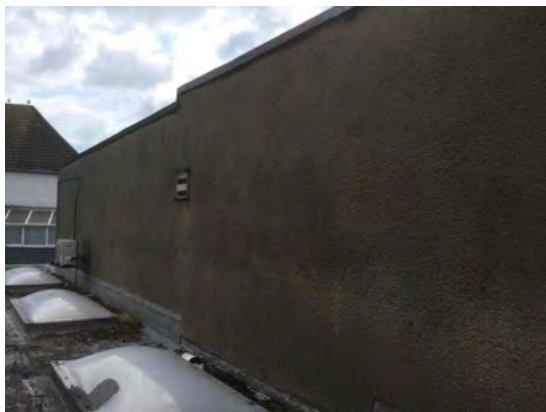
133

**Location:** Left Elevation

**Condition:** Very poor

**Comments:** Rotten timber batten

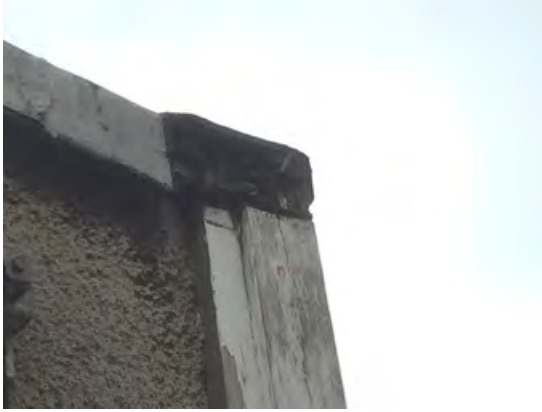
134

**Location:** Left Elevation

**Condition:** Poor

**Decorative Condition:** Very poor

**Comments:** Split and decayed timber corner batten

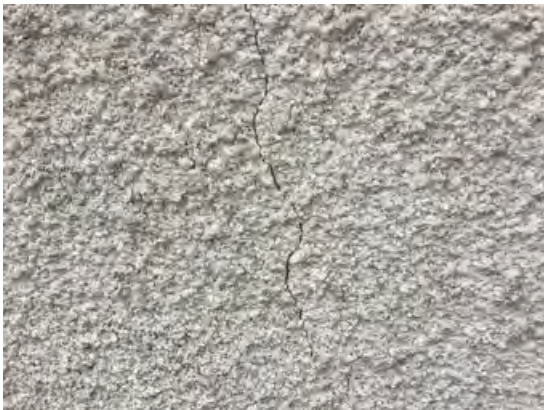
140

**Location:** Left Elevation

**Condition:** Poor

**Comments:** Cracking aside the AC unit

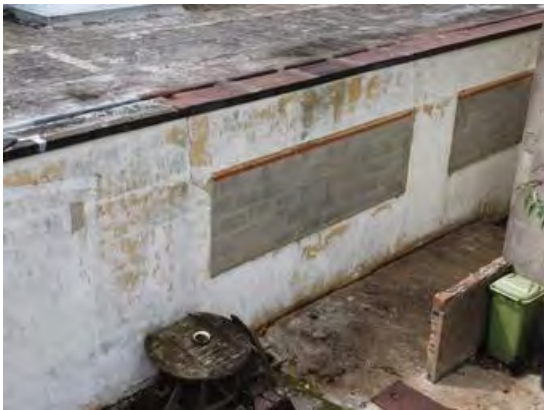
144

**Location:** Left Elevation

**Condition:** Poor

**Decorative Condition:** Poor

**Comments:** Weathered render. Marks on the surface of the render indicate the presence of a former abutting structure

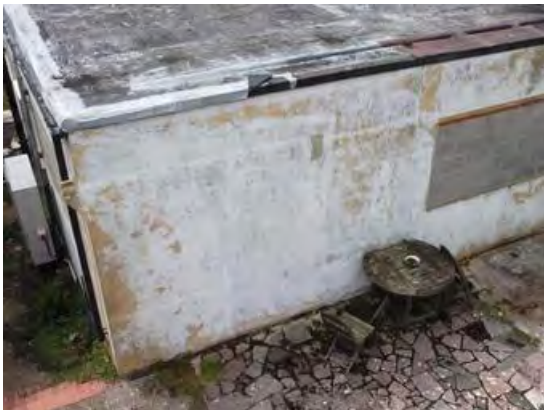
145

**Location:** Left Elevation

**Condition:** Poor

**Decorative Condition:** Poor

**Comments:** Chipped and spalling render at low level

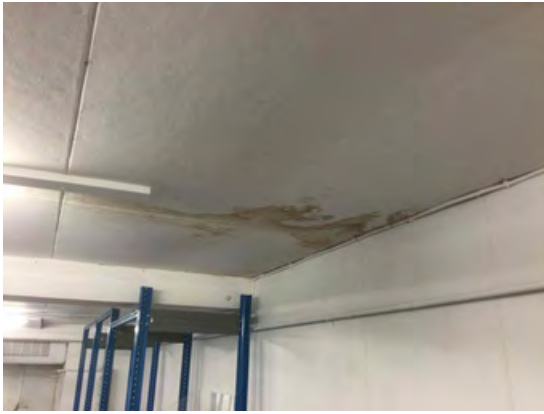
149

**Location:** Front stockroom

**Condition:** Poor

**Decorative Condition:** Poor

**Comments:** Water damage and penetrating dampness along the left elevation

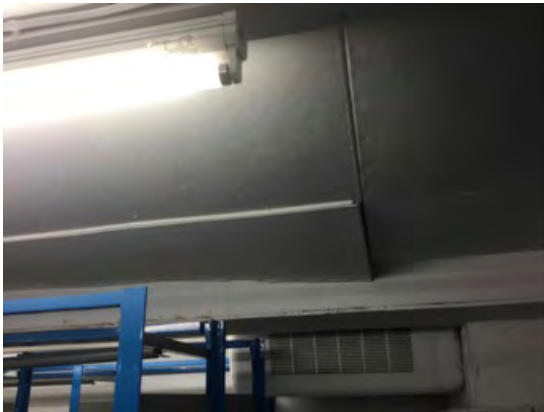
150

**Location:** Front stockroom

**Condition:** Poor

**Decorative Condition:** Poor

**Comments:** Bowing and displaced ceiling lining panels
