**55-57 Devonshire Rd, Bexhill-on-Sea**

**Schedule of Condition UK**

**Inspected by: Philip Cushion**

**Inspection Date: 03 July 2023**

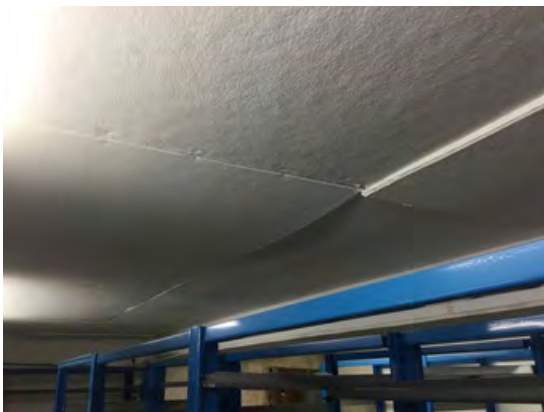
151

**Location:** Front stockroom

**Condition:** Poor

**Decorative Condition:** Poor

**Comments:** Bowing ceiling panels

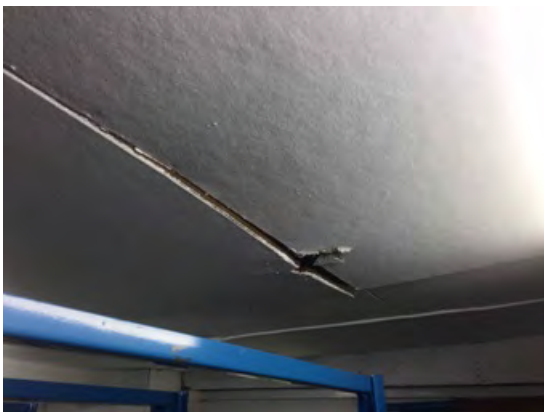
152

**Location:** Front stockroom

**Condition:** Poor

**Decorative Condition:** Poor

**Comments:** Displaced ceiling panels

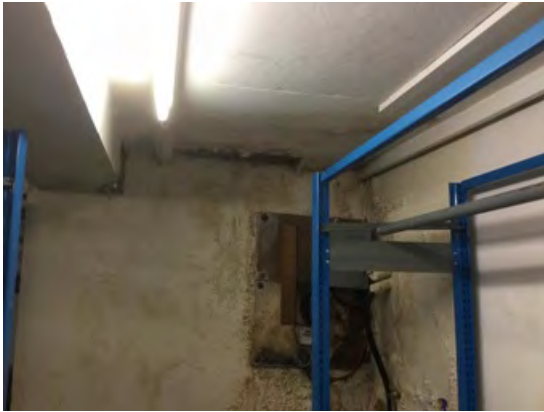
153

**Location:** Front stockroom

**Condition:** Very poor

**Decorative Condition:** Very poor

**Comments:** Severe penetrating dampness

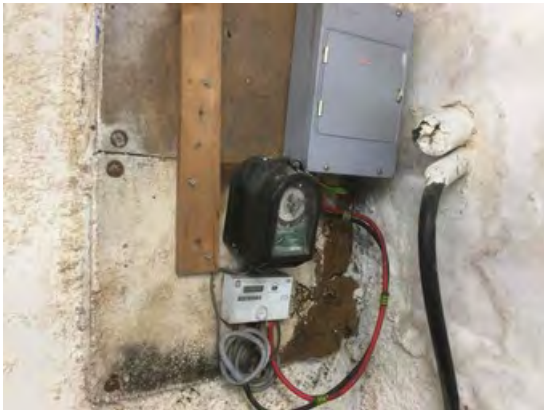
154

**Location:** Front stockroom

**Condition:** Very poor

**Decorative Condition:** N/a

**Comments:** Backer board for the electrical meter has completely disintegrated

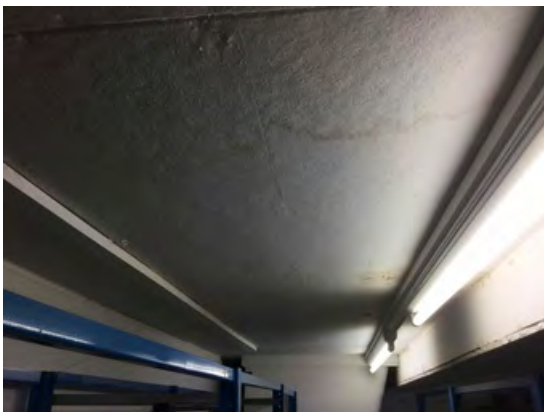
155

**Location:** Front stockroom

**Condition:** Poor

**Decorative Condition:** Poor

**Comments:** Water staining along the front elevation

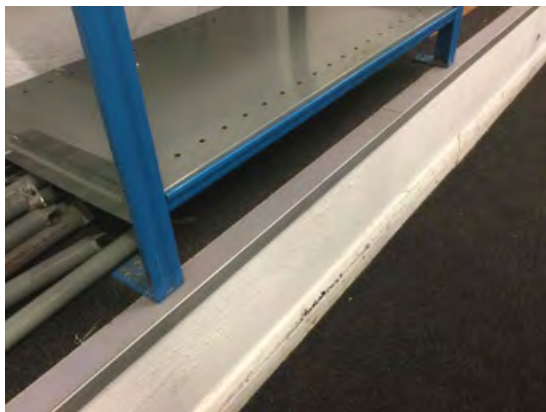
160

**Location:** Front stockroom

**Condition:** Poor

**Decorative Condition:** Poor

**Comments:** Penetrating dampness at low level

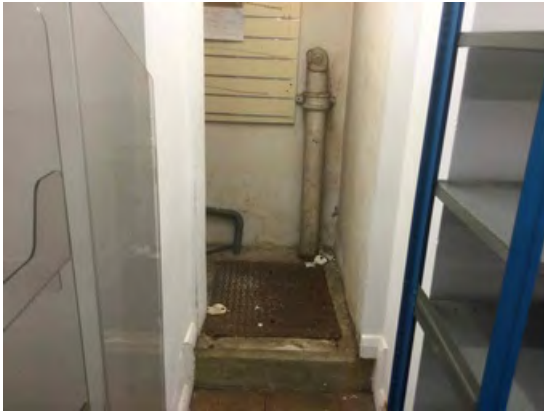
161

**Location:** Front stockroom

**Condition:** Poor

**Decorative Condition:** Poor

**Comments:** Raised area to the rear - poor decorative condition

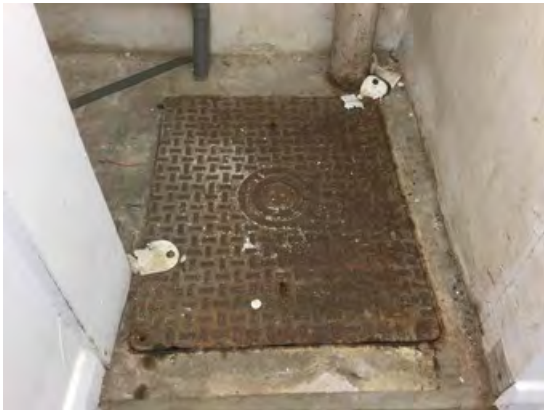
162

**Location:** Front stockroom

**Condition:** Poor

**Decorative Condition:** N/a

**Comments:** Drains not inspected, corroding man hole cover

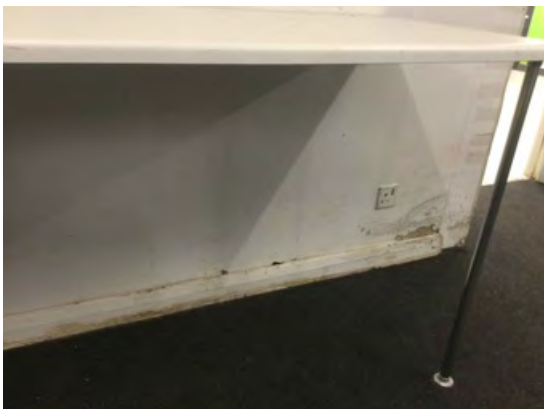
163

**Location:** Front stockroom

**Condition:** Poor

**Decorative Condition:** Very poor

**Comments:** Rising dampness to internal walls

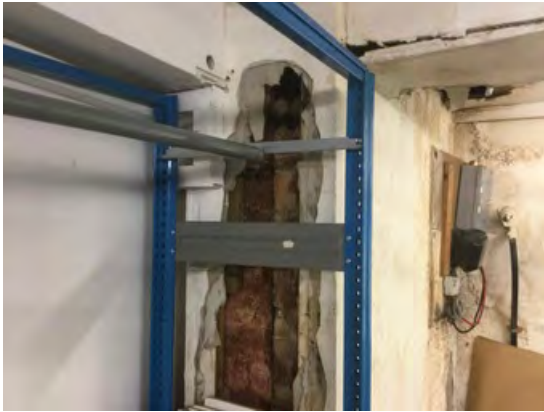
165

**Location:** Front stockroom

**Condition:** Very poor

**Decorative Condition:** N/a

**Comments:** Water damage exposing a corroding steel column

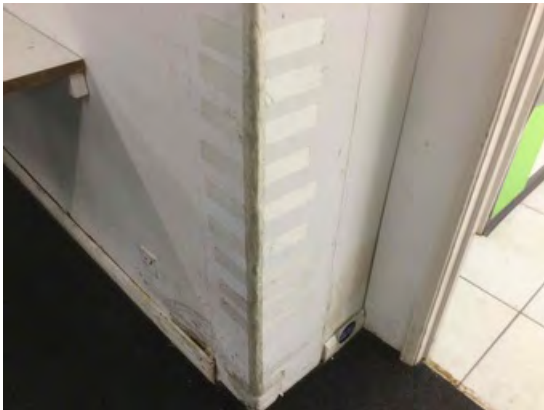
166

**Location:** Front stockroom

**Condition:** Poor

**Decorative Condition:** Poor

**Comments:** Impact damage aside the entrance door

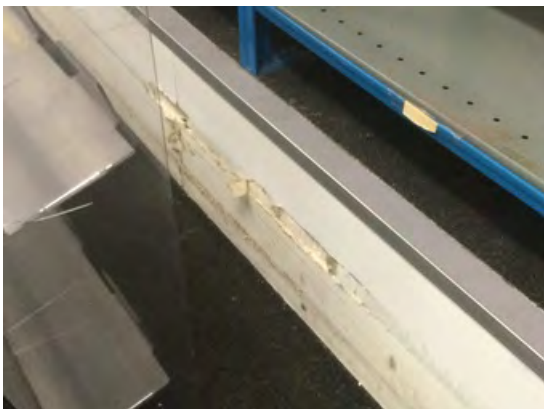
167

**Location:** Front stockroom

**Condition:** Poor

**Decorative Condition:** Poor

**Comments:** Impact damage to the rear at low level

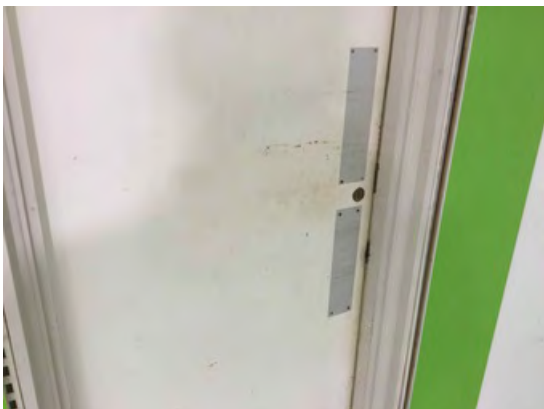
168

**Location:** Welfare lobby

**Condition:** Poor

**Decorative Condition:** Poor

**Comments:** Scuffed and impact damaged door leading from the basement sales area

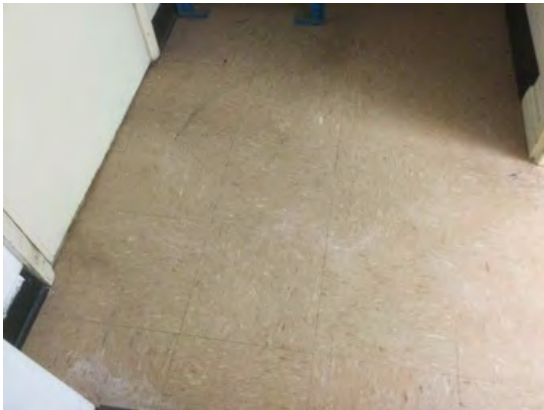
170

**Location:** Welfare lobby

**Condition:** Poor

**Decorative Condition:** N/a

**Comments:** Worn, stained and scuffed vinyl flooring

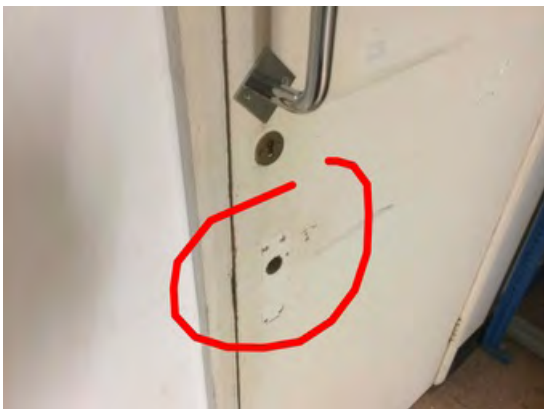
171

**Location:** Welfare lobby

**Condition:** Poor

**Decorative Condition:** N/a

**Comments:** Door handle missing to the basement sales area

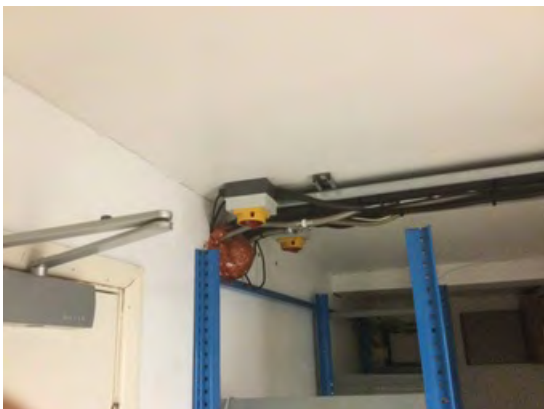
172

**Location:** Welfare lobby

**Condition:** Poor

**Decorative Condition:** N/a

**Comments:** Fire foam used to seal various service penetrations

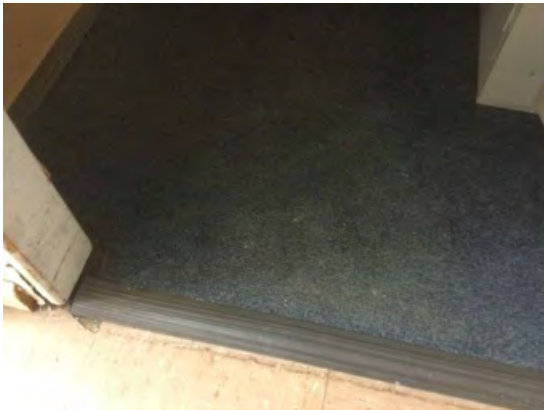
174

**Location:** Welfare lobby

**Condition:** Poor

**Decorative Condition:** N/a

**Comments:** Worn carpets leading to the WCs

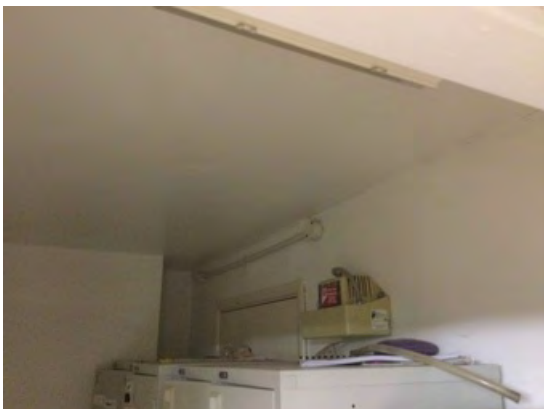
175

**Location:** Welfare lobby

**Condition:** Poor

**Decorative Condition:** N/a

**Comments:** No lighting provided to the outer lobby leading to the WCs

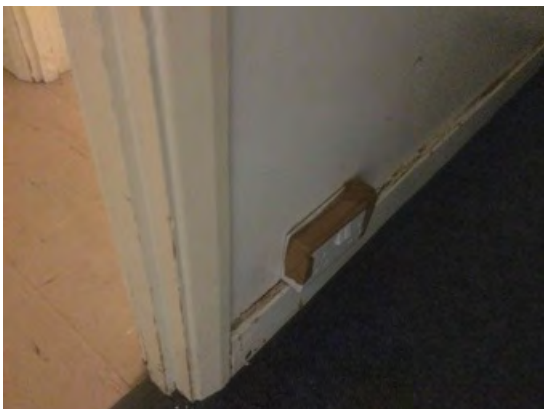
176

**Location:** Welfare lobby

**Condition:** Very poor

**Decorative Condition:** Very poor

**Comments:** Damaged electrical sockets

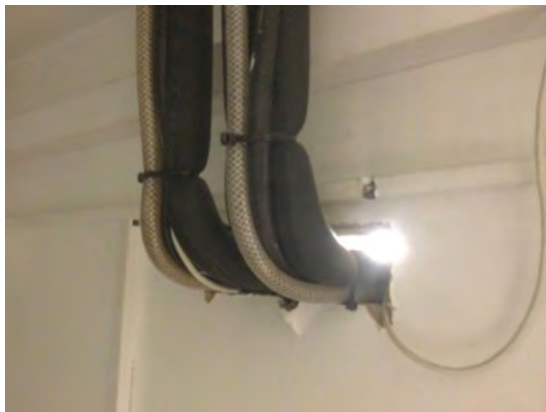
178

**Location:** Welfare lobby

**Condition:** Poor

**Decorative Condition:** N/a

**Comments:** Service penetrations not fire stopped

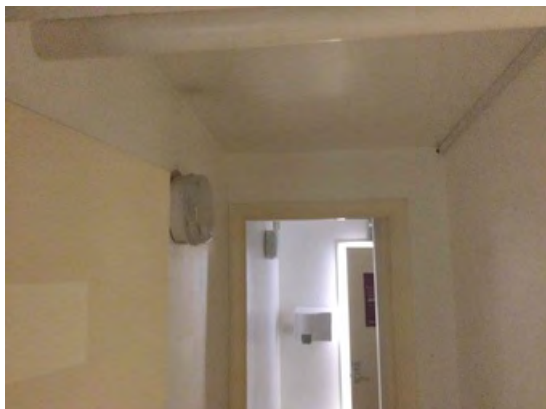
179

**Location:** WCs

**Condition:** Poor

**Decorative Condition:** N/a

**Comments:** General view - lighting defective to the outer lobby

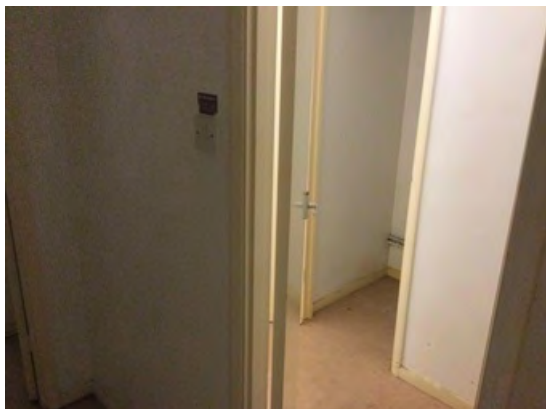
180

**Location:** WCs

**Condition:** N/a

**Decorative Condition:** Poor

**Comments:** Poor decorative condition throughout

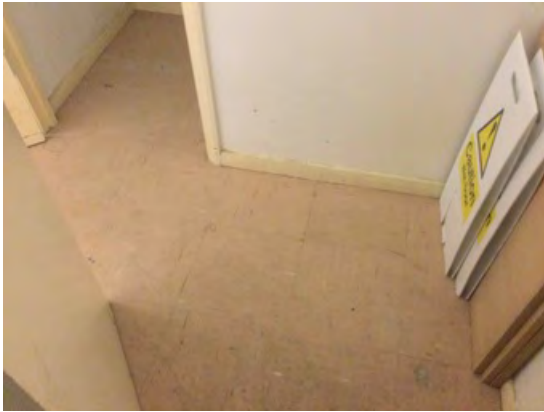
181

**Location:** WCs

**Condition:** Poor

**Decorative Condition:** N/a

**Comments:** Vinyl flooring - worn and soiled throughout

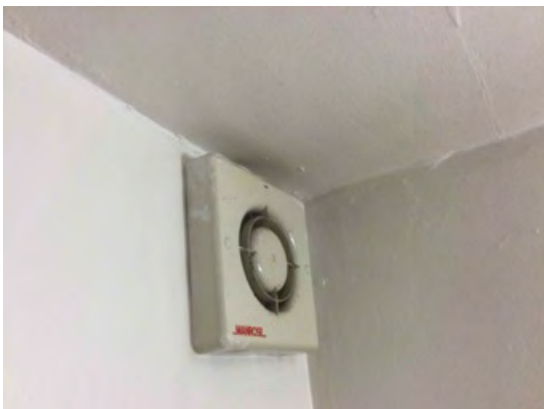
183

**Location:** WCs

**Condition:** Poor

**Decorative Condition:** N/a

**Comments:** Noisy soiled extractors

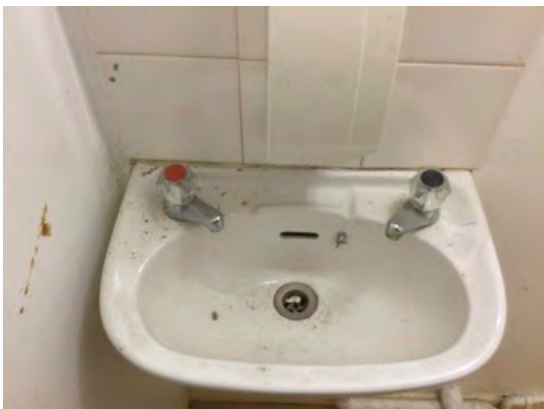
184

**Location:** WCs

**Condition:** Poor

**Decorative Condition:** N/a

**Comments:** Soiled wash basin, taps seized

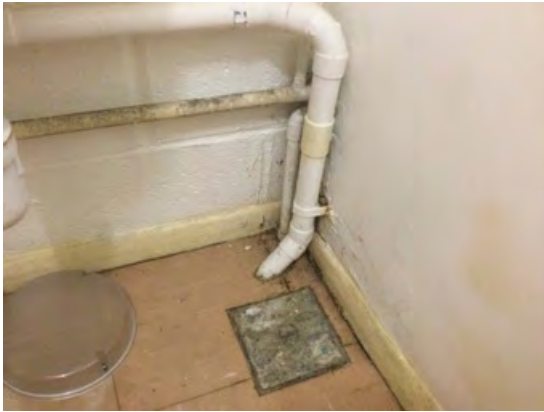
185

**Location:** WCs

**Condition:** Poor

**Decorative Condition:** N/a

**Comments:** Male WC - rising dampness

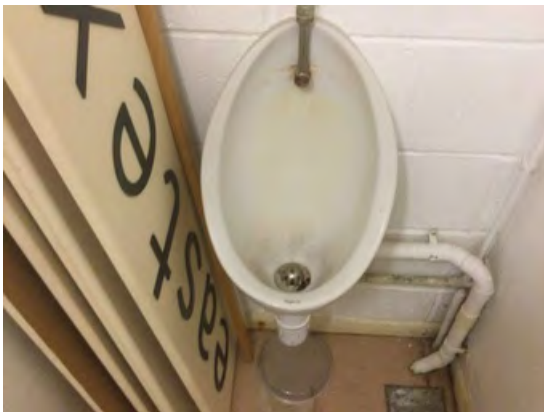
186

**Location:** WCs

**Condition:** Poor

**Decorative Condition:** N/a

**Comments:** Aged, defective urinal

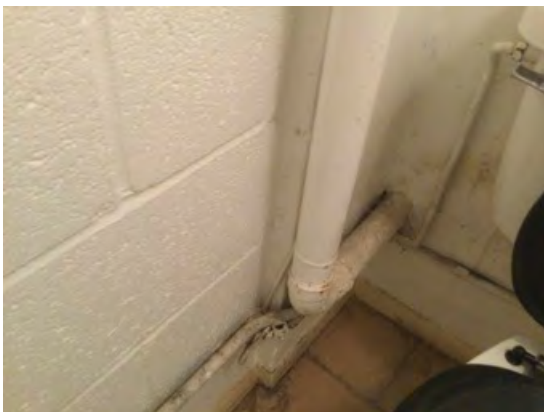
187

**Location:** WCs

**Condition:** N/a

**Decorative Condition:** Poor

**Comments:** Poor decorative condition throughout

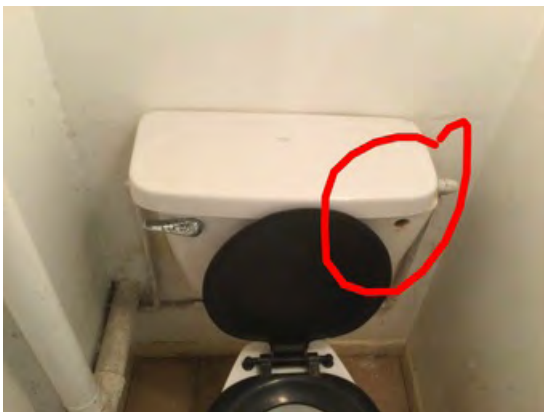
188

**Location:** WCs

**Condition:** N/a

**Decorative Condition:** N/a

**Comments:** Corroding flush handle in Male WC, missing stop to unused handle aperture

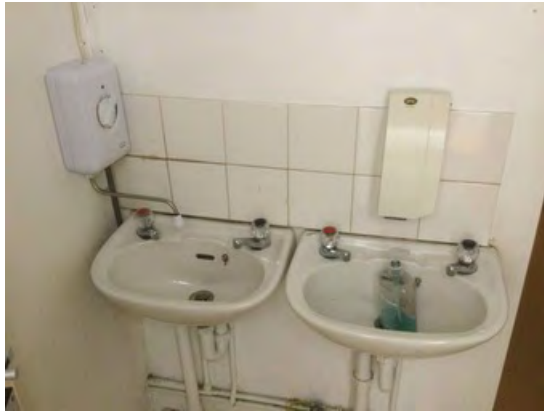
189

**Location:** WCs

**Condition:** Poor

**Decorative Condition:** N/a

**Comments:** Female WC - displaced wash basins, taps seized. Hollow splash back tiling

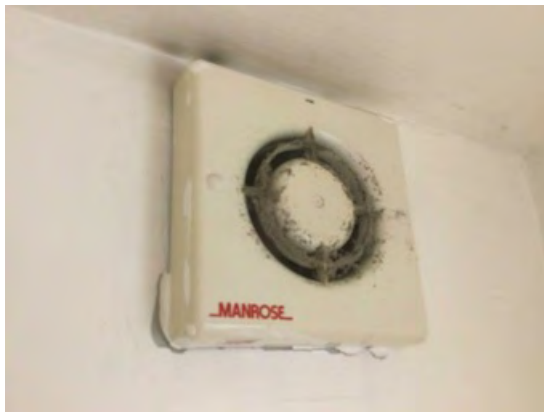
190

**Location:** WCs

**Condition:** Poor

**Decorative Condition:** N/a

**Comments:** Defective extractor - female WC

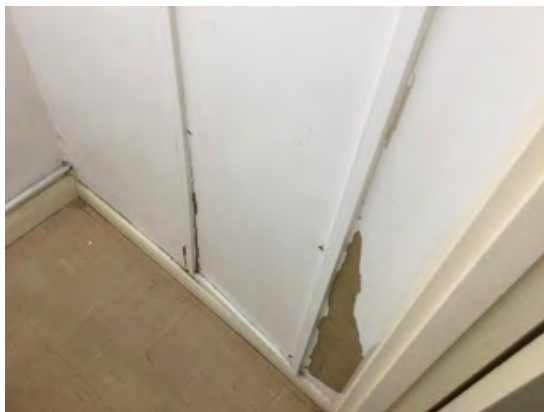
191

**Location:** WCs

**Condition:** Poor

**Decorative Condition:** Poor

**Comments:** Damage around the wall panel in the rear cubicle to the female WC

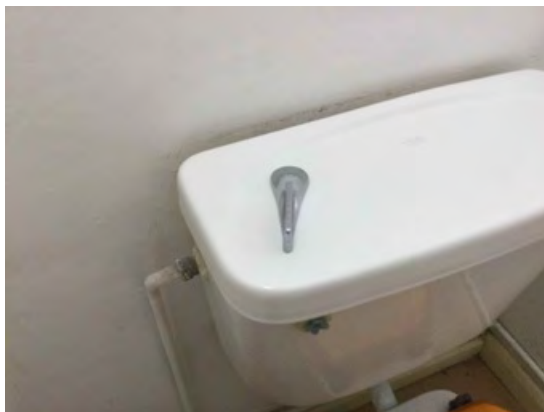
192

**Condition:** Poor

**Comments:** Handle detached, rear Female WC

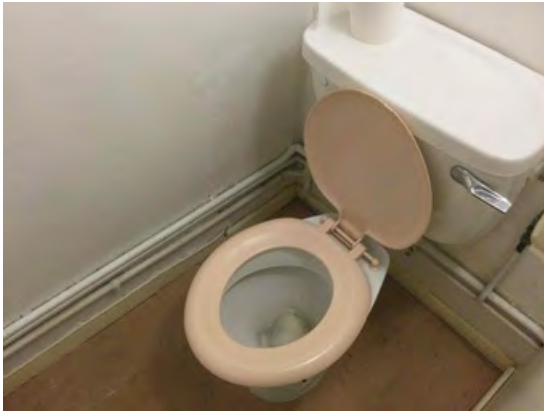
193

**Condition:** Poor

**Comments:** Aged WC seat, female WC

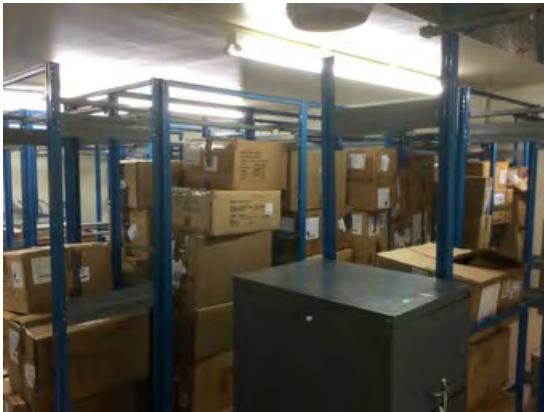
194

**Comments:** Former tenants racking systems, fittings and equipment remains

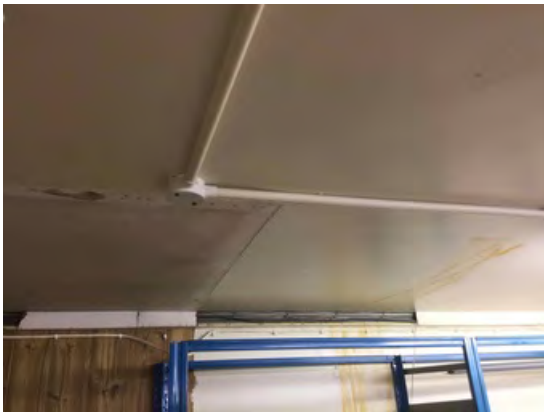
195

**Condition:** Poor

**Decorative Condition:** Poor

**Comments:** Ceilings - cracked and poorly finished plaster, stained paintwork

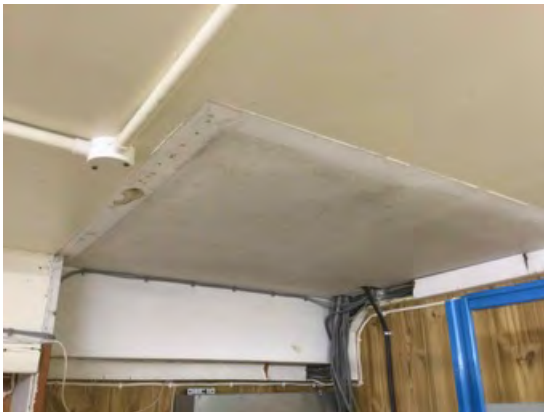
196

**Condition:** Poor

**Decorative Condition:** Poor

**Comments:** Missing paintwork where a partition wall has been removed

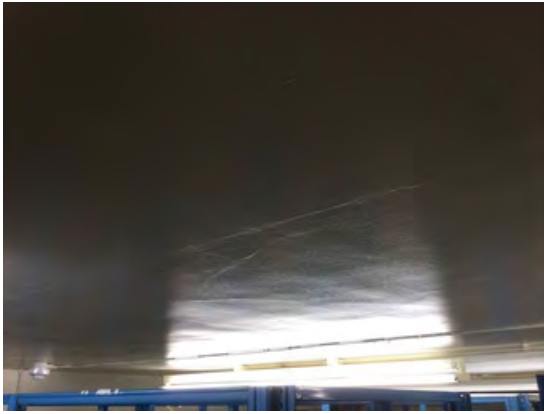
197

**Condition:** Poor

**Decorative Condition:** Poor

**Comments:** Cracked and uneven ceiling plaster

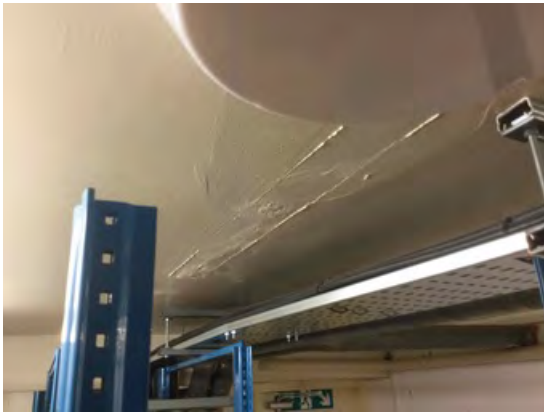
198

**Condition:** Poor

**Decorative Condition:** Poor

**Comments:** Patchy finish - old light fitting locations

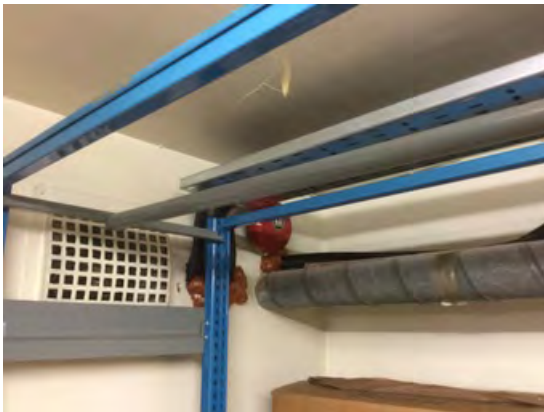
199

**Comments:** Service penetrations filled with fire foam

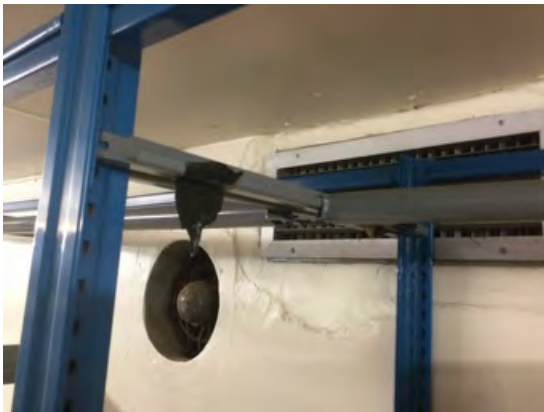
200

**Comments:** Redundant services - rear elevation

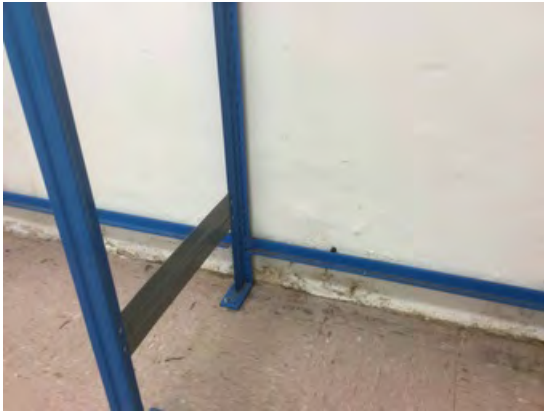
201

**Condition:** Poor

**Comments:** Rising dampness - rear left corner

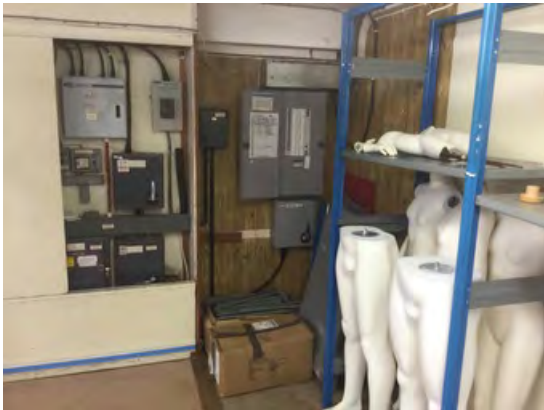
202

**Comments:** Front left corner - electrical services not tested. Former partitioned cupboard/ enclosure removed

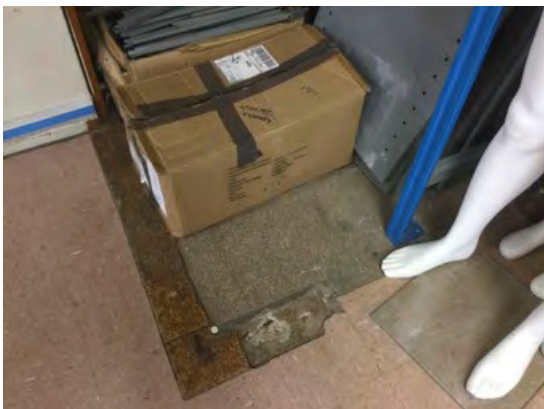
203

**Condition:** Poor

**Comments:** Flooring not made good following removal of partitioning

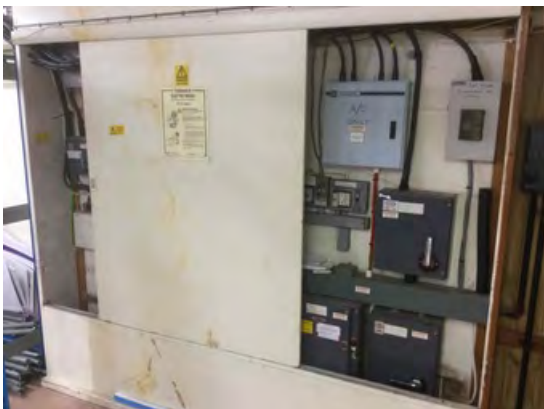
204

**Condition:** Poor

**Decorative Condition:** Poor

**Comments:** Missing door to the electrical cupboard

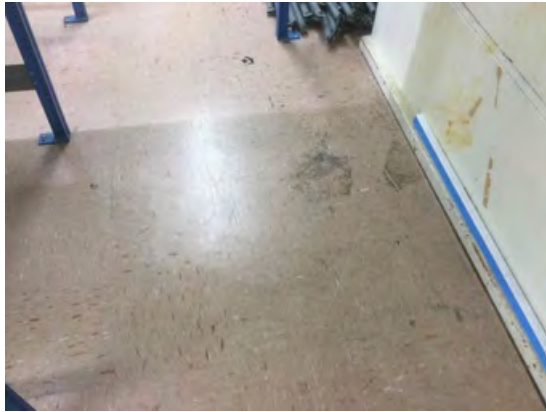
205

**Condition:** Poor

**Comments:** Vinyl flooring - aged, scuffed and worn

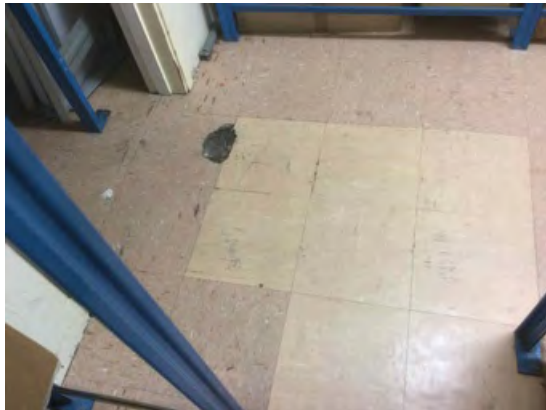
206

**Condition:** Poor

**Comments:** Damaged screed leading to the rear stockroom, patched vinyl tiles

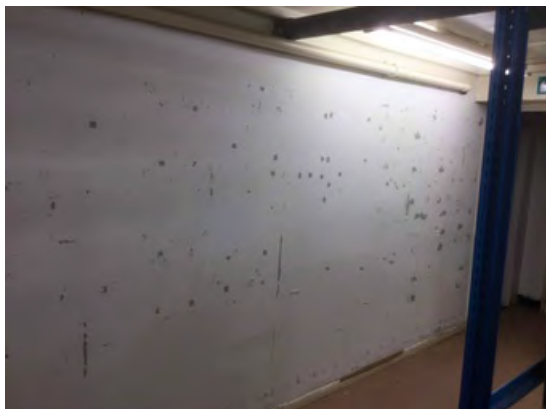
207

**Condition:** Poor

**Decorative Condition:** Very poor

**Comments:** Wall spattered with marks and blue tac

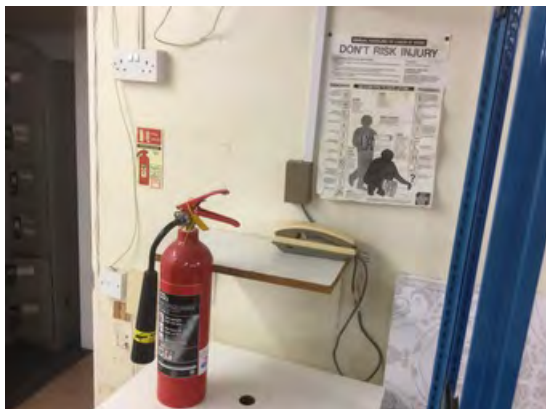
208

**Comments:** Former tenants fittings remain

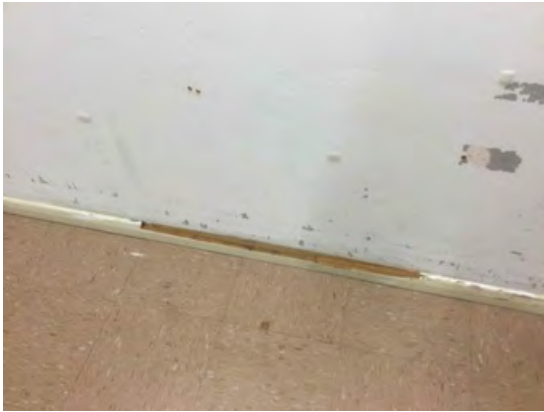
209

**Location:** Middle stockroom  
**Condition:** Poor  
**Decorative Condition:** Poor  
**Comments:** Damaged skirtings

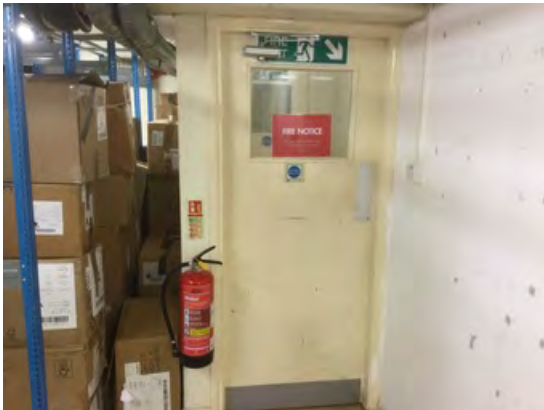
210

**Location:** Middle stockroom  
**Condition:** N/a  
**Decorative Condition:** Poor  
**Comments:** Yellowing gloss paint, poor decorative condition throughout

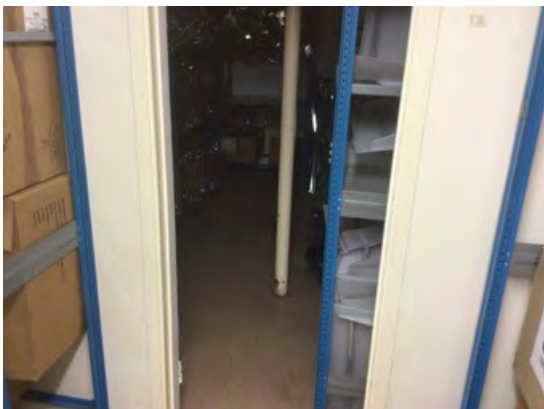
211

**Location:** Rear stockroom  
**Condition:** Very poor  
**Decorative Condition:** N/a  
**Comments:** Entrance door has been removed

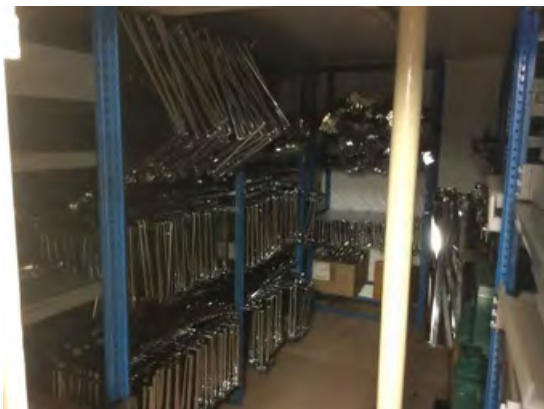
212

**Location:** Rear stockroom  
**Condition:** Very poor  
**Decorative Condition:** N/a  
**Comments:** Former tenants racking systems and equipment remains

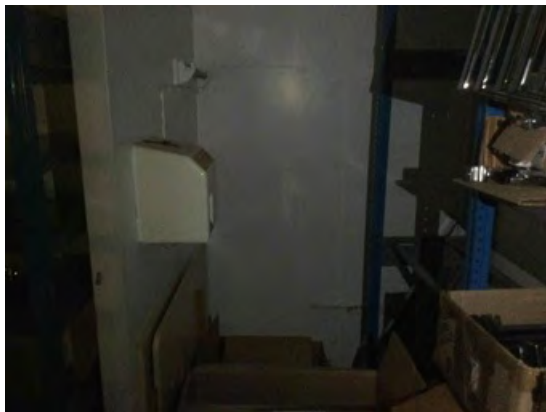
214

**Decorative Condition:** Poor

**Comments:** Former WC area, redundant fittings remain, limited access for inspection, lighting defective, poor decorative condition throughout

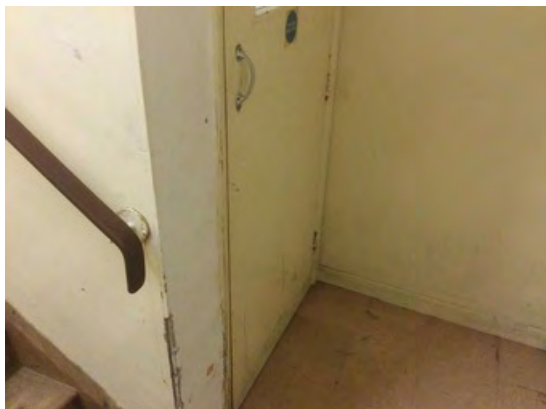
215

**Decorative Condition:** Poor

**Comments:** Basement level - poor decorative condition

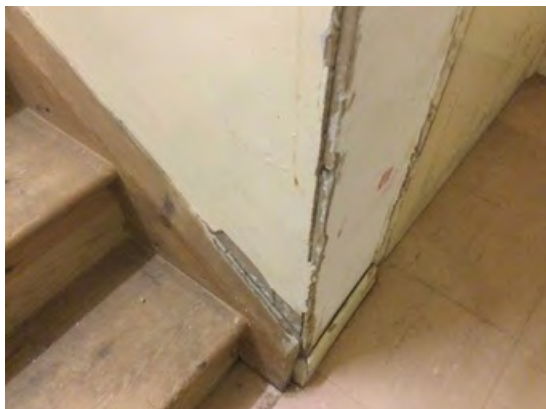
216

**Decorative Condition:** Poor

**Comments:** Impact damage at basement level

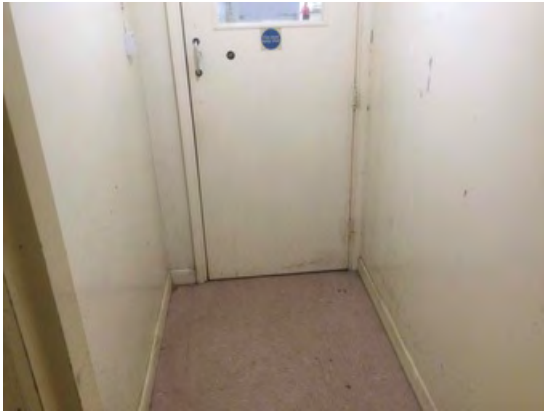
217

**Decorative Condition:** Poor

**Comments:** Lobby leading to the stockroom - poor decorative condition

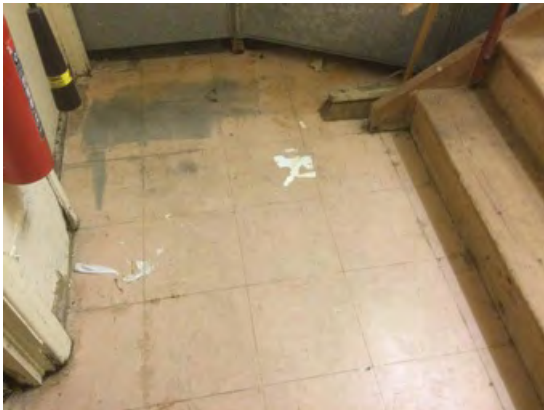
218

**Condition:** Poor

**Comments:** Worn and aged vinyl flooring - basement level

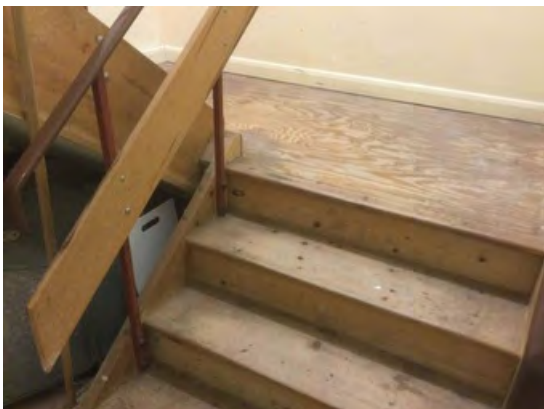
219

**Condition:** Poor

**Comments:** No paint finish to the stairs, worn treads

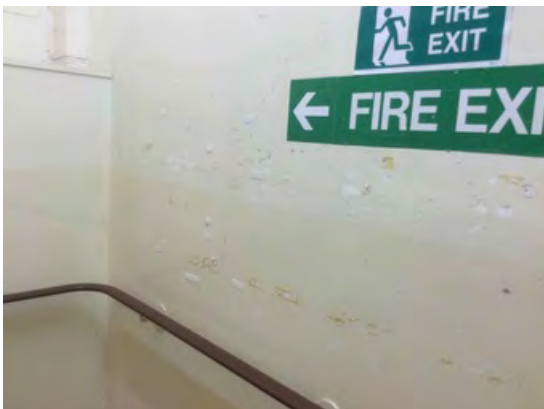
220

**Decorative Condition:** Poor

**Comments:** Stairwell walls - poor decorative condition

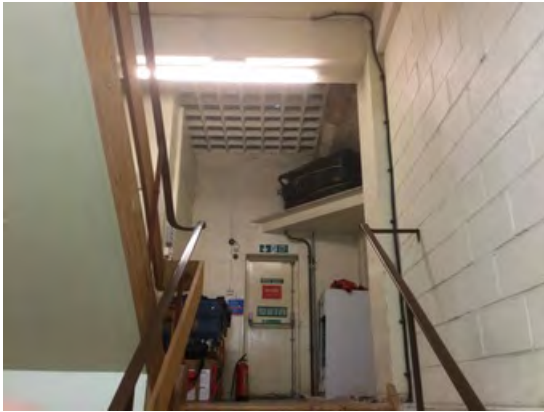
221

**Decorative Condition:** Poor

**Comments:** General view - poor decorative order throughout

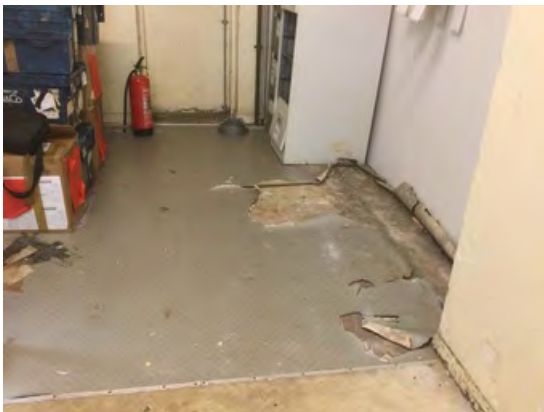
222

**Condition:** Very poor

**Comments:** Lifting and damaged vinyl - ground level

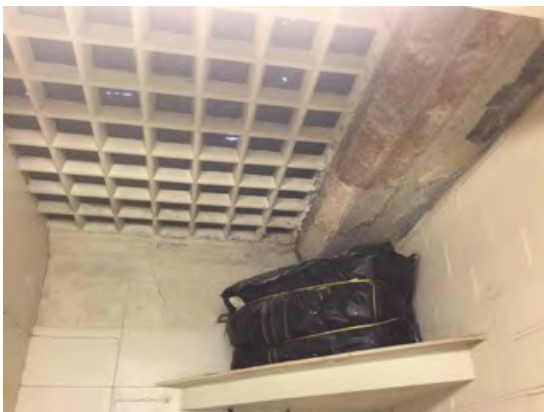
223

**Condition:** Very poor

**Decorative Condition:** Very poor

**Comments:** Leaking flat roof

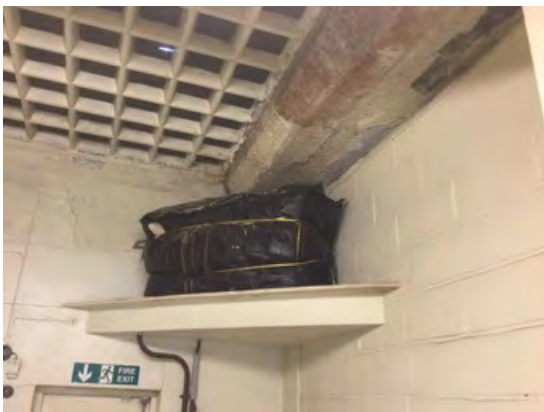
224

**Comments:** Plumbing systems not tested

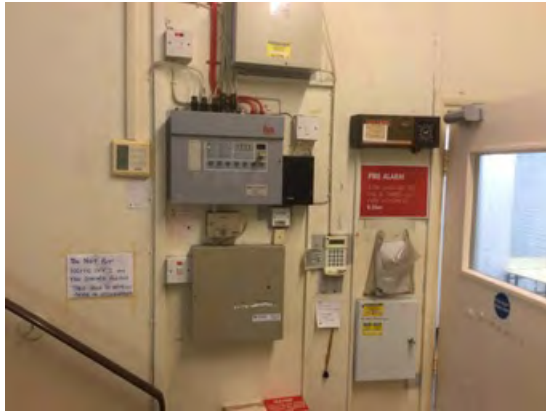
225

**Comments:** Fire alarm and security systems - not tested

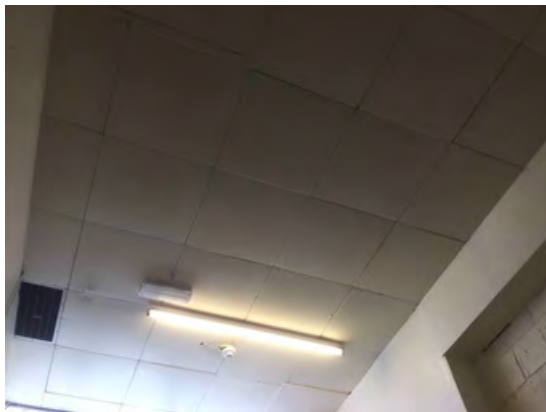
226

**Condition:** Poor

**Decorative Condition:** Poor

**Comments:** Bowing ceilings at first floor level

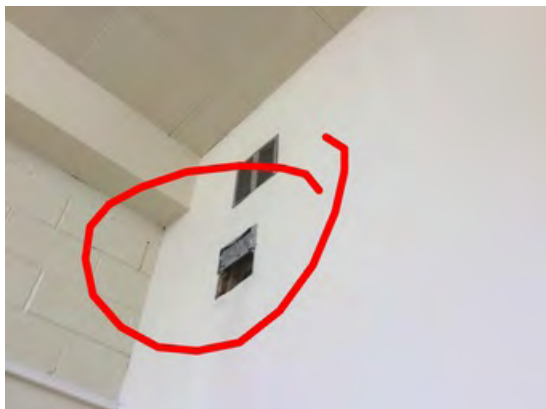
227

**Condition:** Poor

**Comments:** Missing vent louvres

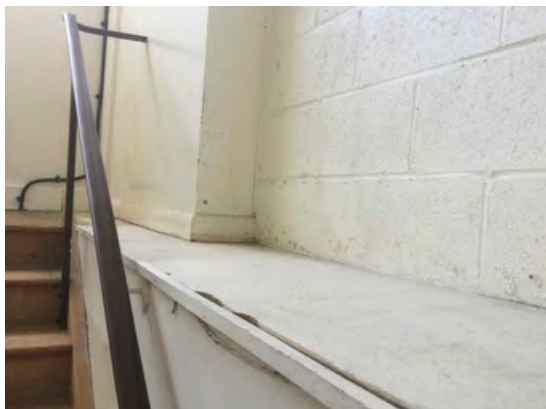
228

**Decorative Condition:** Poor

**Comments:** Soiling throughout

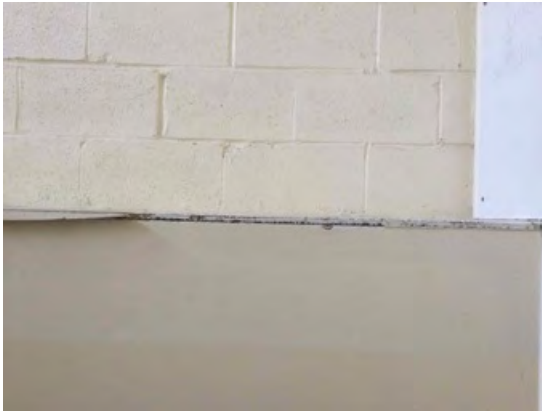
229

**Comments:** Missing edge trim - first floor landing level

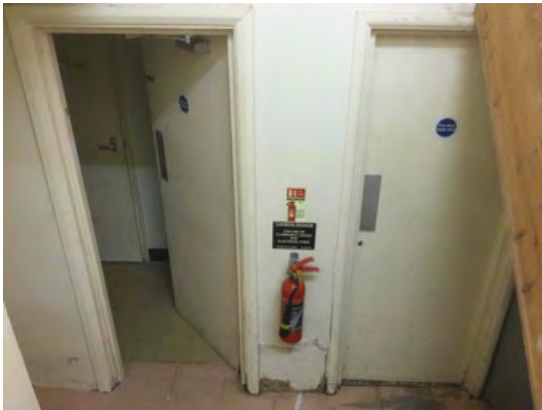
230

**Decorative Condition:** Poor

**Comments:** General view of the entrance

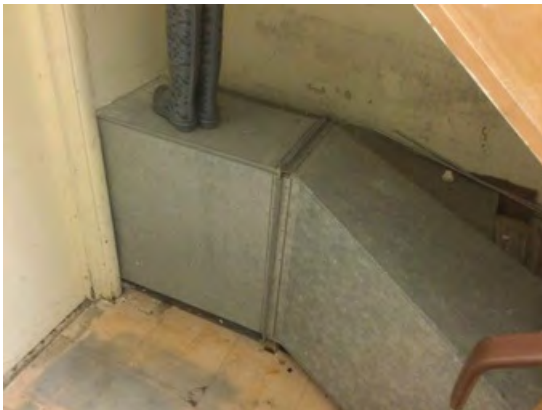
231

**Condition:** Very poor

**Comments:** Disused ventilation systems

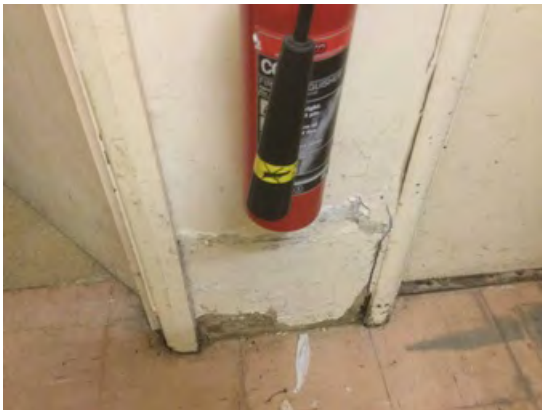
232

**Condition:** Poor

**Decorative Condition:** Very poor

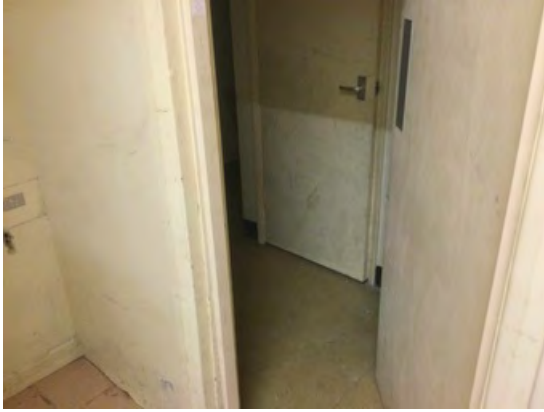
233

**Location:** Rear WC as redundant vent room

**Condition:** N/a

**Decorative Condition:** Very poor

**Comments:** Very poor condition throughout, aged and worn finishes. Redundant disused WC and vent room in need of complete refurbishment

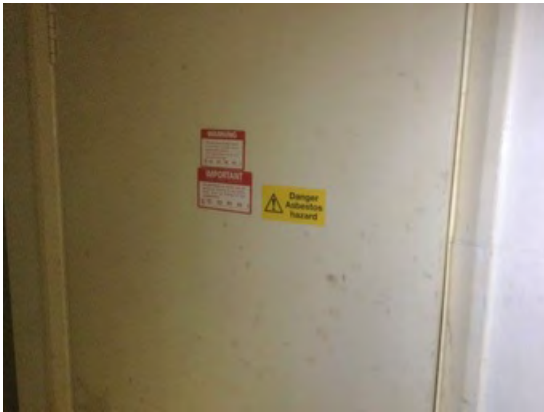
234

**Location:** Rear WC as redundant vent room

**Condition:** Very poor

**Decorative Condition:** Very poor

**Comments:** Vent room access door - reported asbestos, no safe access

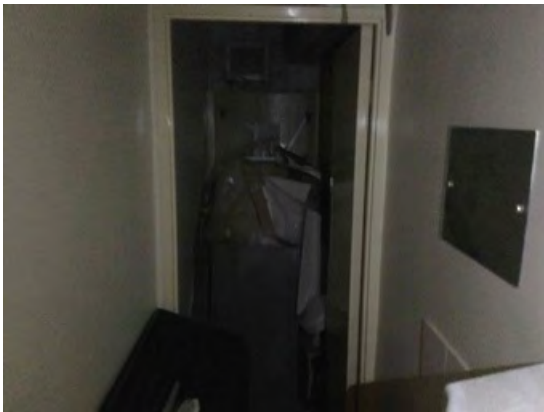
235

**Location:** Rear WC as redundant vent room

**Condition:** Very poor

**Decorative Condition:** Very poor

**Comments:** Disused WC

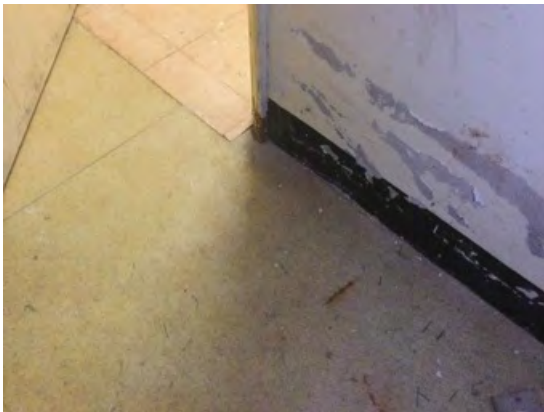
236

**Location:** Rear WC as redundant vent room

**Condition:** Very poor

**Decorative Condition:** Very poor

**Comments:** Worn vinyl flooring, rising dampness

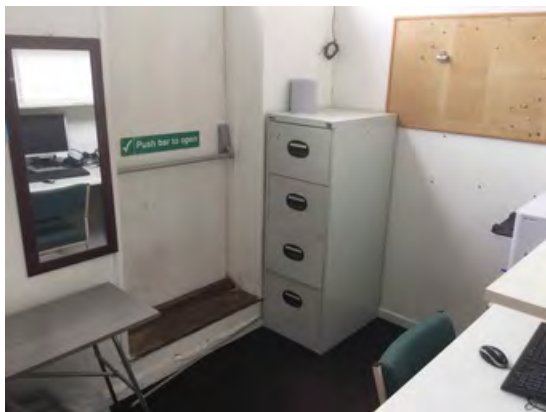
240

**Location:** Office

**Decorative Condition:** Poor

**Comments:** General view - former tenants fittings remain including shelving, worktops, floor safe, Comms equipment, furniture, notice boards and filing cabinets. Poor decorative condition throughout

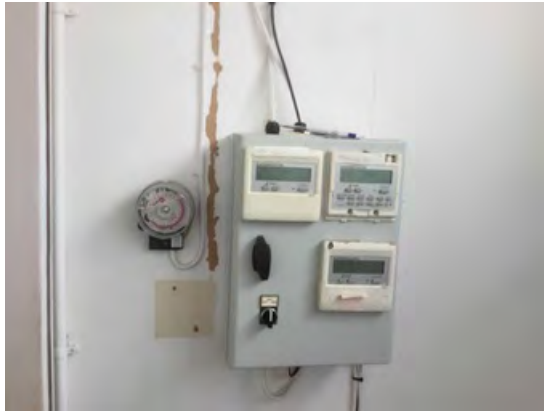
241

**Location:** Office

**Comments:** AC controls - not tested at the time of inspection

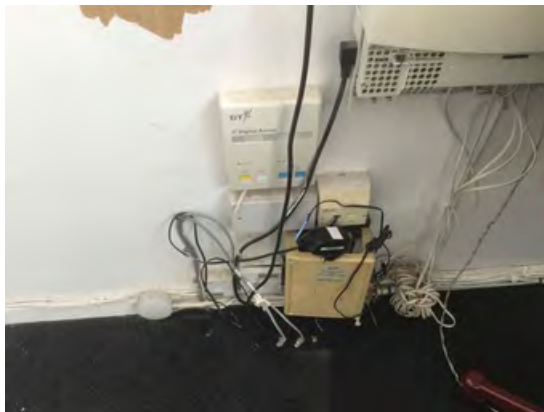
242

**Location:** Office

**Comments:** Displaced and yellowing BT box

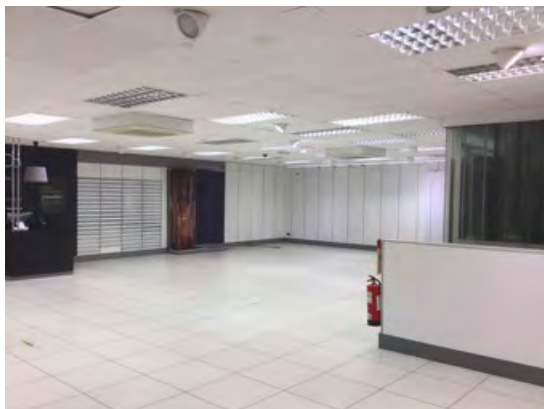
243

**Location:** First Floor Sales

**Decorative Condition:** Poor

**Comments:** General view - former tenants bespoke shop fit remains including tiled vinyl flooring, perimeter wall panelling, shop fixturing, former tenants sales desk and display lighting. Aged and tired shop fit, poor decorative condition throughout.

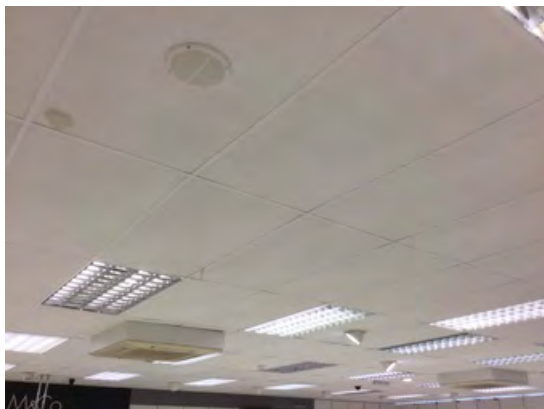
244

**Location:** First Floor Sales

**Condition:** Poor

**Comments:** Ceilings - aged and soiled, paint finish applied to the ceiling grid

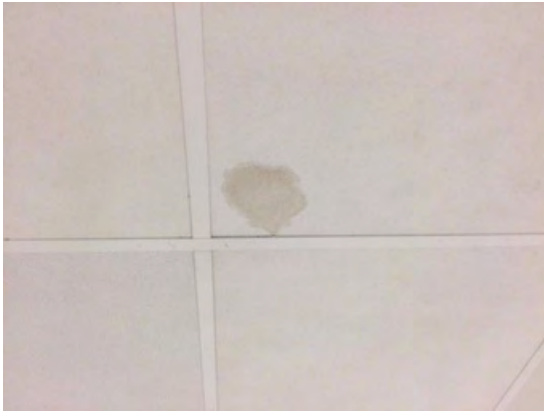
245

**Location:** First Floor Sales

**Condition:** Poor

**Comments:** Sporadic stained tiles

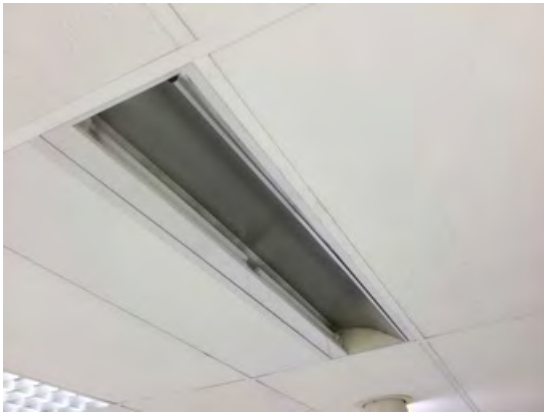
246

**Location:** First Floor Sales

**Condition:** Poor

**Comments:** Soiled and aged former tenant display lighting systems remain

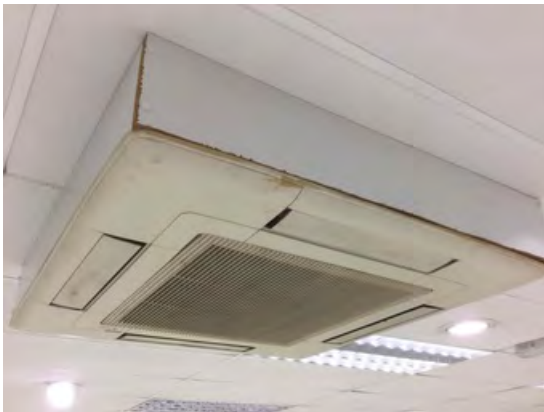
247

**Location:** First Floor Sales

**Condition:** Poor

**Comments:** 2no yellowing, aged and soiled ceiling cassettes

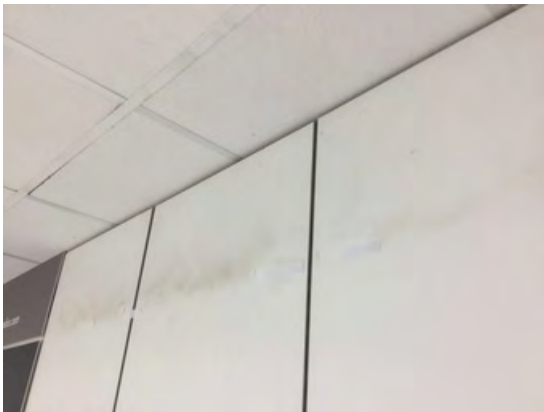
248

**Location:** First Floor Sales

**Comments:** Soiling affecting the perimeter wall panels

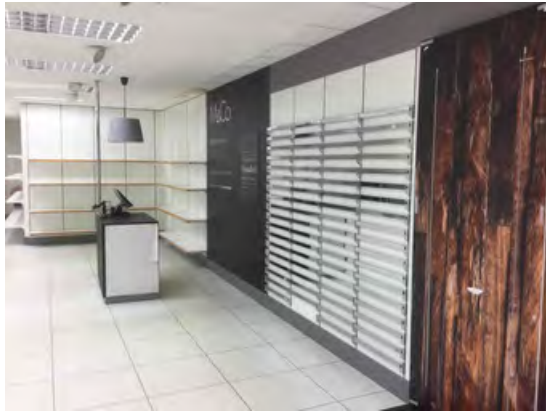
249

**Location:** First Floor Sales

**Comments:** Former tenets shop fixturing and graphics panels remain

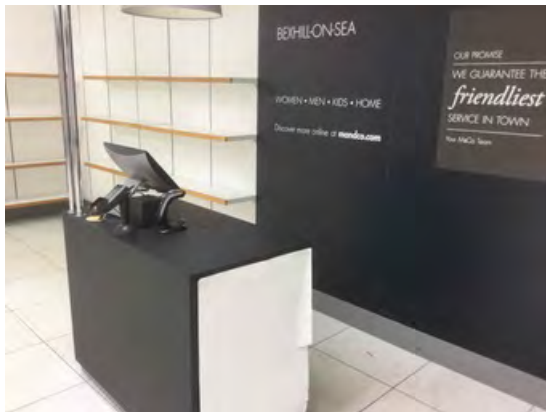
250

**Location:** First Floor Sales

**Comments:** Former tenants sales desk remains

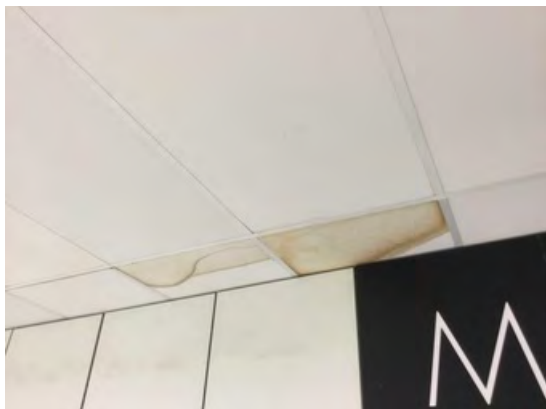
251

**Location:** First Floor Sales

**Condition:** Poor

**Comments:** Water stained ceiling tiles bending the sales desk

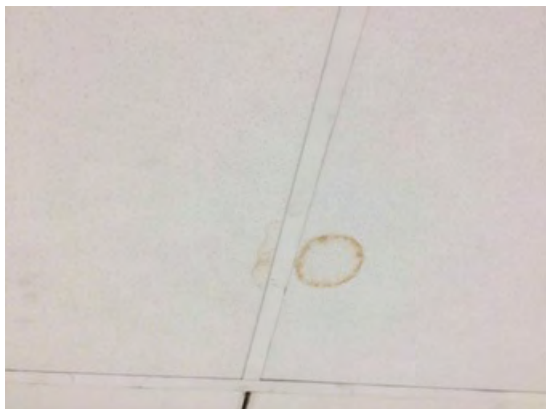
252

**Location:** First Floor Sales

**Condition:** Poor

**Comments:** Sporadic stained ceiling tiles
