**55-57 Devonshire Rd, Bexhill-on-Sea**

**Schedule of Condition UK**

**Inspected by: Philip Cushion**

**Inspection Date: 03 July 2023**

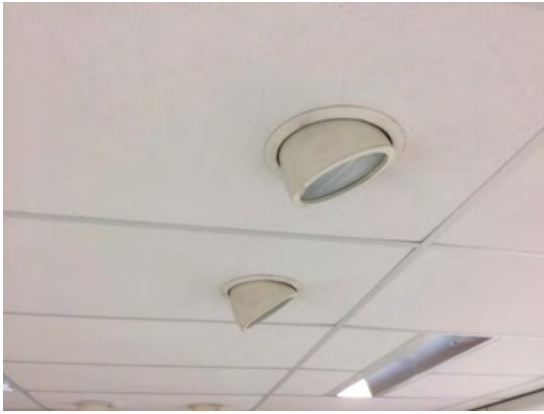
253

**Location:** First Floor Sales

**Condition:** Poor

**Comments:** Soiled and aged display lights

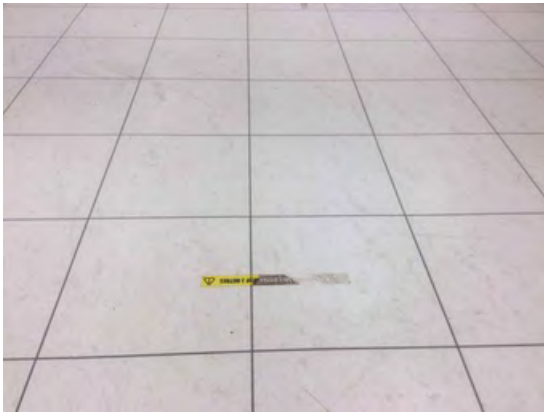
254

**Location:** First Floor Sales

**Condition:** Poor

**Comments:** Vinyl flooring - aged, soiled and heavily scratched throughout

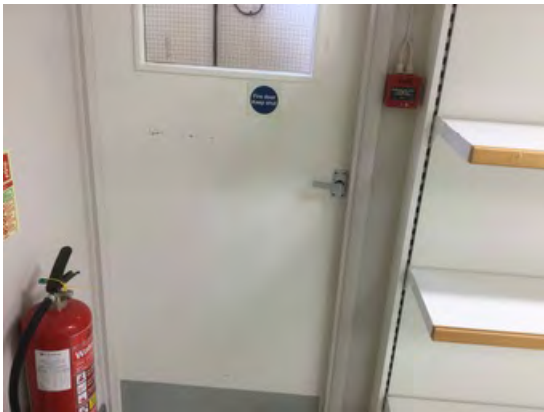
255

**Location:** First Floor Sales

**Condition:** Fair

**Decorative Condition:** Poor

**Comments:** Rear door leading to the stairwell - soiled and marked decorations

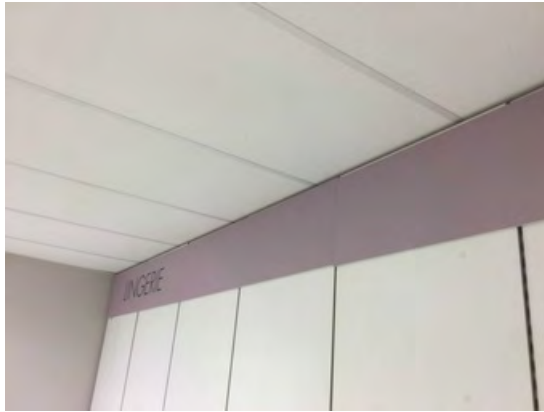
257

**Location:** First Floor Sales

**Comments:** Flames panels forming a feature element - former tenants bespoke shop fit

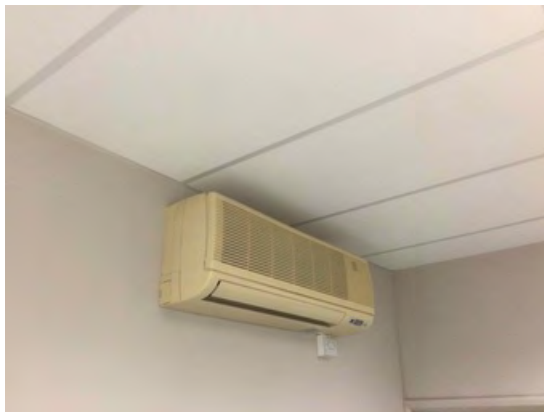
258

**Location:** First Floor Sales

**Condition:** Poor

**Comments:** Aged and yellowing AC unit to the fitting room area

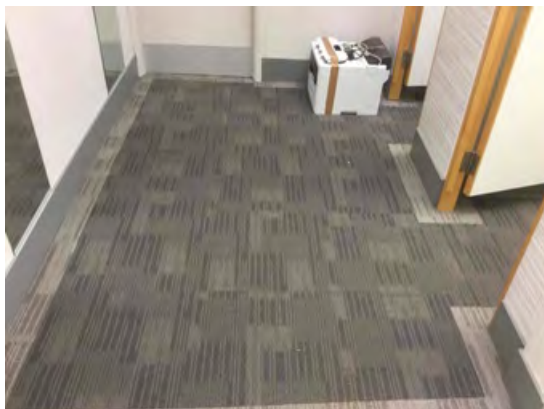
259

**Location:** First Floor Sales

**Condition:** Fair

**Comments:** Worn and soiled carpets

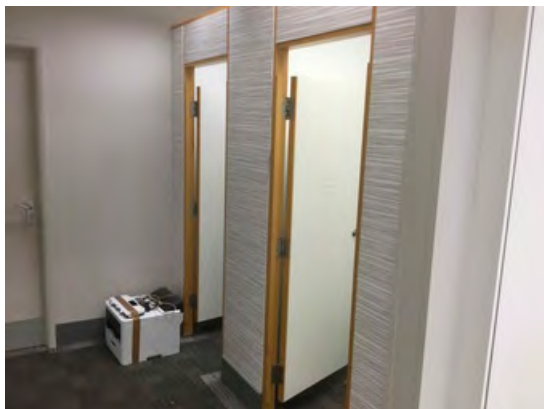
260

**Location:** First Floor Sales

**Comments:** Fitting rooms - former tenants bespoke shop fit, graphics applied to the cubicles walls

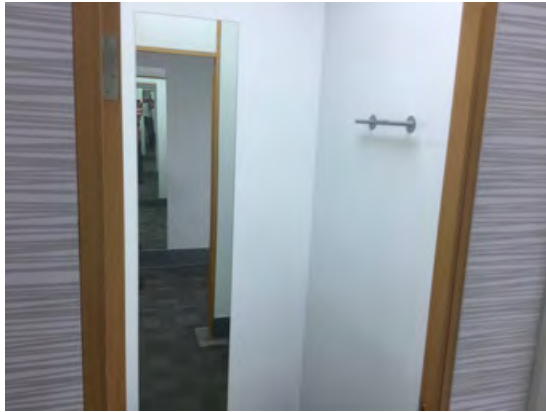
261

**Location:** First Floor Sales

**Condition:** Fair

**Comments:** General view inside the fitting rooms

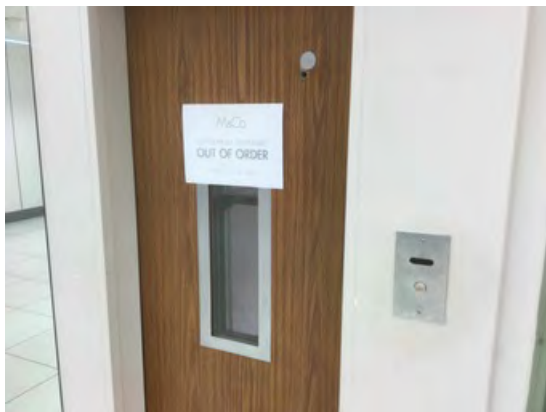
263

**Location:** Customer stairwell and lift

**Condition:** Poor

**Comments:** Lift of considerable age, not operational. 'End of life'

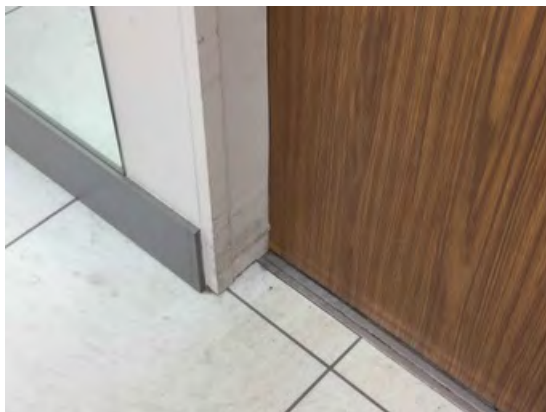
264

**Location:** Customer stairwell and lift

**Decorative Condition:** Poor

**Comments:** Scuffing aside the lift car - first floor level

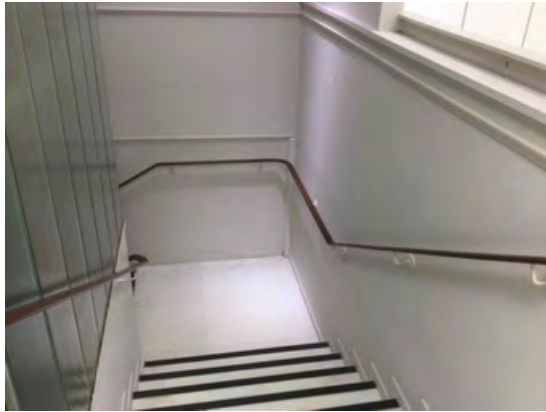
265

**Location:** Customer stairwell and lift

**Decorative Condition:** Fair

**Comments:** View down from first floor level - fair decorative condition

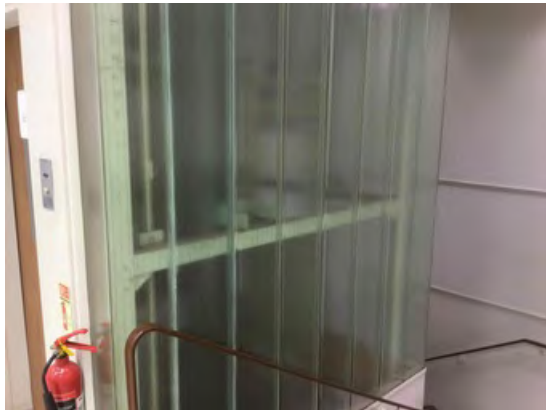
266

**Location:** Customer stairwell and lift

**Condition:** Fair

**Comments:** Glazed surround to the lift car

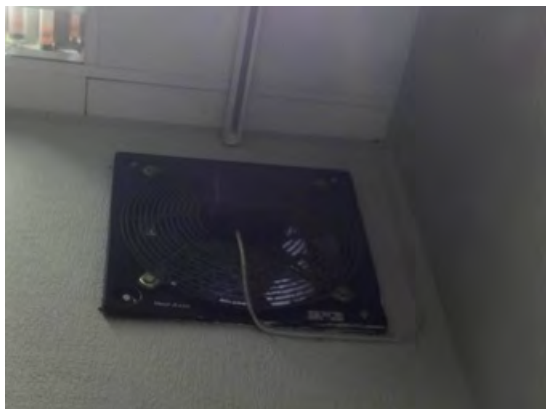
267

**Location:** Customer stairwell and lift

**Condition:** Poor

**Comments:** Redundant extractor

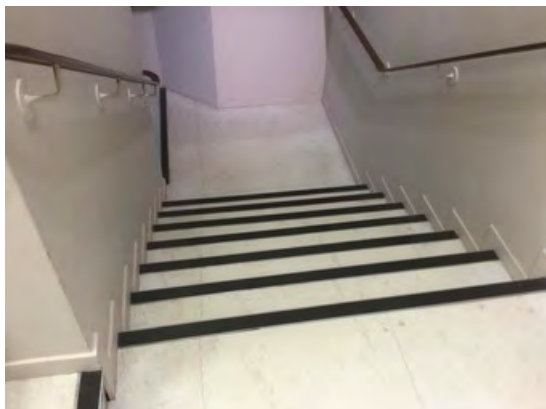
268

**Location:** Customer stairwell and lift

**Condition:** Fair

**Comments:** Vinyl flooring - soiled, marked, remains serviceable

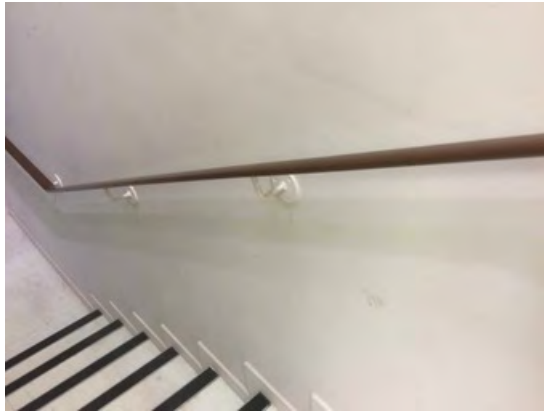
269

**Location:** Customer stairwell and lift

**Decorative Condition:** Fair

**Comments:** Minor soil marks

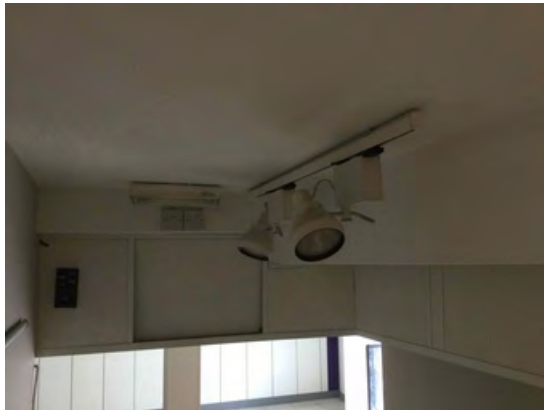
270

**Location:** Customer stairwell and lift

**Comments:** Former tenants display lighting remains

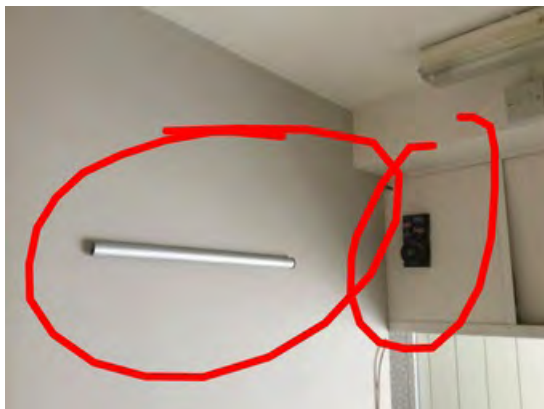
271

**Location:** Customer stairwell and lift

**Comments:** Redundant fittings at ground level

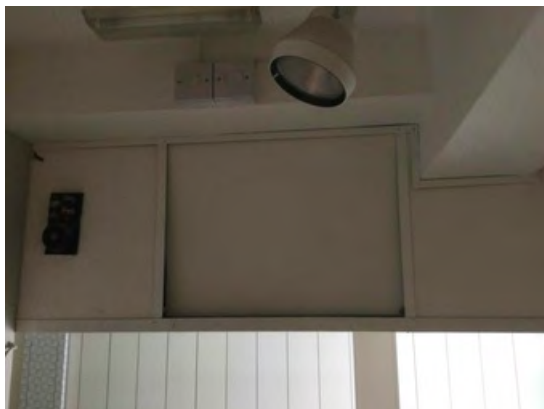
272

**Location:** Customer stairwell and lift

**Comments:** Displaced tile to the bulkhead at ground level

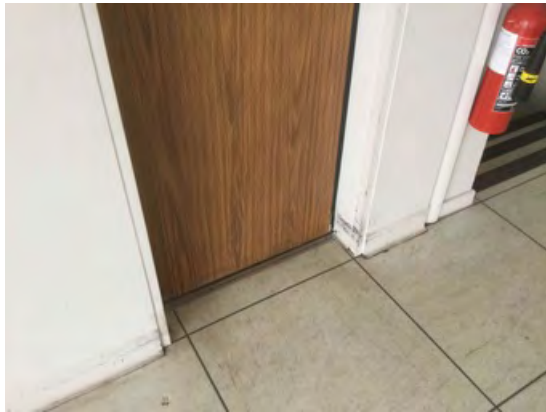
274

**Location:** Customer stairwell and lift

**Decorative Condition:** Poor

**Comments:** Heavy scuffing aside the lift car - ground floor

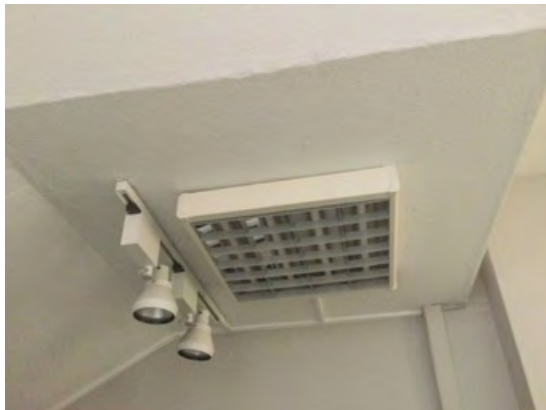
276

**Location:** Customer stairwell and lift

**Condition:** N/a

**Decorative Condition:** N/a

**Comments:** Former tenants bespoke lighting systems remain

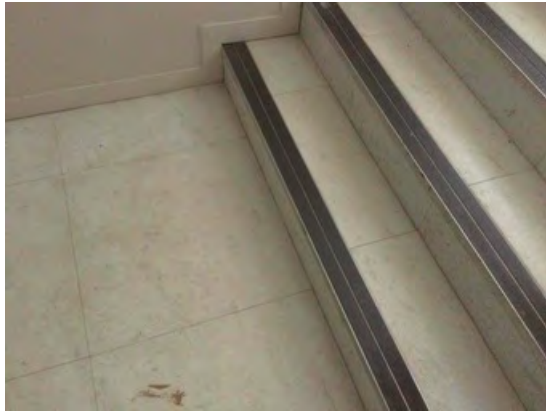
277

**Location:** Customer stairwell and lift

**Condition:** Fair

**Comments:** Soiled and marked vinyl

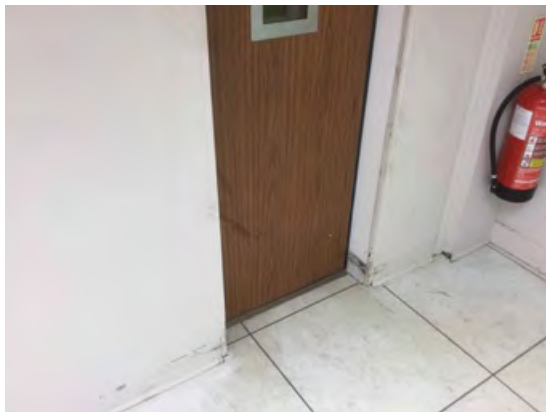
278

**Location:** Customer stairwell and lift

**Decorative Condition:** Poor

**Comments:** Heavy scuffing aside the lift car to basement level

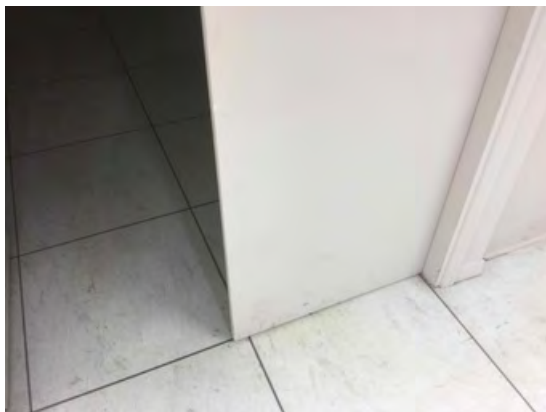
279

**Location:** Customer stairwell and lift

**Decorative Condition:** Poor

**Comments:** Soiled fire doors leading to the stairwell at basement level

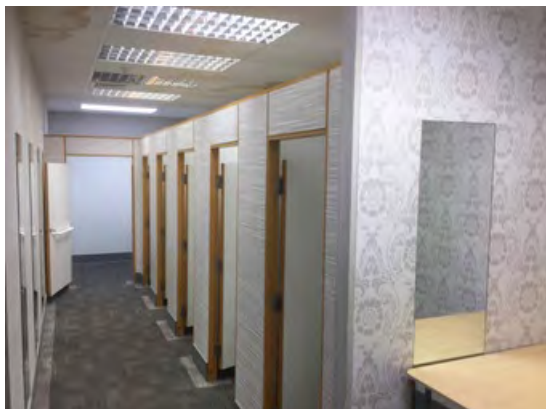
280

**Location:** Ground floor sales

**Condition:** Fair

**Comments:** Former tenants bespoke shop fit remains - partitioned fittings rooms provided t the rear of the sales floor, the cubicles have applied vinyl graphics, cubicles are in fair condition.

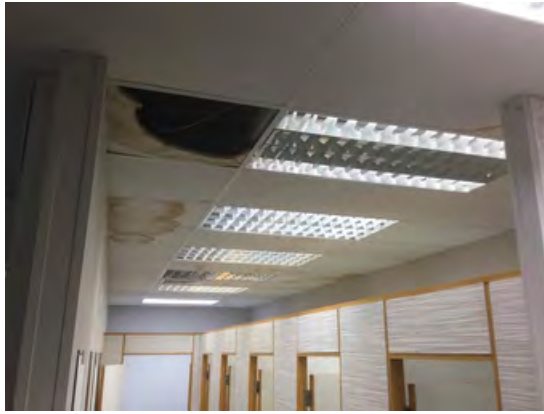
281

**Location:** Ground floor sales

**Condition:** Poor

**Comments:** The flat roof is leaking at the rear causing significant damage to the suspended ceilings

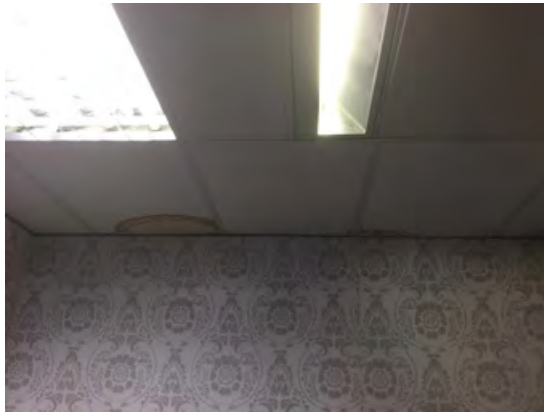
282

**Location:** Ground floor sales

**Condition:** Poor

**Comments:** Stained ceiling tiles

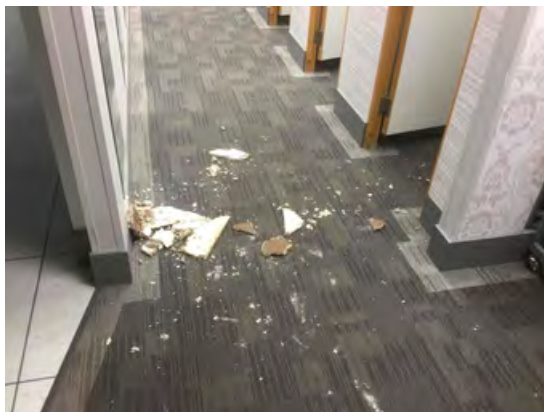
283

**Location:** Ground floor sales

**Condition:** Fair

**Comments:** Stained carpets and general wear. The carpets remain in fair condition. A ceiling tile has disintegrated

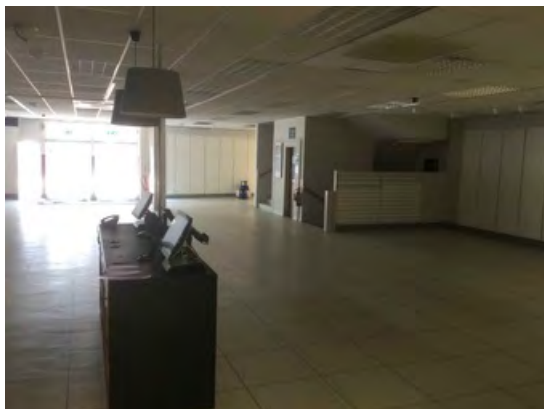
284

**Location:** Ground floor sales

**Decorative Condition:** Poor

**Comments:** General view - former tenants bespoke shop fit remains including tiled vinyl flooring, perimeter wall panelling, shop fixturing, former tenants sales desk and display lighting. Aged and tired shop fit, poor decorative condition throughout.

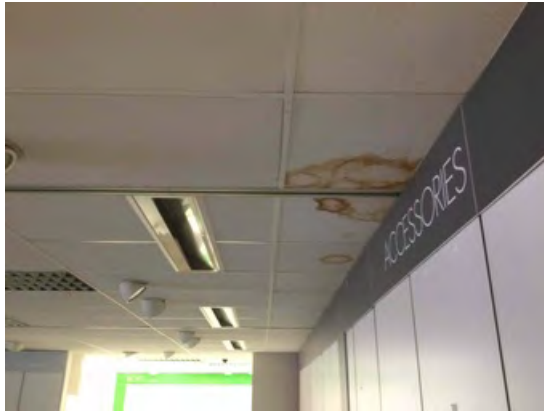
285

**Location:** Ground floor sales

**Condition:** Poor

**Comments:** Water staining along the rear of the sales floor, the suspended ceilings are generally soiled and in poor condition

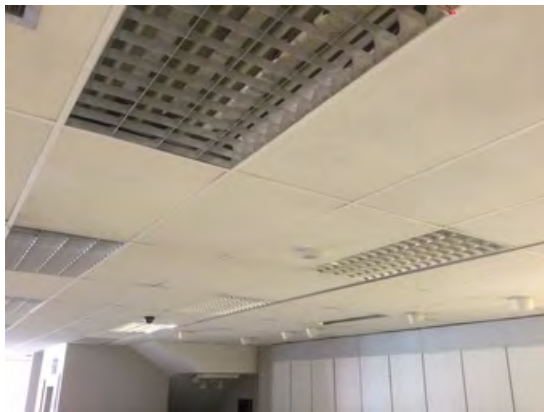
286

**Location:** Ground floor sales

**Comments:** Soiled ceiling tiles, lighting was not operational at the time of inspection

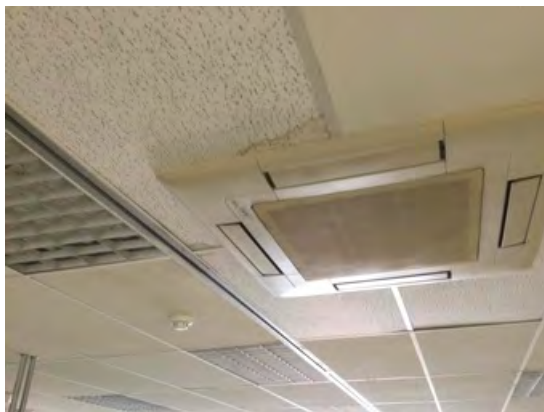
287

**Location:** Ground floor sales

**Condition:** Poor

**Comments:** Miss-match of ceiling tiles, the AC units are aged and yellowing and approaching 'end of life'

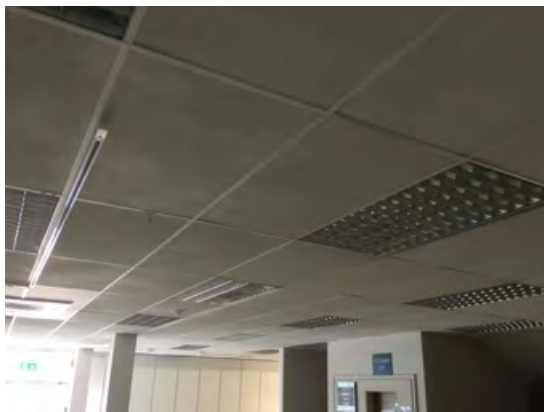
288

**Location:** Ground floor sales

**Condition:** Poor

**Comments:** Soiling affecting the ceiling tiles, the suspended ceilings are aged and in poor condition

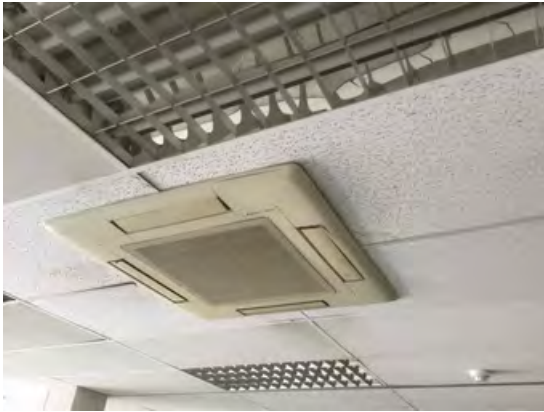
289

**Location:** Ground floor sales

**Condition:** Poor

**Comments:** Miss-matching ceiling tiles, aged and yellowing cassettes

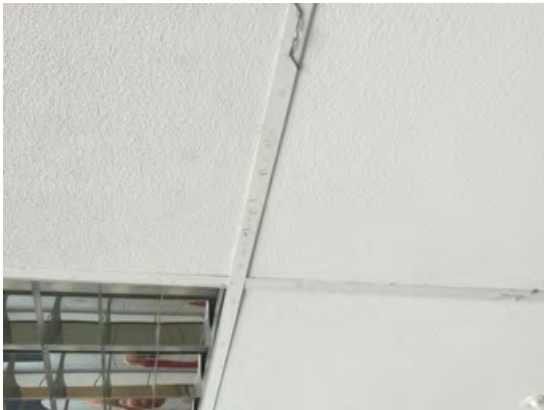
290

**Location:** Ground floor sales

**Condition:** Poor

**Decorative Condition:** Poor

**Comments:** Scuffed finish to the ceiling grid, the ceiling grid has previously been painted

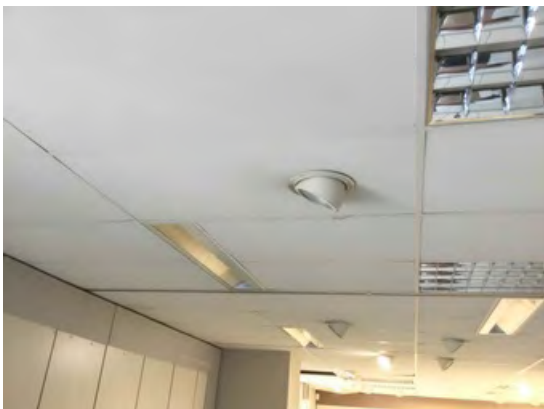
291

**Location:** Ground floor sales

**Condition:** Poor

**Comments:** Soiling noted around the former tenants bespoke display lighting systems

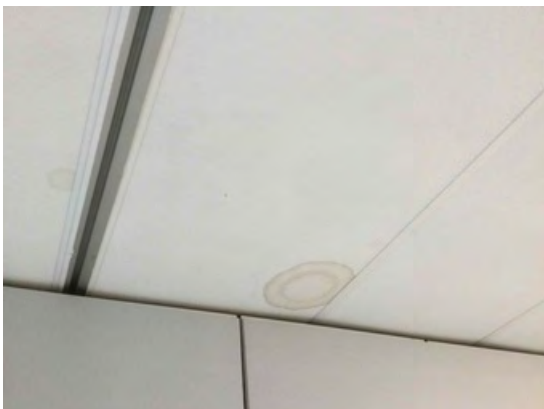
292

**Location:** Ground floor sales

**Condition:** Poor

**Comments:** Various sporadic stains along the shop front

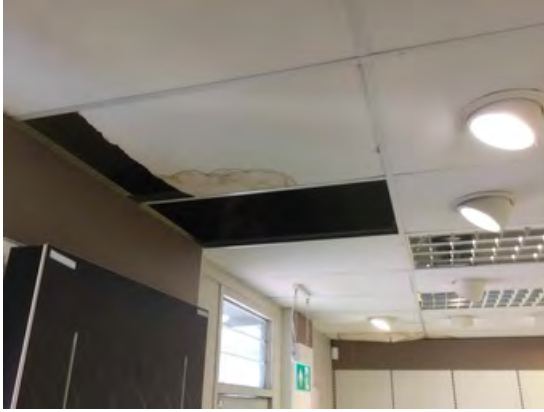
293

**Location:** Ground floor sales

**Condition:** Poor

**Comments:** Water ingress from the front canopy roof

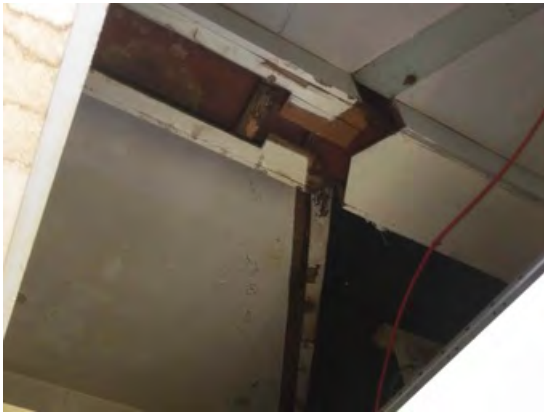
294

**Location:** Ground floor sales

**Condition:** Poor

**Comments:** Missing boxing leaving structural steelwork exposed above the suspended ceiling to the shop front

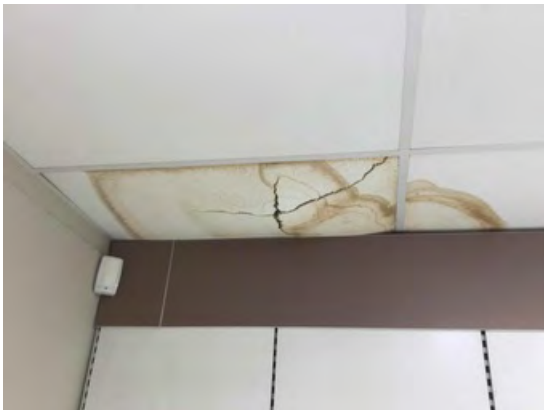
295

**Location:** Ground floor sales

**Condition:** Poor

**Comments:** Water staining along the left party wall

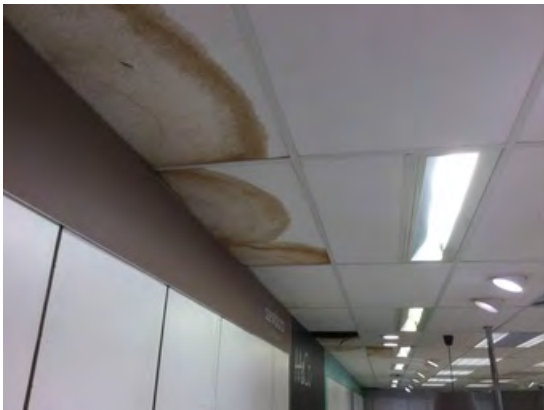
296

**Location:** Ground floor sales

**Condition:** Poor

**Comments:** Significant water ingress along the left party wall

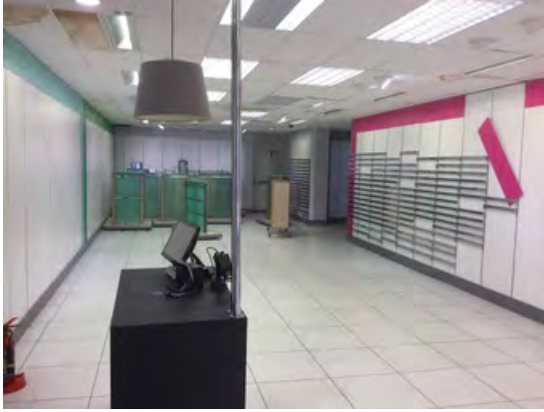
297

**Location:** Ground floor sales

**Decorative Condition:** Poor

**Comments:** General view of the sales area to the left side of the store

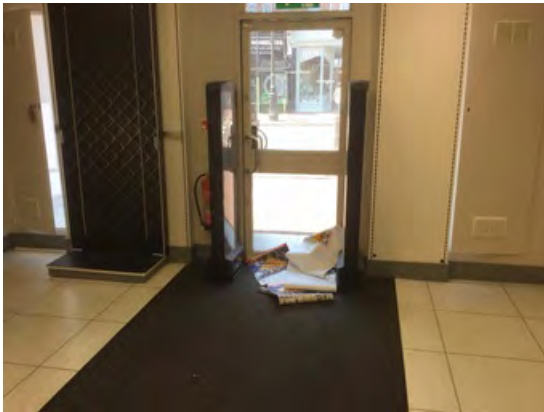
298

**Location:** Ground floor sales

**Condition:** Fair

**Comments:** Left hand shop entrance - former tenants security systems remain, the barrier matting is in fair condition

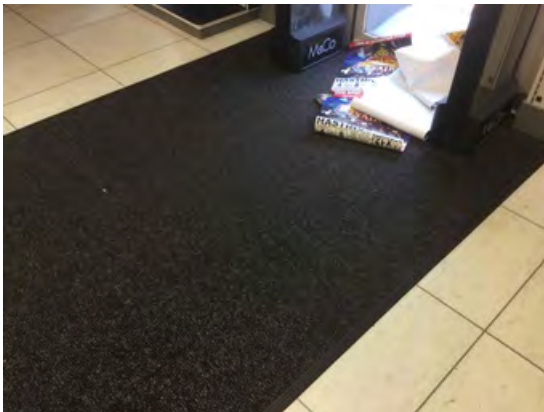
299

**Location:** Ground floor sales

**Condition:** Fair

**Comments:** Barrier matting to the left shop entrance is in fair condition

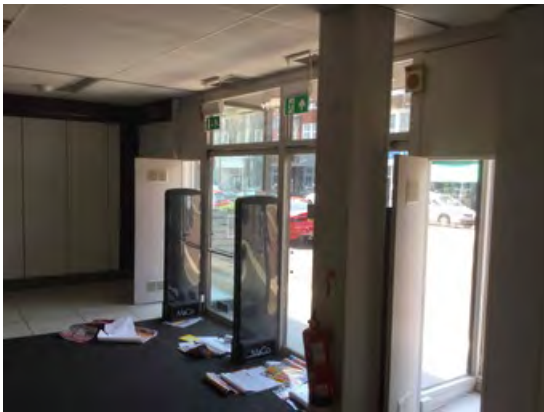
300

**Location:** Ground floor sales

**Comments:** View of the right hand/ main entrance - the former tenants security systems remain

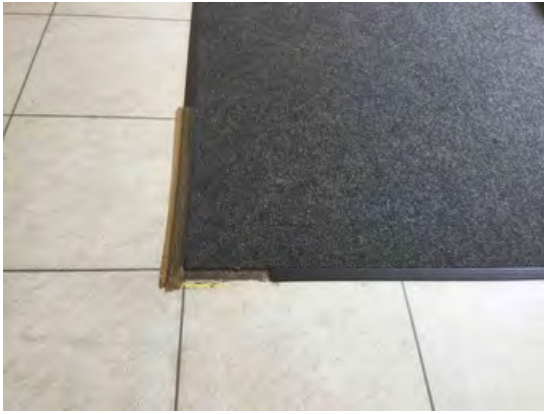
301

**Location:** Ground floor sales

**Condition:** Poor

**Comments:** Damaged edging trim to the barrier matting, general wear

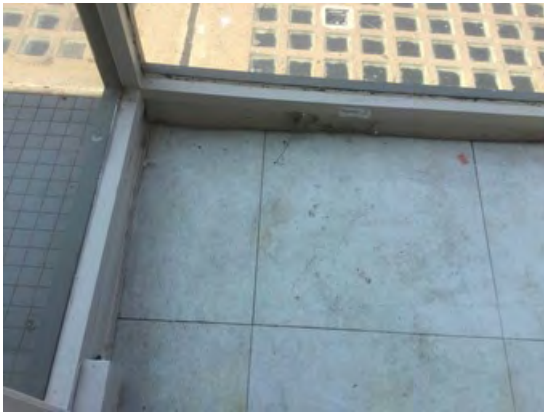
302

**Location:** Ground floor sales

**Condition:** Poor

**Decorative Condition:** Poor

**Comments:** Shop window displays - the vinyl flooring is solar faded, stained and worn. The window frames are in poor decorative order

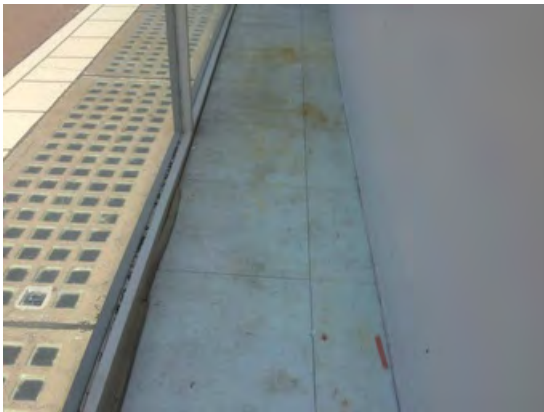
303

**Location:** Ground floor sales

**Condition:** Poor

**Comments:** Stained vinyl

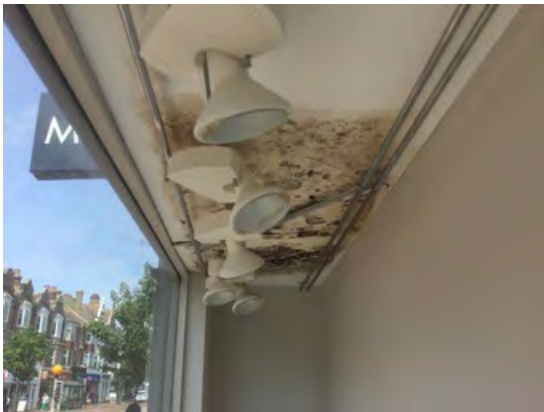
304

**Location:** Ground floor sales

**Condition:** Very poor

**Decorative Condition:** Very poor

**Comments:** Significant damage due to roof leaks

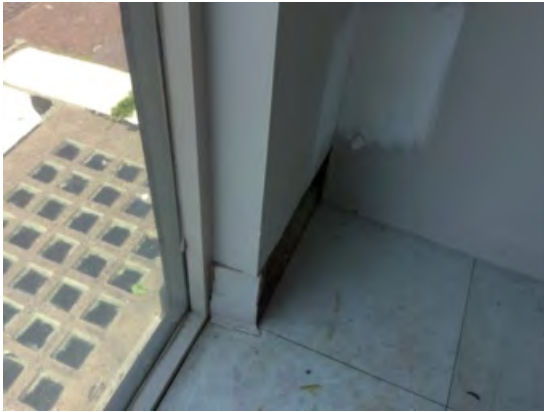
305

**Location:** Ground floor sales

**Condition:** Poor

**Comments:** Missing skirting

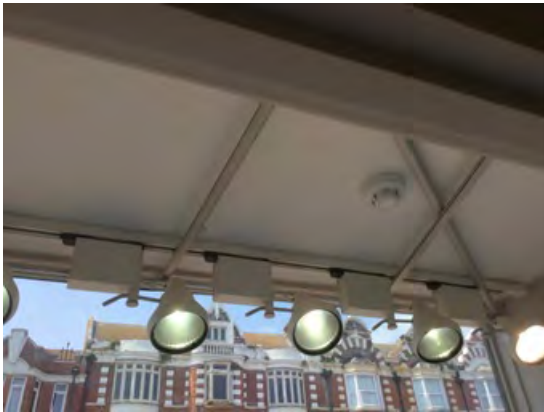
306

**Location:** Ground floor sales

**Condition:** Poor

**Comments:** Former tenants display lights remain - light fittings are soiled and aged

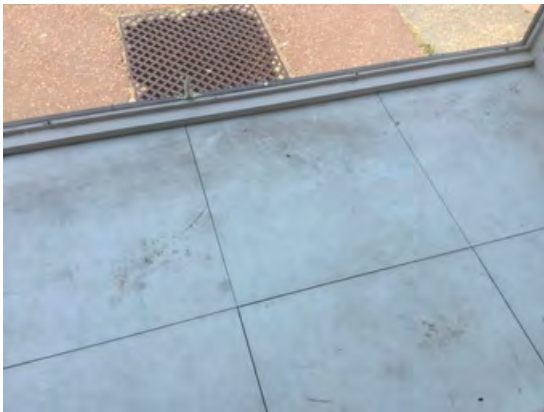
307

**Location:** Ground floor sales

**Condition:** Poor

**Comments:** Soiled and worn vinyl tiles to the shop window display areas

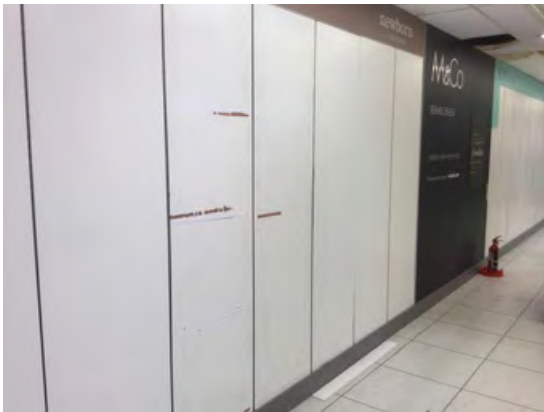
308

**Location:** Ground floor sales

**Condition:** Poor

**Comments:** Perimeter wall panelling - soiled throughout, frequent scuff marks and remnants of adhesive tape

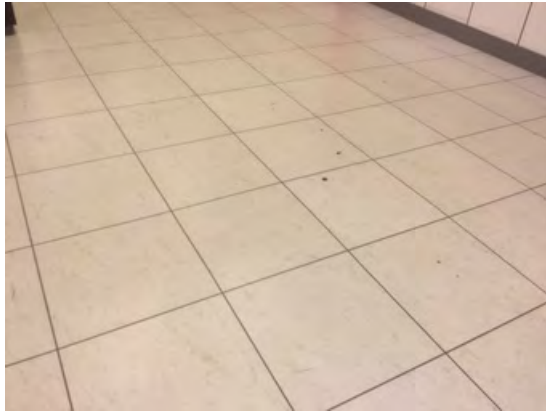
309

**Location:** Ground floor sales

**Condition:** Poor

**Comments:** Vinyl flooring is subject to heavy soiling and scuffing throughout

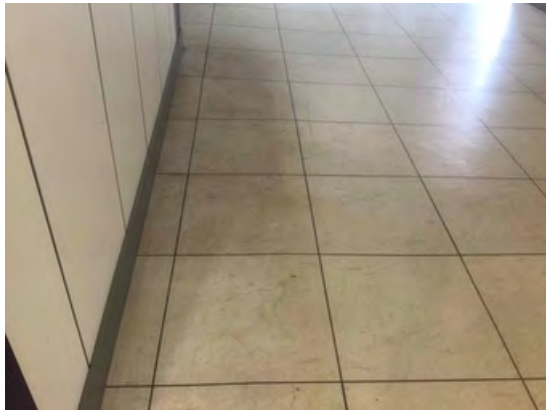
310

**Location:** Ground floor sales

**Condition:** Poor

**Comments:** Heavy soiling and wear to the vinyl flooring

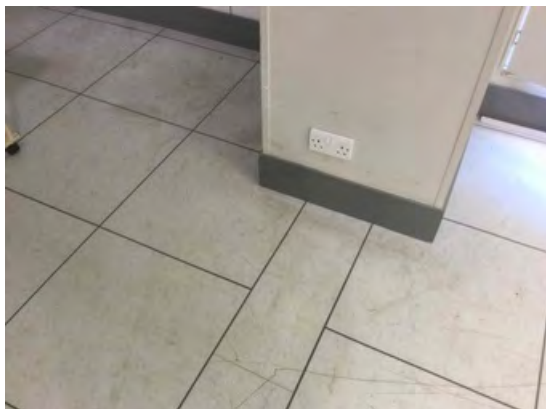
311

**Location:** Ground floor sales

**Condition:** Poor

**Comments:** Scuffed and marked vinyl flooring

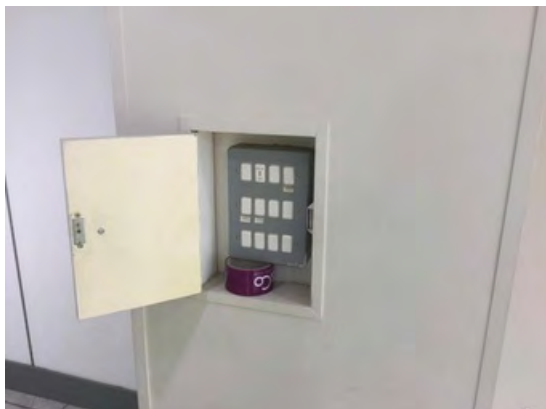
312

**Location:** Ground floor sales

**Condition:** Fair

**Comments:** Light switching - fair visual condition

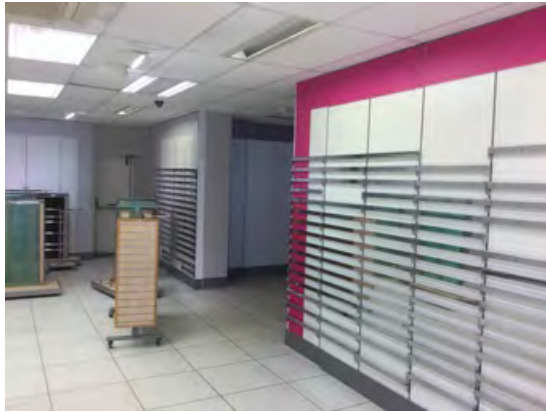
313

**Location:** Ground floor sales

**Comments:** General view towards the rear - former tenants clothing display systems remain

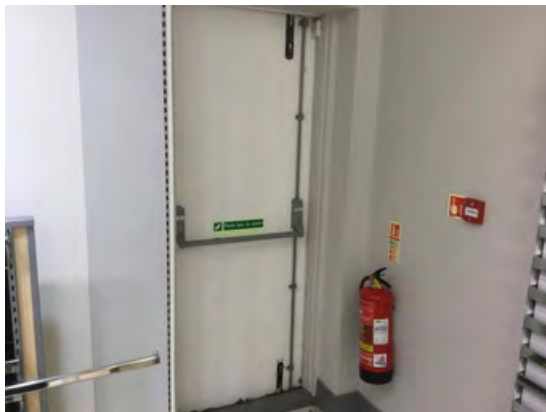
314

**Location:** Ground floor sales

**Decorative Condition:** Poor

**Comments:** Rear exit door - not tested at the time of inspection

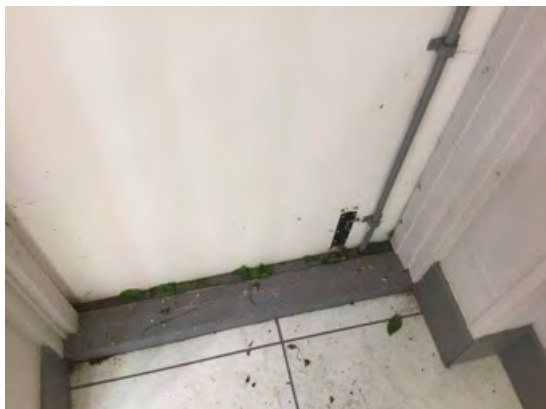
315

**Location:** Ground floor sales

**Condition:** Poor

**Decorative Condition:** Poor

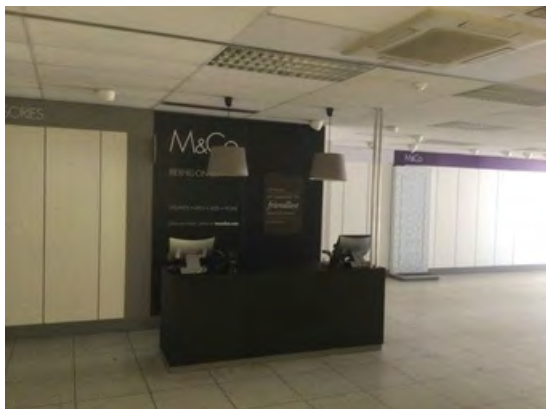
316

**Location:** Ground floor sales

**Condition:** N/a

**Comments:** Former tenants sales desk remains

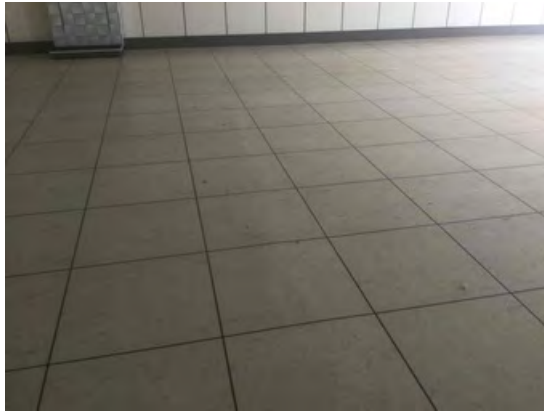
317

**Location:** Ground floor sales

**Comments:** Undulations noted in the floor screed

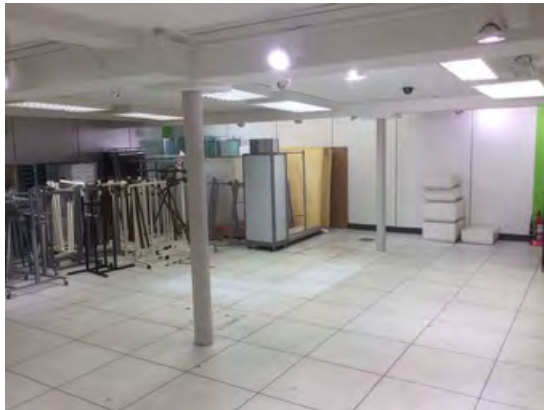
318

**Location:** Basement sales

**Decorative Condition:** Poor

**Comments:** General view - former tenants bespoke shop fit remains including tiled vinyl flooring, perimeter wall panelling, shop fixturing, former tenants desk and display lighting. Aged and tired shop fit, poor decorative condition throughout.

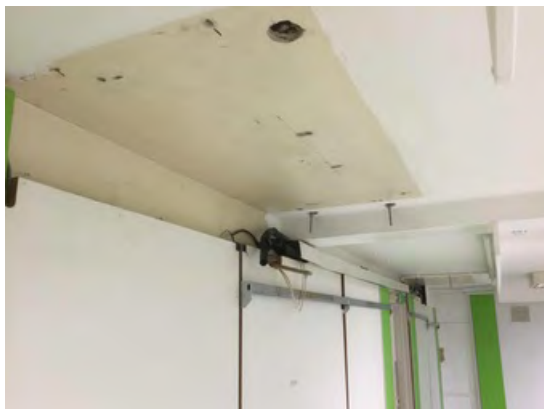
319

**Location:** Basement sales

**Condition:** Poor

**Comments:** AC systems removed, redundant pipework remains

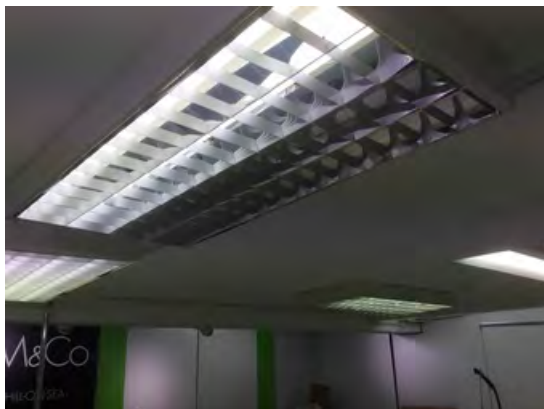
320

**Location:** Basement sales

**Condition:** Poor

**Comments:** Various defective lamps

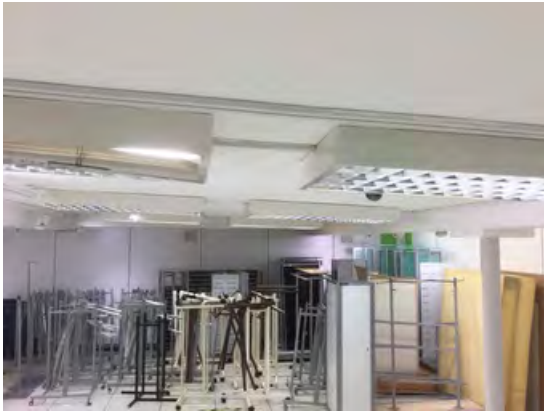
321

**Location:** Basement sales

**Condition:** Poor

**Comments:** Ceilings slope downwards towards the front of the store

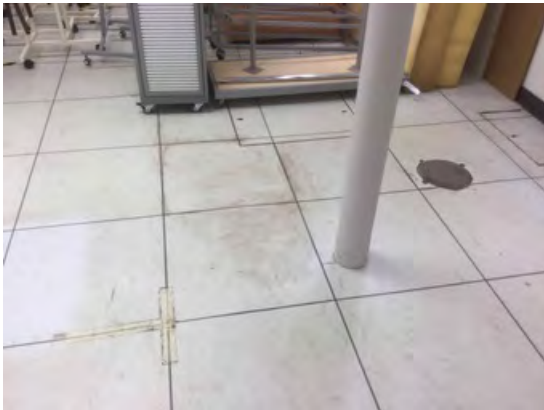
322

**Location:** Basement sales

**Condition:** Poor

**Comments:** Vinyl flooring - damaged, subject to heavy wear and soiling

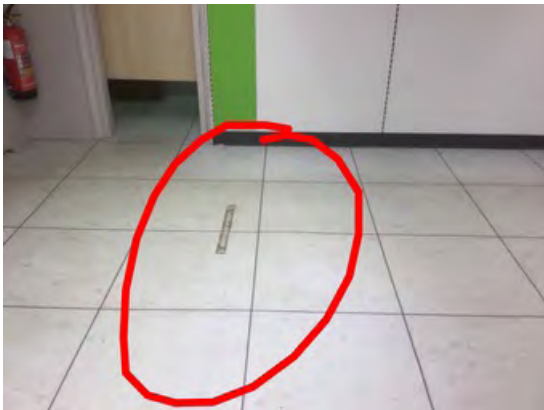
323

**Location:** Basement sales

**Condition:** Poor

**Comments:** Lifting section of vinyl flooring aside the basement fitting room

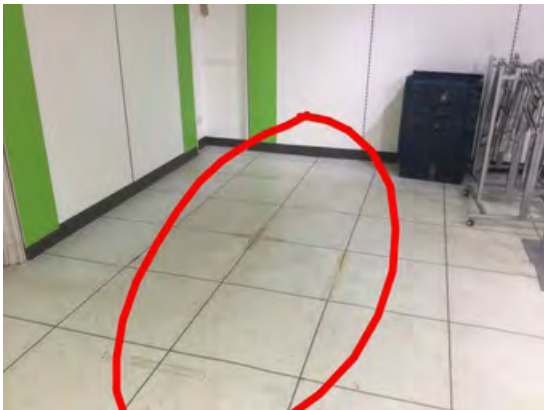
324

**Location:** Basement sales

**Condition:** Poor

**Comments:** Undulating and lifting vinyl flooring

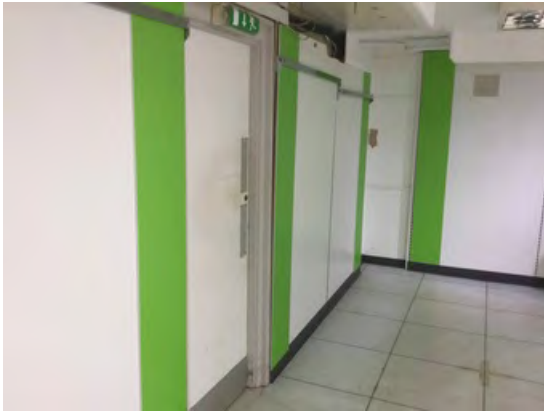
325

**Location:** Basement sales

**Comments:** Foamed panels applied to the perimeter wall panels

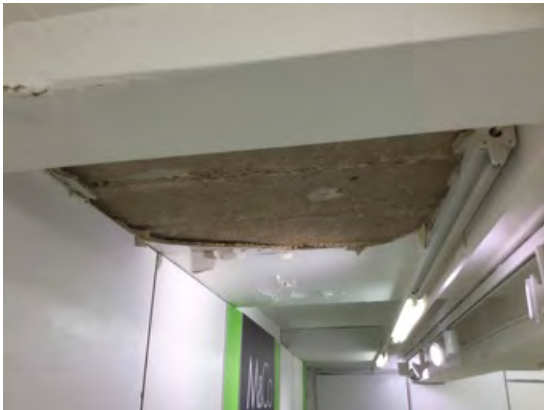
326

**Location:** Basement sales

**Condition:** Very poor

**Decorative Condition:** Very poor

**Comments:** Penetrating dampness along the shop frontage

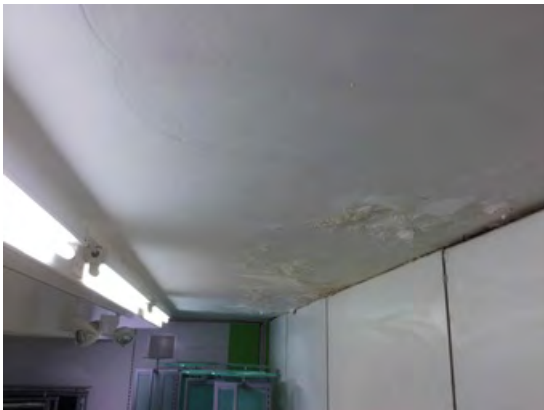
327

**Location:** Basement sales

**Condition:** Very poor

**Decorative Condition:** Very poor

**Comments:** Penetrating dampness

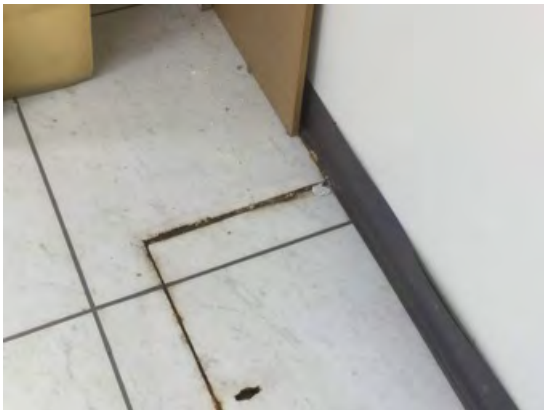
328

**Location:** Basement sales

**Condition:** Poor

**Comments:** Damp affected flooring along the front elevation

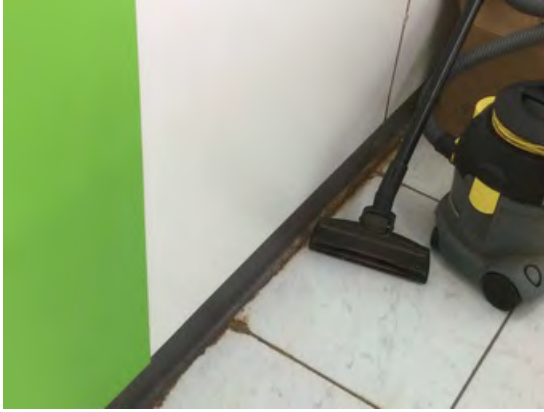
329

**Location:** Basement sales

**Condition:** Very poor

**Comments:** Penetrating dampness along the front elevation

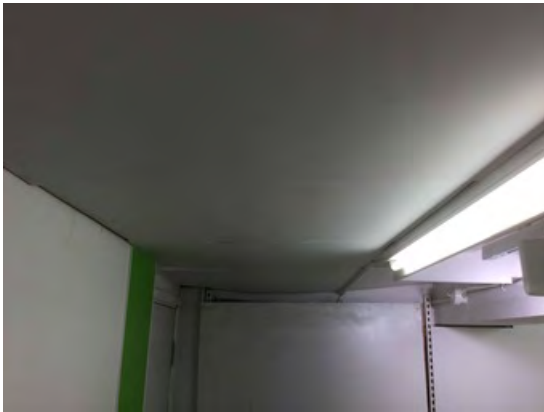
330

**Location:** Basement sales

**Condition:** Poor

**Comments:** Bowing and damp affected ceilings

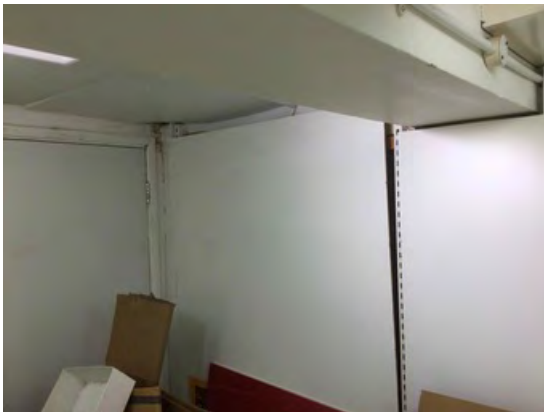
331

**Location:** Basement sales

**Condition:** Poor

**Comments:** Displaced wall panelling - front left corner

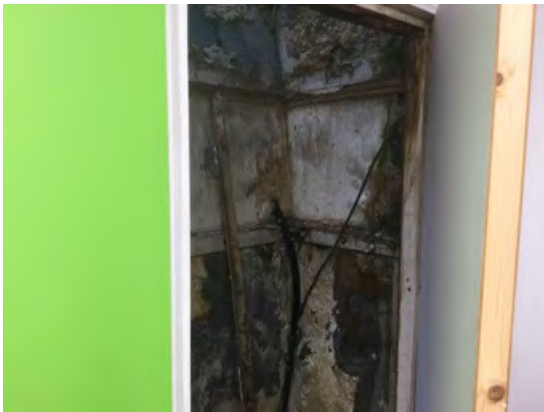
332

**Location:** Basement sales

**Condition:** Very poor

**Decorative Condition:** Very poor

**Comments:** Severe penetrating dampness to the concealed walkway along the front elevation

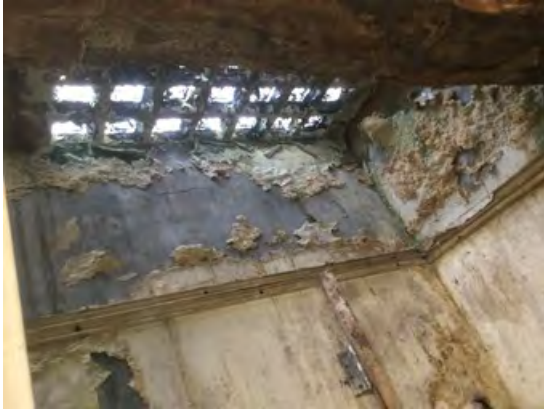
333

**Location:** Basement sales

**Condition:** Very poor

**Comments:** Leaky basement lights

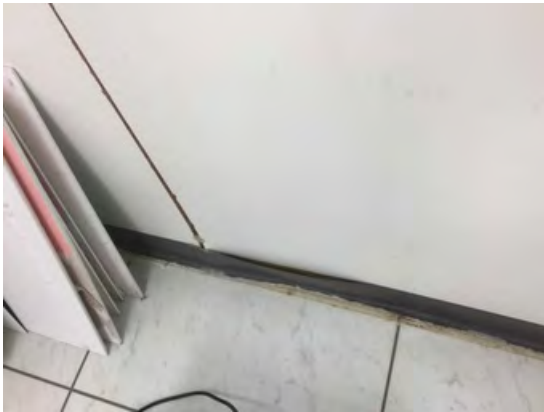
334

**Location:** Basement sales

**Condition:** Very poor

**Comments:** Dampness noted around the perimeter of the sales floor

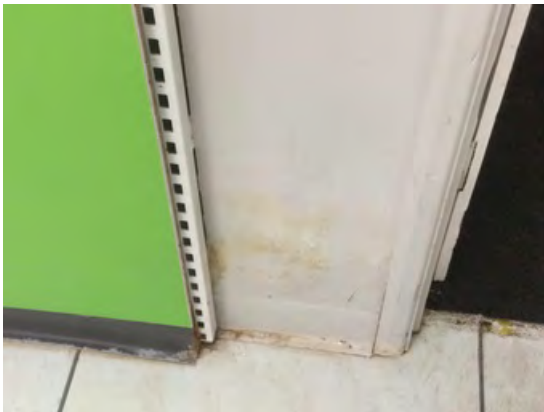
335

**Location:** Basement sales

**Decorative Condition:** Poor

**Comments:** Soiled decorations, poor decorative condition throughout

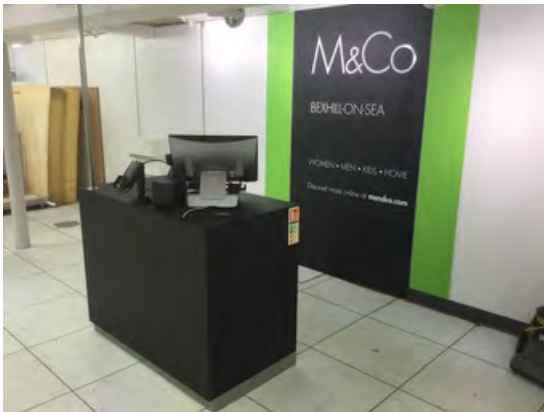
336

**Location:** Basement sales

**Comments:** Former tenants sales desk remains

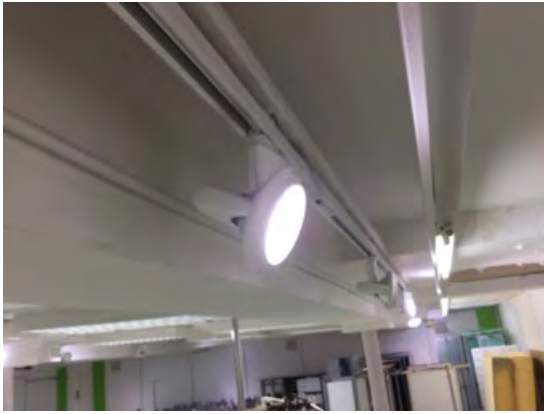
337

**Location:** Basement sales

**Comments:** Former tenants bespoke sales lighting systems remain

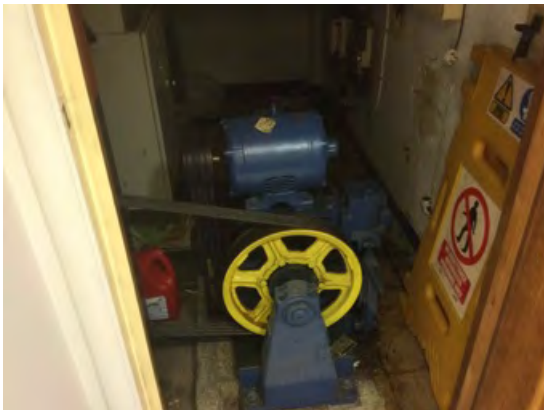
339

**Location:** Basement sales

**Condition:** Very poor

**Comments:** Complete lack of protection around the lift mechanism

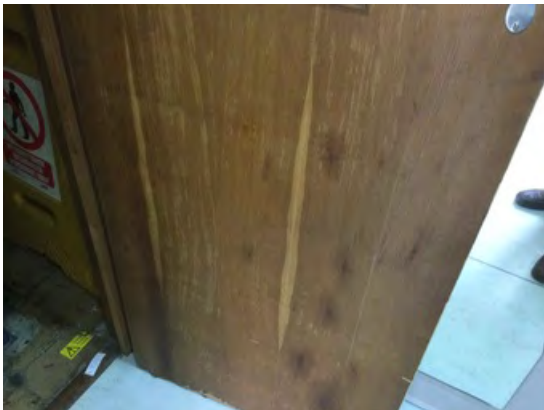
340

**Location:** Basement sales

**Decorative Condition:** Poor

**Comments:** Worn lacquer to the electrical cupboard door

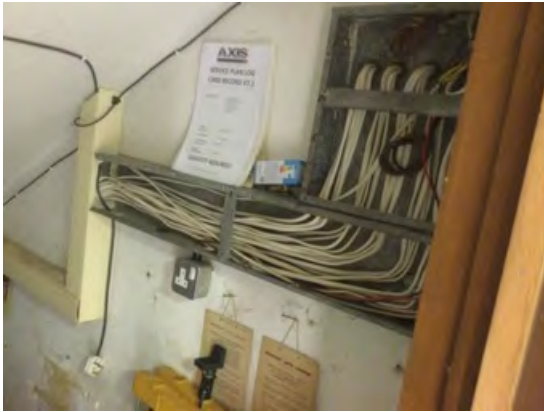
341

**Location:** Basement sales

**Condition:** Poor

**Comments:** Missing trunking lids

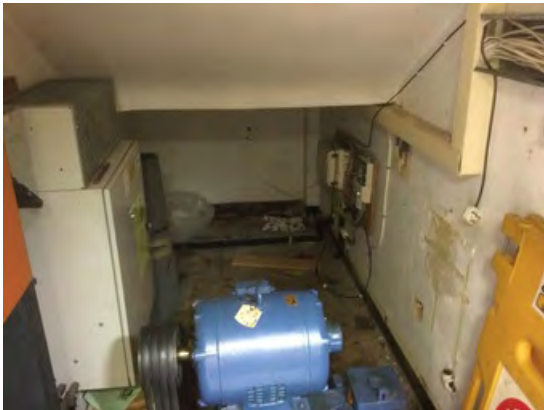
342

**Location:** Basement sales

**Condition:** Poor

**Decorative Condition:** Poor

**Comments:** Electrical systems - not tested at the time of inspection, lack of safe access due to the lift equipment

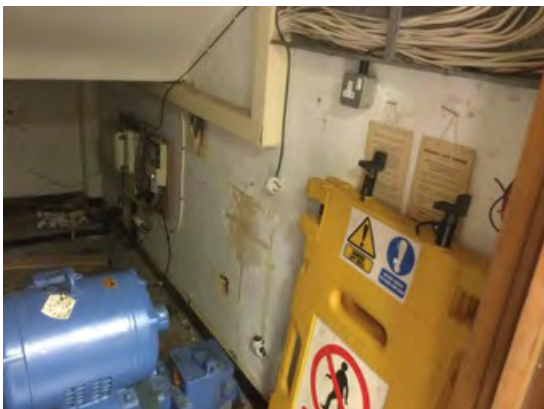
343

**Location:** Basement sales

**Decorative Condition:** Poor

**Comments:** Poor decorative condition throughout
