UNIT 7 GREENHILLS BUSINESS CENTRE - Schedule of Condition

Unit 7 Greenhills Business Ctr, Spennymoor

Inspection Date: 28 March 2023

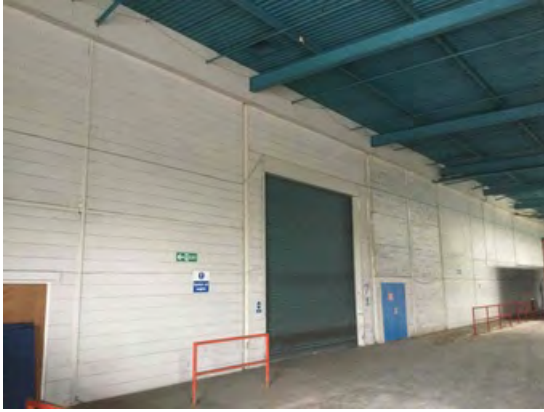
Location: Elevation 1

Condition: Fair

Comments: General view - soiled decorations, no significant impact damage or structural defects to the external wall

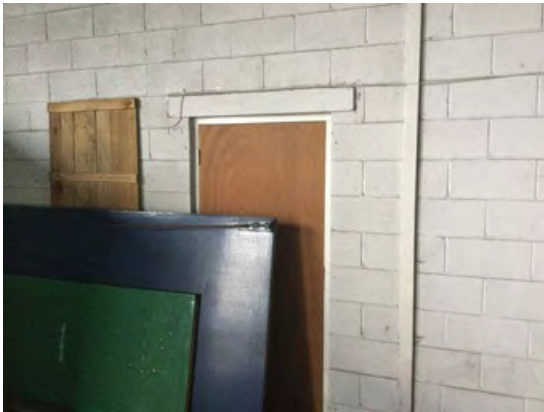
2

Location: Elevation 1

Comments: Single leaf entrance door infilled

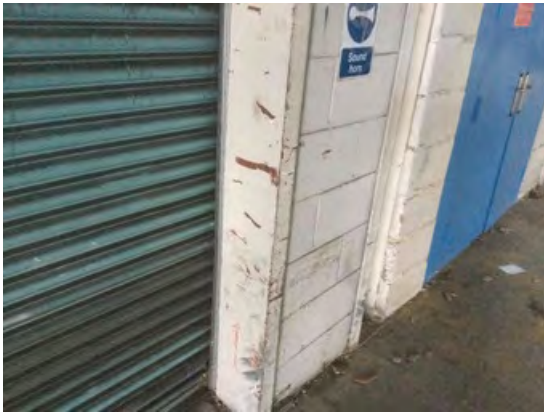
6

Location: Elevation 1

Comments: Scuffed decorations - right door reveal

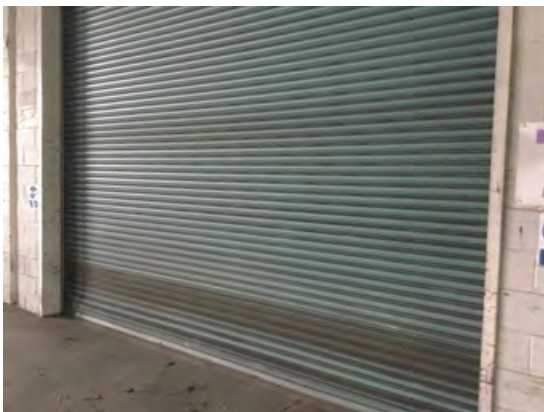
7

Location: Elevation 1

Comments: Shutter door - operational, soiled and minor indentations

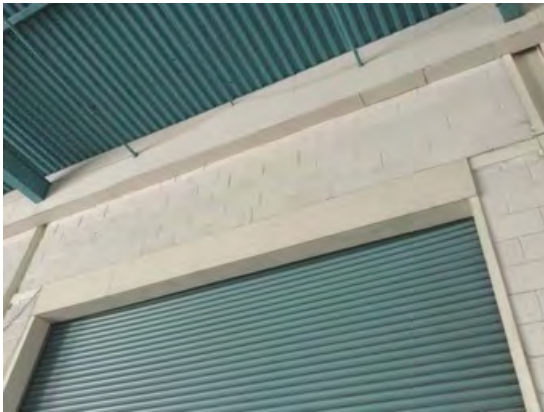
10

Location: Elevation 1

Comments: Doing to head of the shutter door - lightly soiled, no defects

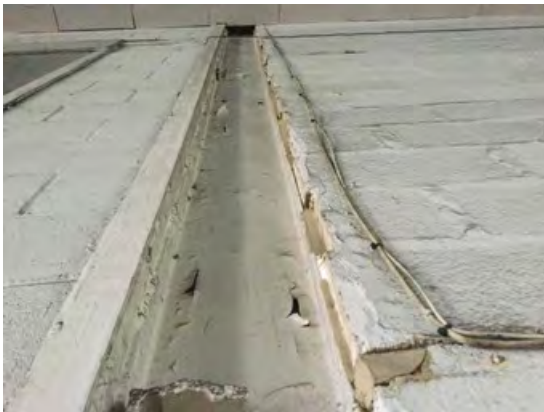
11

Location: Elevation 1

Condition: Poor

Comments: Displaced blockwork to the right of the loading bay

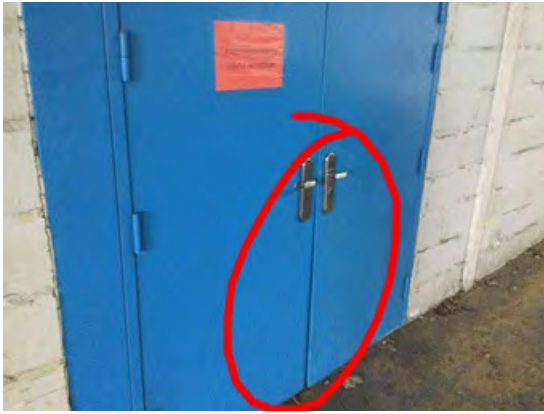
13

Location: Elevation 1

Comments: Displaced right hand leaf to the double pedestrian doors, minor scuffing

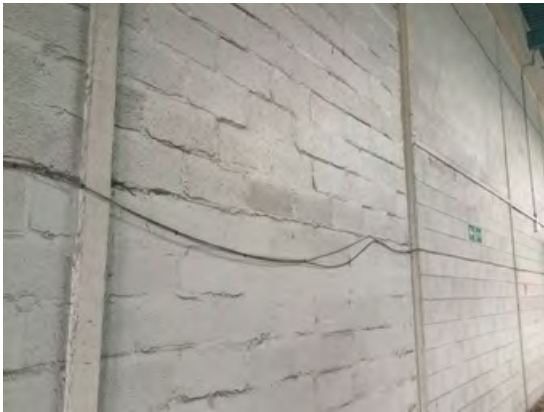
14

Location: Elevation 1

Comments: Unclipped cables

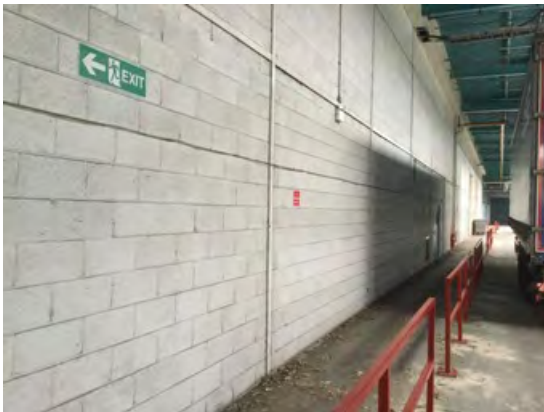
15

Location: Elevation 1

Comments: General view - soiled decorations

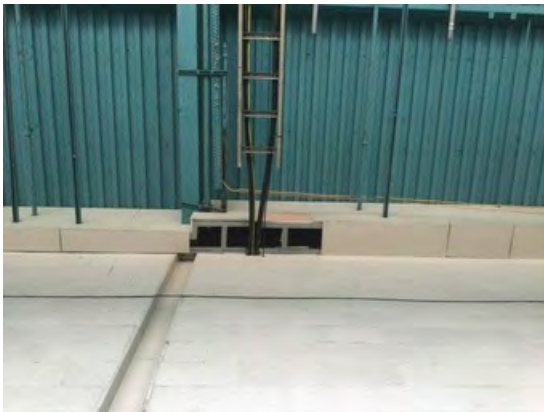
16

Location: Elevation 1

Condition: Poor

Comments: Missing section of fire cladding

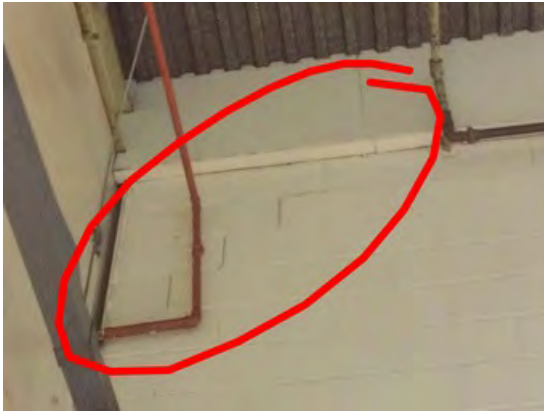
21

Location: Elevation 2

Comments: Stepped cracking - upper left corner

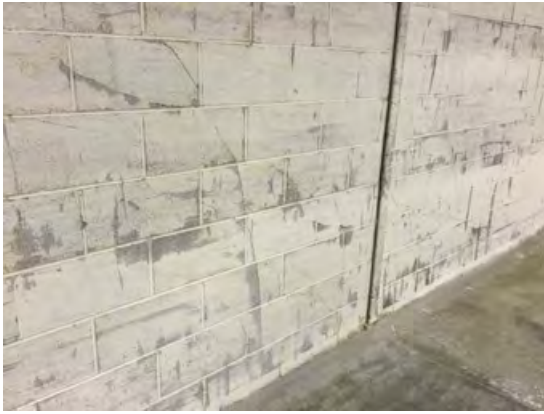
33

Location: Elevation 2

Comments: Scuffed blockwork

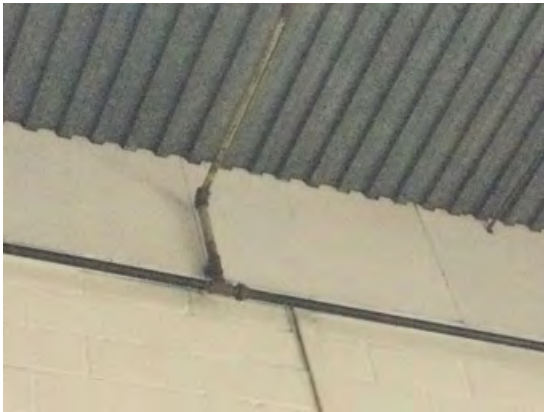
34

Location: Elevation 2

Condition: Poor

Comments: Corroding, redundant pipework

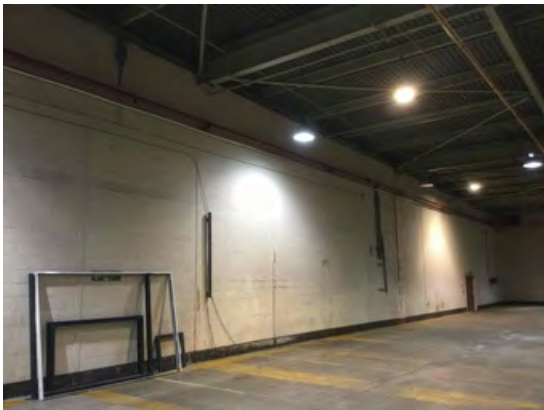
35

Location: Elevation 3

Comments: General view - various redundant brackets and fixings remain, soiled decorations throughout

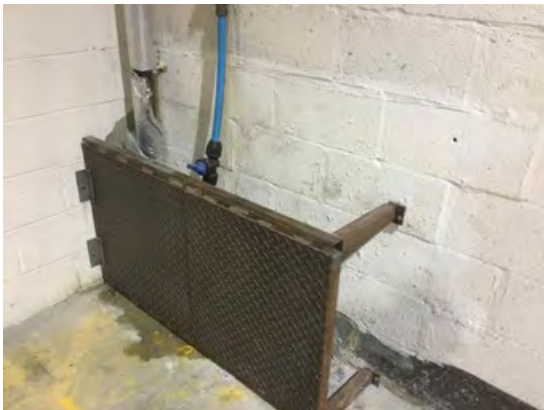
36

Location: Elevation 3

Condition: Poor

Comments: Corroded barrier around the water main

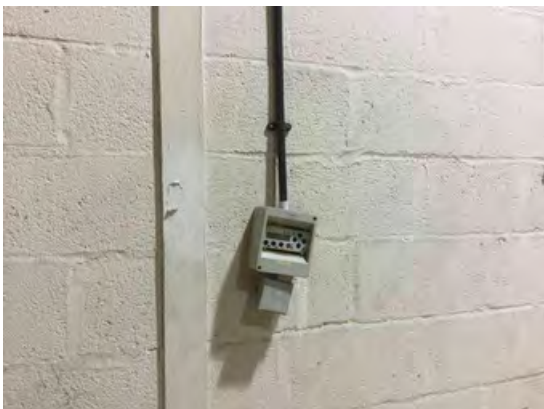
39

Location: Elevation 3

Condition: Poor

Comments: Displaced gas heater control

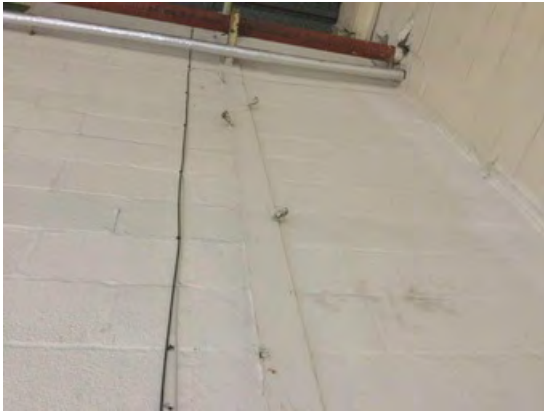
49

Location: Elevation 3

Comments: Old clips and brackets

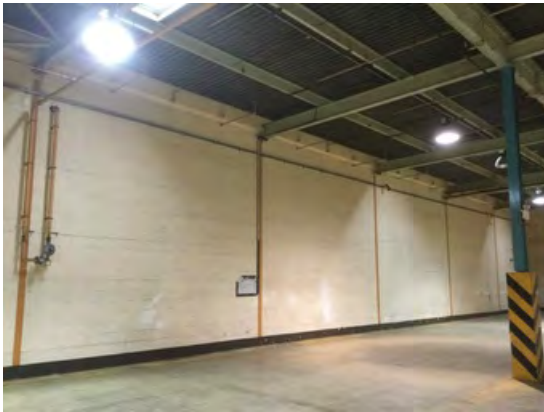
50

Location: Elevation 4

Comments: General view - soiled decorations, fair condition

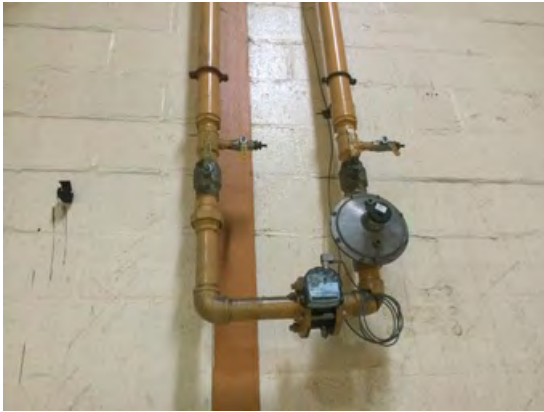
53

Location: Elevation 4

Comments: Gas meter - not tested, soiled pipework

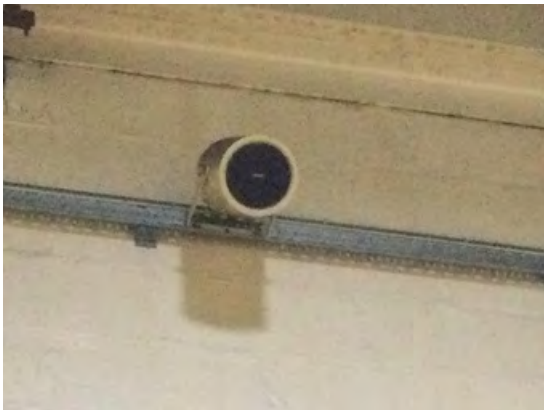
55

Location: Elevation 4

Condition: Poor

Comments: 2no redundant speakers

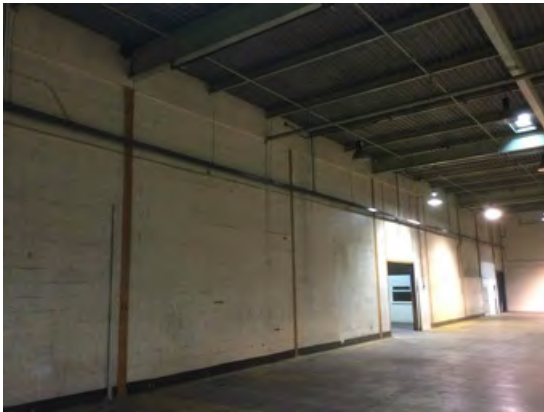
58

Location: Elevation 5

Condition: Fair

Decorative Condition: Poor

Comments: General view - soiled decorations throughout

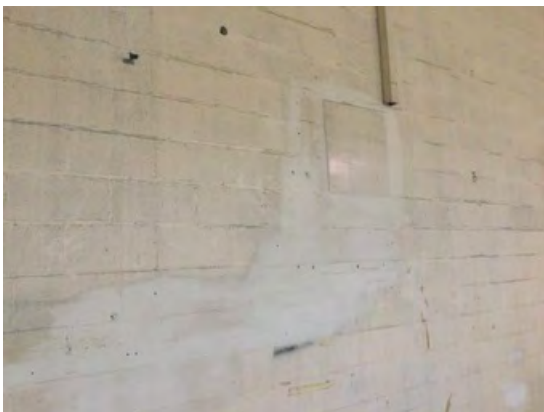
59

Location: Elevation 5

Condition: Fair

Decorative Condition: Poor

Comments: Patchy decorations, many fixing holes in the blockwork

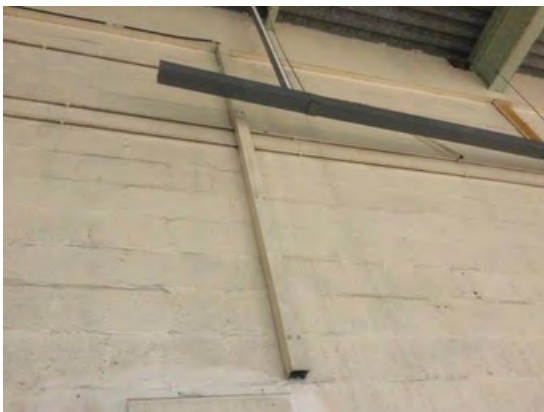
60

Location: Elevation 5

Comments: Redundant containment

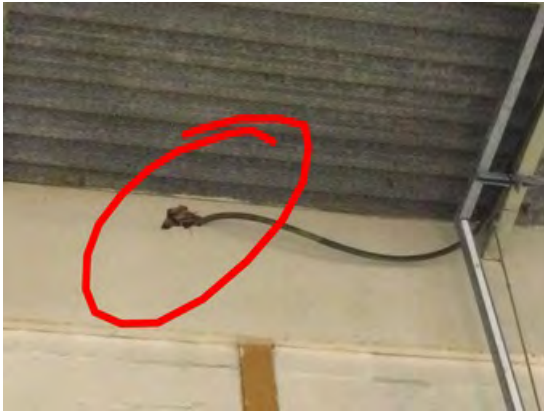
61

Location: Elevation 5

Condition: Poor

Comments: Infilled service penetration

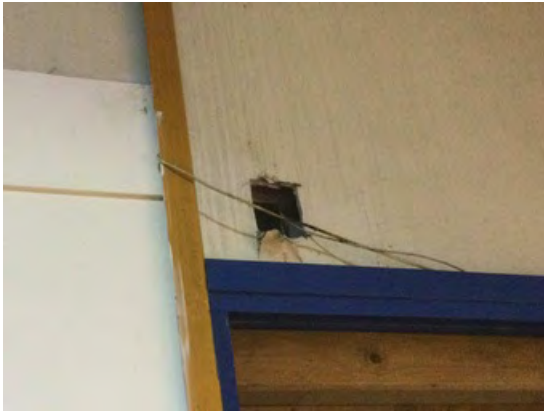
69

Location: Elevation 5

Condition: Poor

Comments: Infilled service penetration

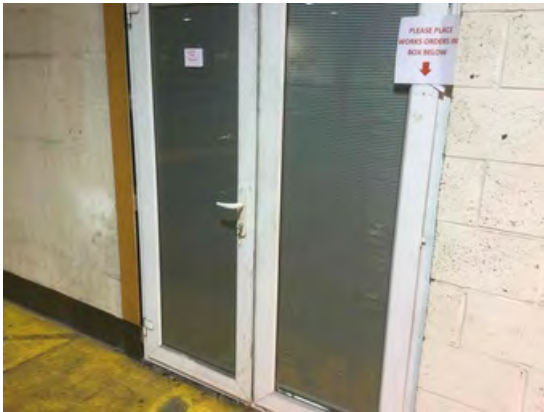
70

Location: Elevation 5

Condition: Poor

Comments: UPVC doors - heavy scuffing, soiled and affected by adhesive tape marks

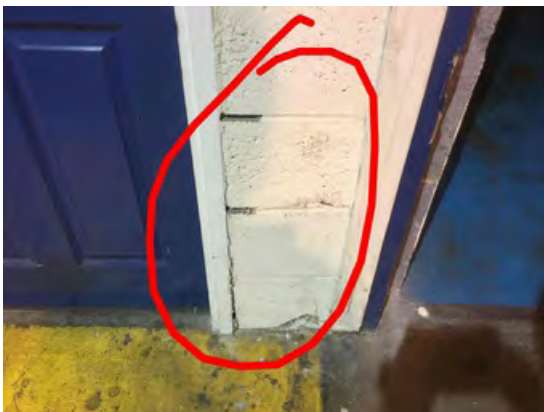
72

Location: Elevation 5

Condition: Fair

Decorative Condition: Poor

Comments: Minor impact damage

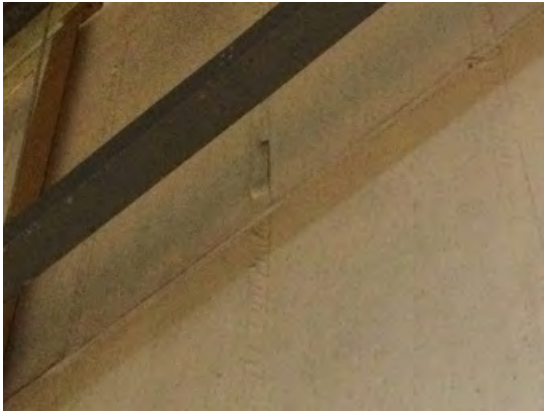
73

Location: Elevation 5

Condition: Fair

Decorative Condition: Very poor

Comments: Rippled and lifting joint tape to the partition wall

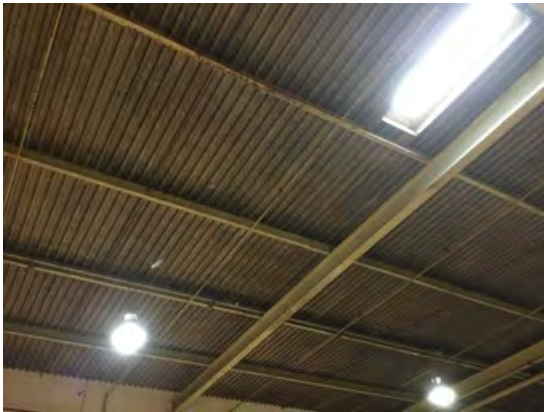
74

Location: Bay 1

Condition: Fair

Decorative Condition: Poor

Comments: Roof cladding is heavily soiled, steelwork affected by surface corrosion

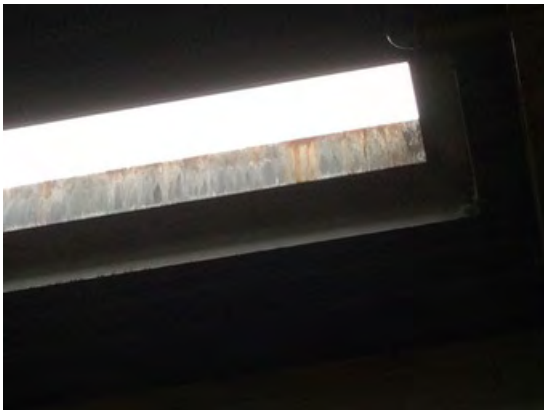
76

Location: Bay 1

Condition: Poor

Comments: Corrosion around the rooflight

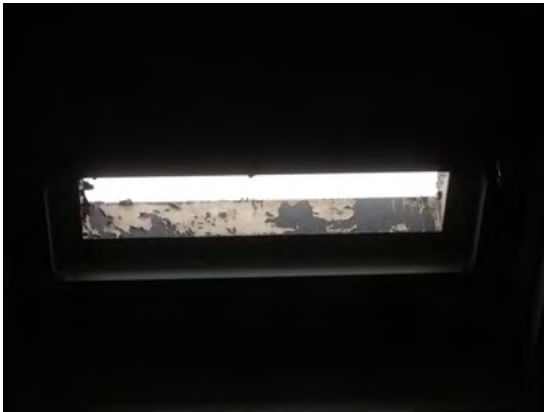
82

Location: Bay 2

Condition: Fair

Decorative Condition: Poor

Comments: Flaking paint to the rooflight surround

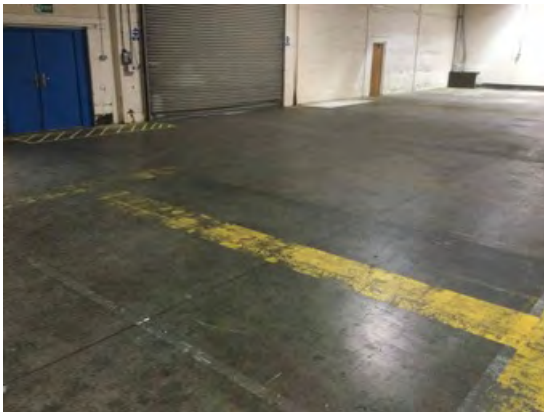
83

Location: Bay 2

Condition: Fair

Decorative Condition: Poor

Comments: Worn paint markings, slab is soiled and affected by general wear

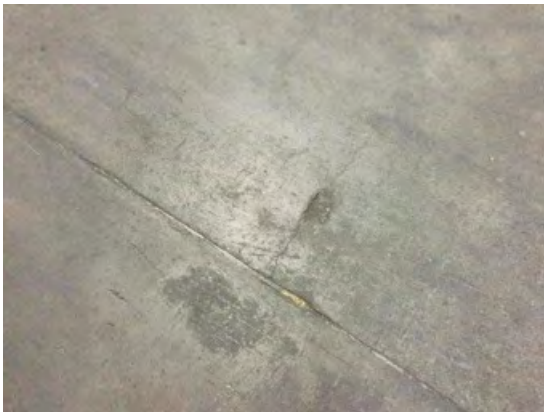
84

Location: Bay 2

Condition: Fair

Comments: Minor indentations and cracks

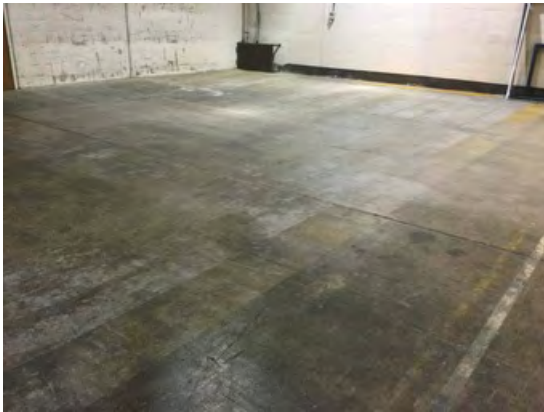
90

Location: Bay 3

Condition: Fair

Decorative Condition: Poor

Comments: Floor subject to general wear, worn paint markings, minor damage and cracks

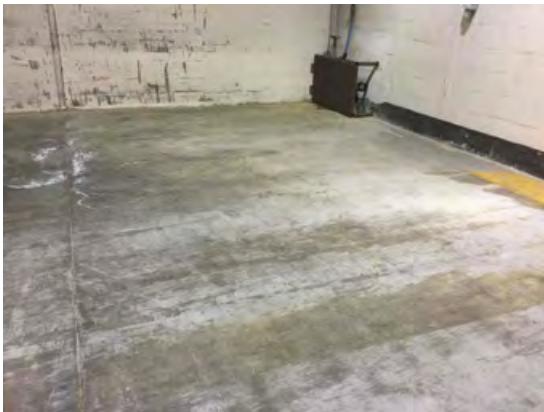
92

Location: Bay 3

Decorative Condition: Very poor

Comments: Painted area - very poor decorative condition

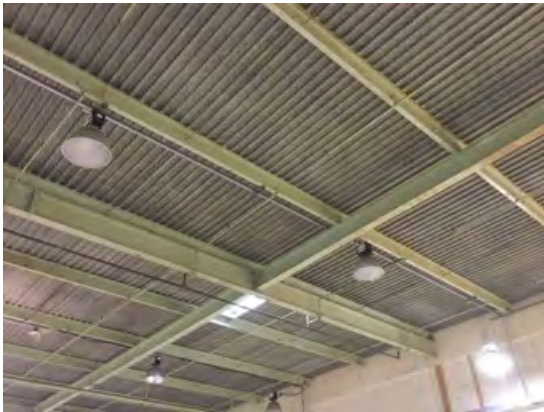
94

Location: Bay 4

Condition: Poor

Comments: 3no defective lamps

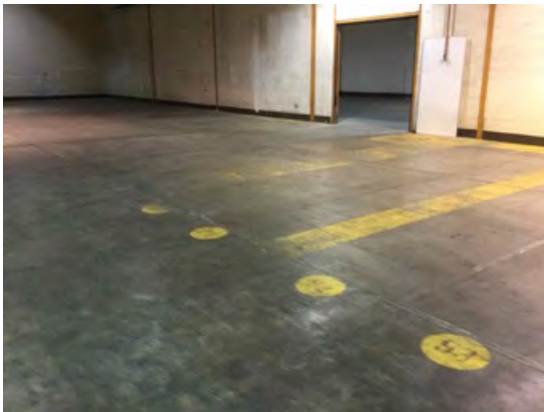
96

Location: Bay 4

Condition: Fair

Decorative Condition: Poor

Comments: Slab subject to general wear, worn paint markings, minor imperfections, cracks and damage

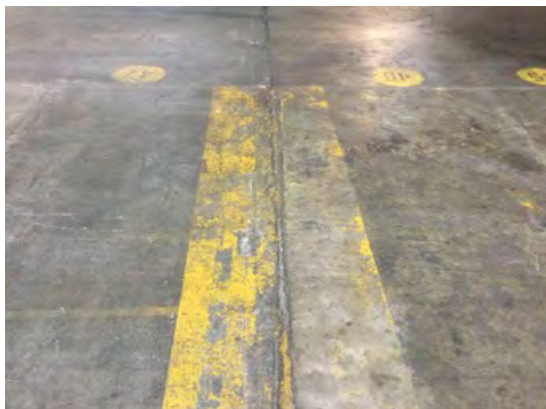
100

Location: Bay 5

Comments: Worn and frayed bay joints

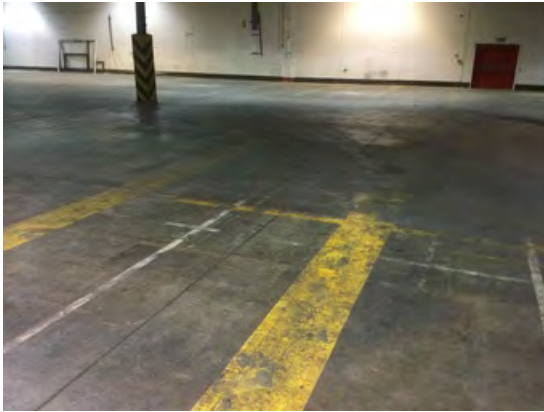
109

Location: Bay 8

Condition: Fair

Decorative Condition: Poor

Comments: Worn paint markings, soiled slab. Minor surface damage and general wear

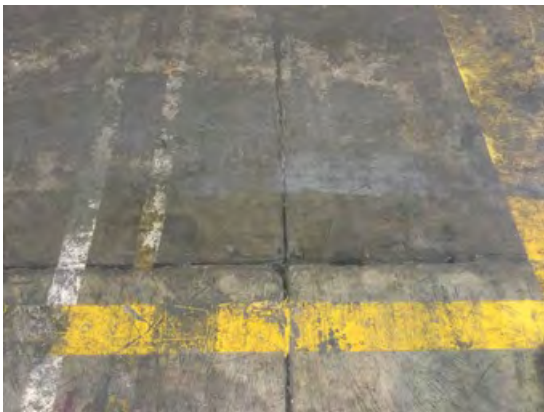
110

Location: Bay 8

Comments: Frayed bay joints

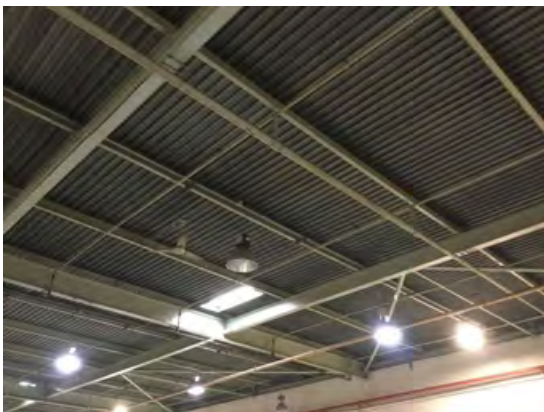
111

Location: Bay 9

Condition: Fair

Decorative Condition: Poor

Comments: Roof cladding is heavily soiled, steelwork affected by surface corrosion. 1no defective lamp, 1no disused destrat fan

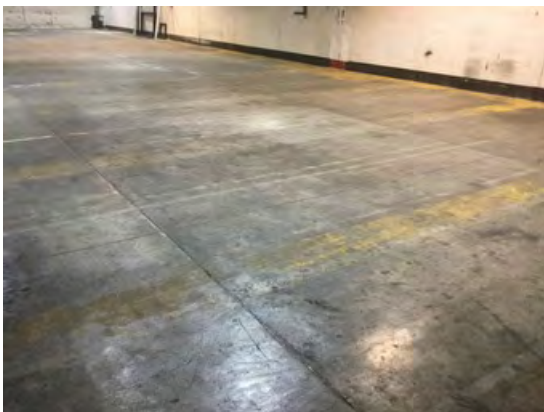
112

Location: Bay 9

Condition: Fair

Decorative Condition: Poor

Comments: Worn paint markings, general surface wear

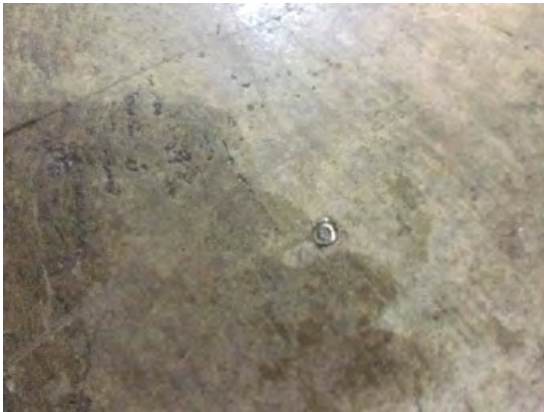
114

Location: Bay 9

Comments: Sporadic redundant fixing bolts across the warehouse floor generally

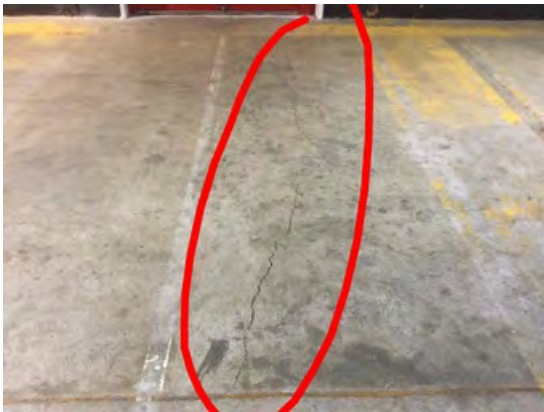
115

Location: Bay 9

Condition: Poor

Comments: Heavy cracking running towards the exit door

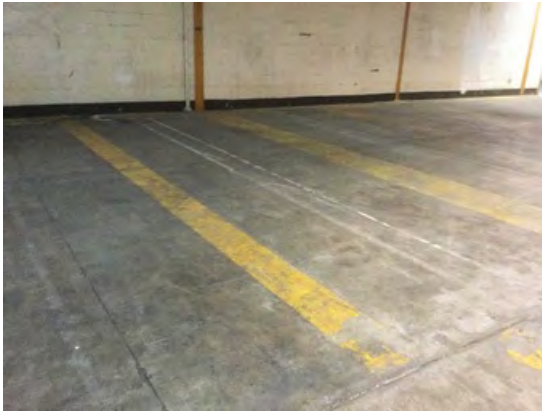
117

Location: Bay 10

Condition: Fair

Decorative Condition: Poor

Comments: Worn paint markings, general wear and minor surface damage

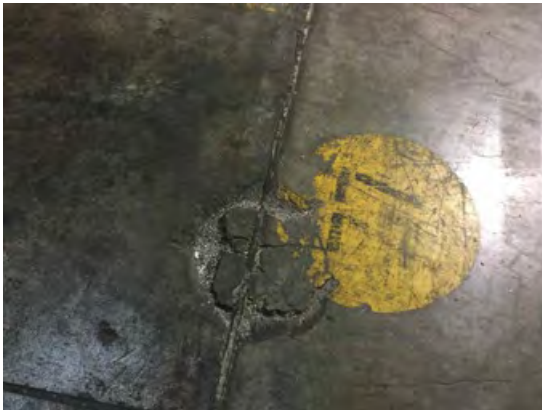
118

Location: Bay 10

Comments: Localised damage to the screed

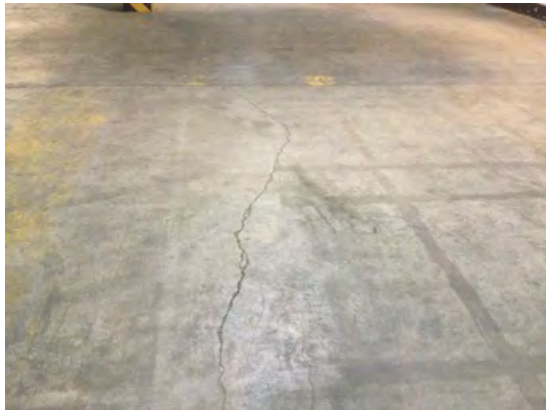
122

Location: Bay 11

Comments: Surface cracking in the screed

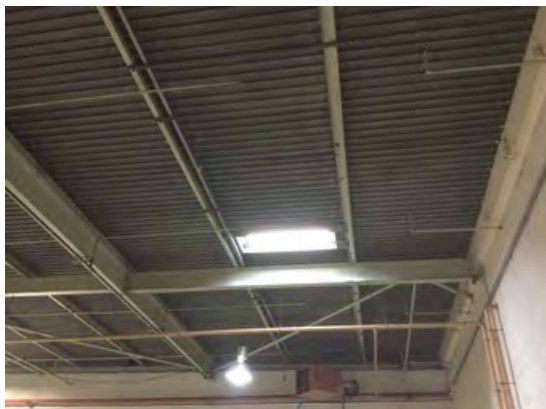
124

Location: Bay 12

Condition: Fair

Decorative Condition: Poor

Comments: Roof cladding is heavily soiled, steelwork affected by surface corrosion

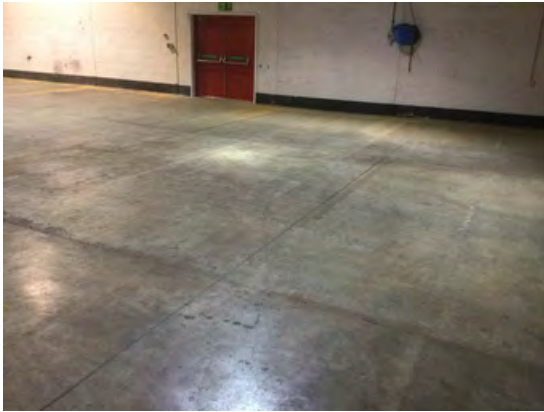
125

Location: Bay 12

Condition: Fair

Decorative Condition: Poor

Comments: Slab subject to general wear, worn paint markings. Surface damage

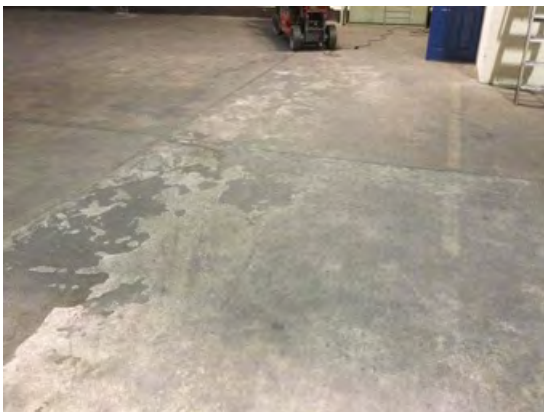
128

Location: Bay 13

Condition: Poor

Comments: Heavy wear to the screed adjacent the entrance from the main warehouse

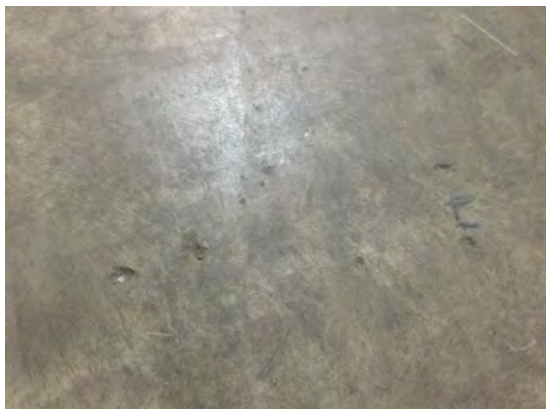
132

Location: Bay 13

Comments: Sporadic redundant bolts

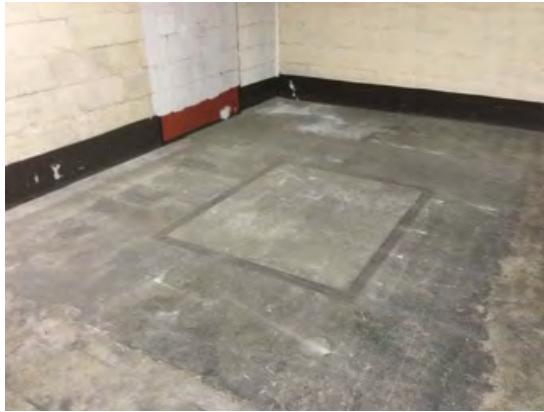
133

Location: Bay 13

Comments: Patch repaired area, protruding fixing bolts remain

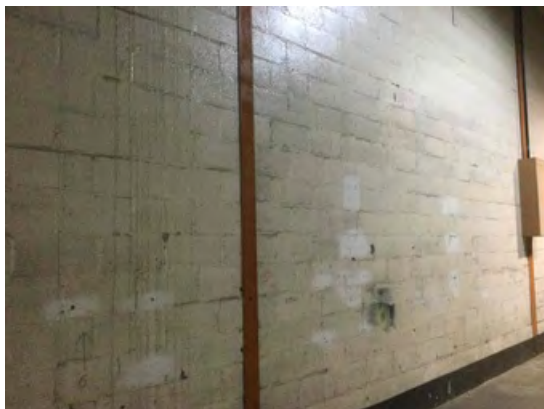
136

Location: Bay 13

Decorative Condition: Poor

Comments: Heavily soiled decorations

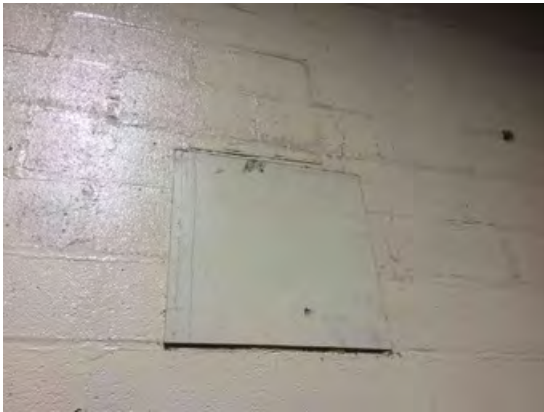
138

Location: Bay 13

Comments: Patched service aperture

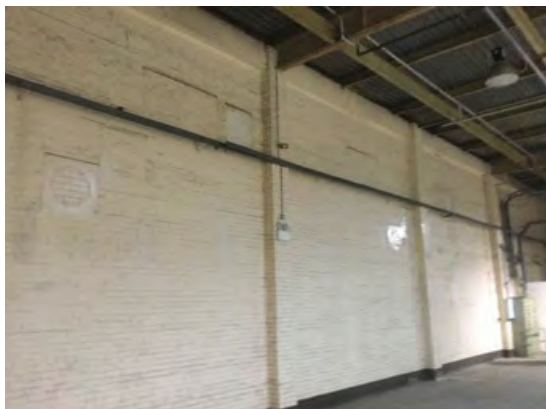
143

Location: Bay 13

Condition: Fair

Decorative Condition: Poor

Comments: General view - uneven brickwork, soiled decorations

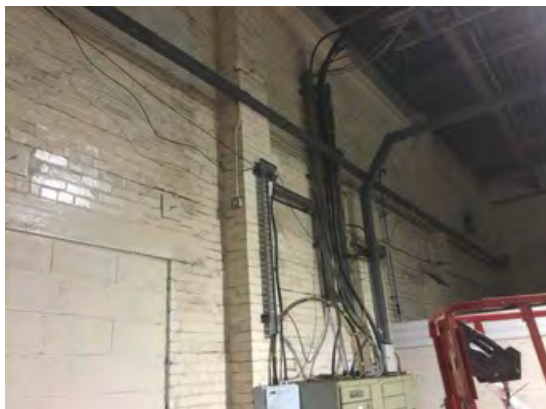
144

Location: Bay 13

Comments: Untidy cabling

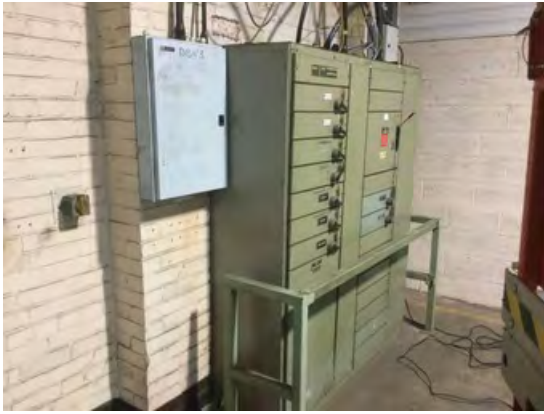
145

Location: Bay 13

Comments: Aged and soiled electrical board - not tested

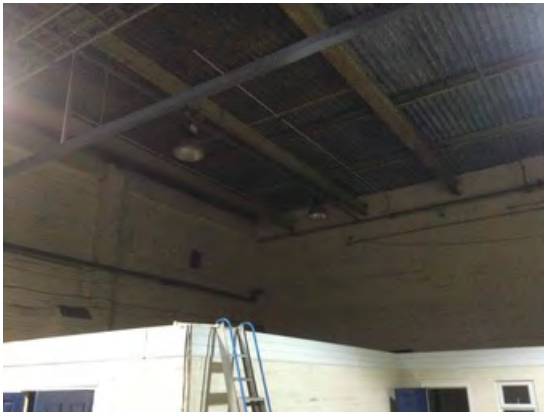
146

Location: Bay 13

Decorative Condition: Poor

Comments: Heavy soiling above the office block

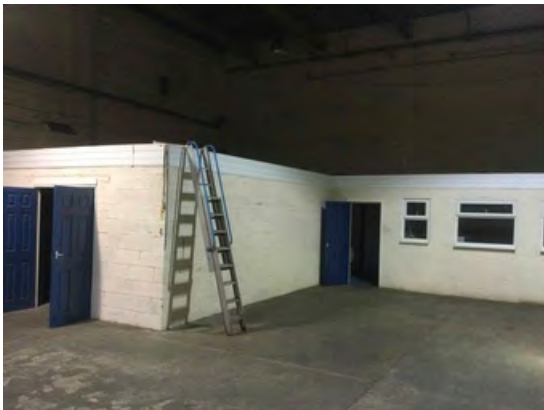
147

Location: Bay 13

Condition: Fair

Decorative Condition: Poor

Comments: Office block walls are soiled externally

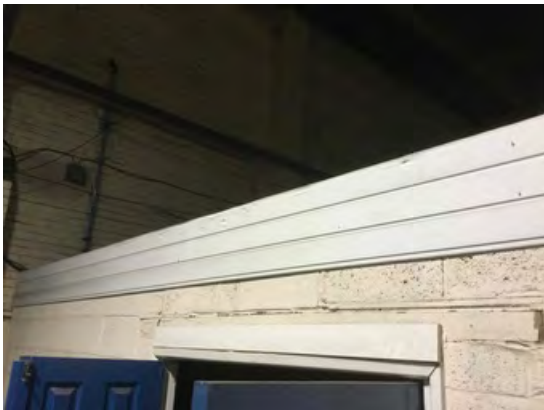
148

Location: Bay 13

Condition: Fair

Comments: Indented pvc fascia

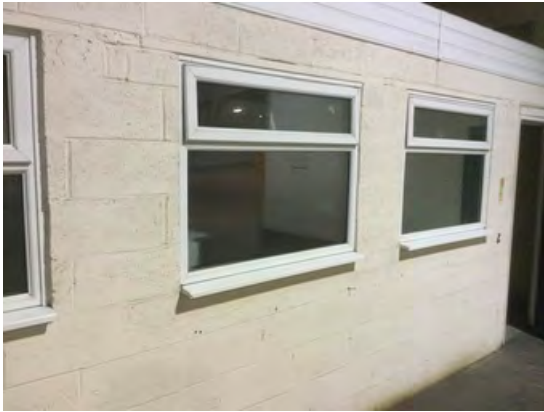
149

Location: Bay 13

Condition: Fair

Decorative Condition: Poor

Comments: Lightly soiled UPVC windows and decorations

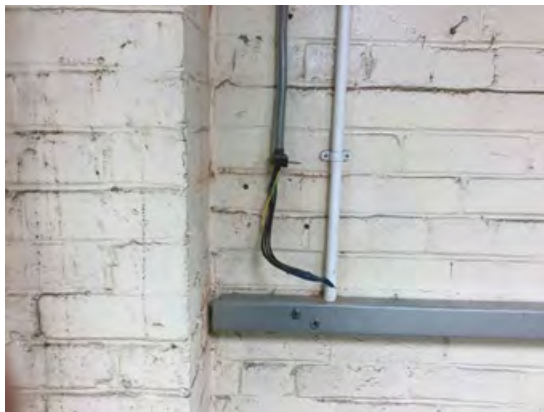
154

Location: Office 1

Condition: Very poor

Comments: Cut cabling

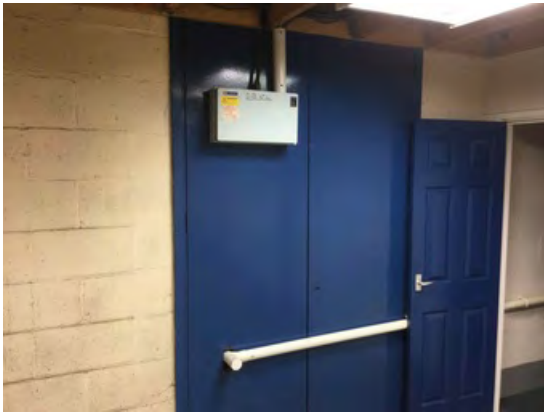
158

Location: Office 1

Comments: Door opening infilled

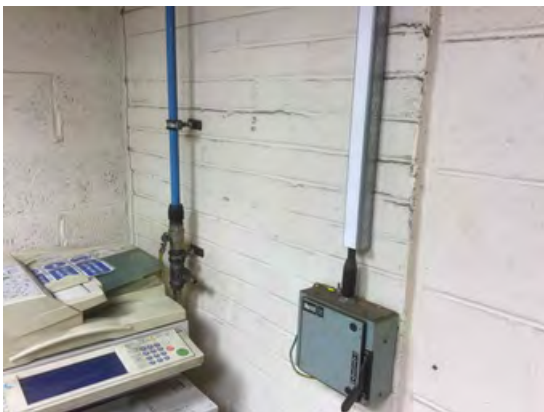
159

Location: Office 1

Comments: Soiled electrical components

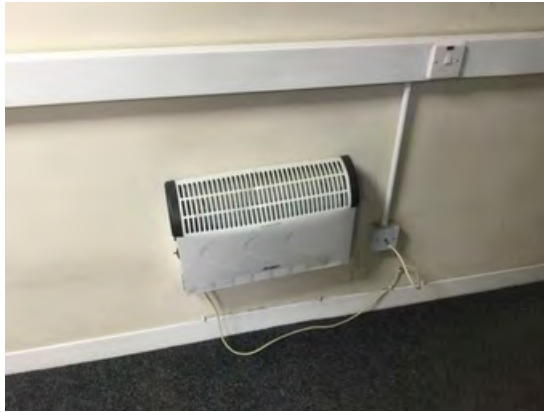
165

Location: Office 3

Condition: Poor

Comments: Damaged wall heater

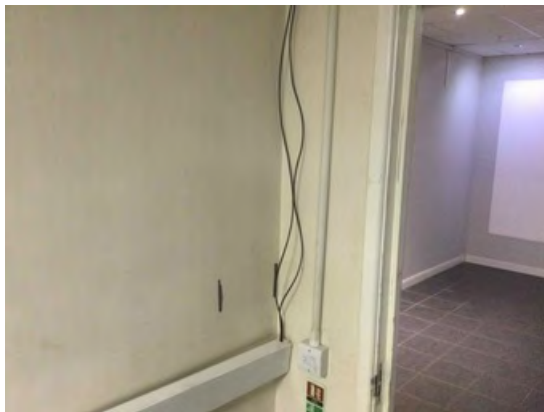
166

Location: Office 3

Comments: Unclipped cables

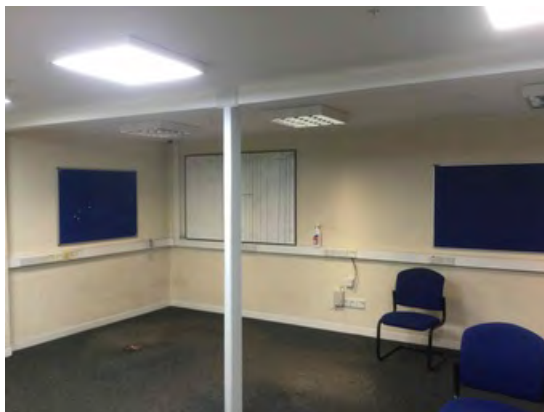
167

Location: Office 3

Decorative Condition: Poor

Comments: General view - soiled decorations

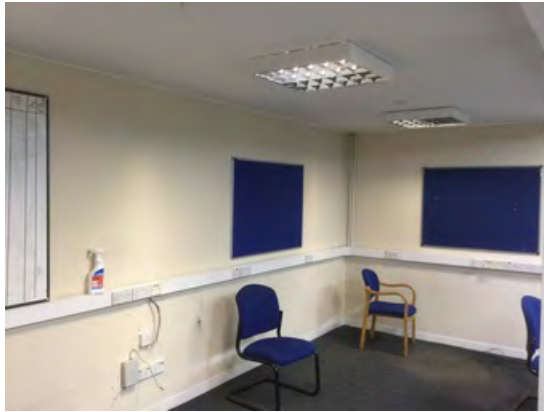
169

Location: Office 3

Condition: N/a

Comments: Former tenants notice boards remain

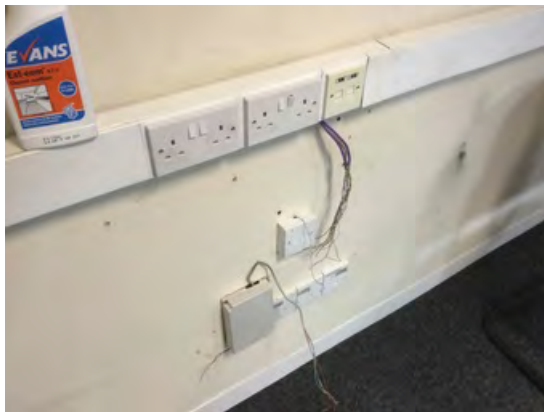
170

Location: Office 3

Condition: Poor

Comments: Damaged BT Comms cabling

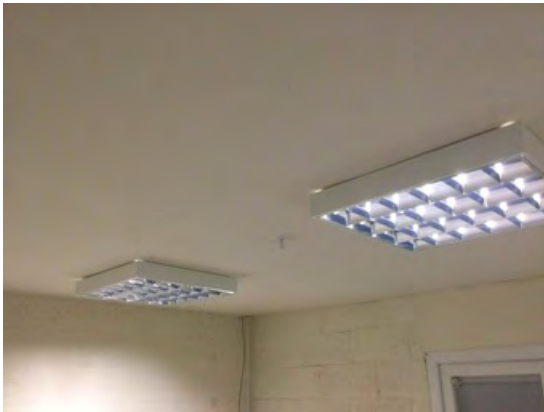
174

Location: Office 5

Decorative Condition: Poor

Comments: Lightly soiled ceilings

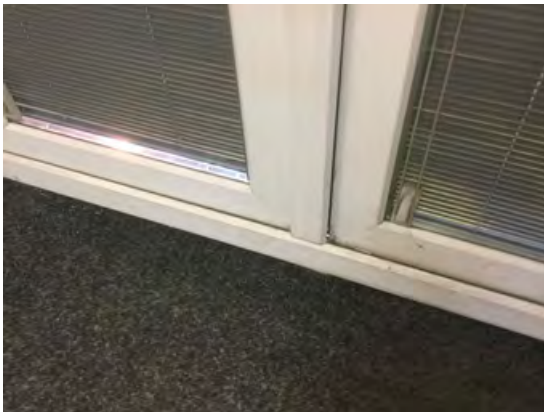
176

Location: Office 5

Condition: Poor

Comments: Heavily scuffed upvc frames

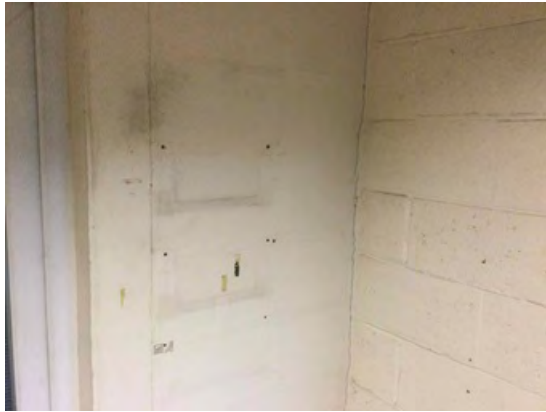
177

Location: Office 5

Decorative Condition: Poor

Comments: Various fixing holes, soiled decorations

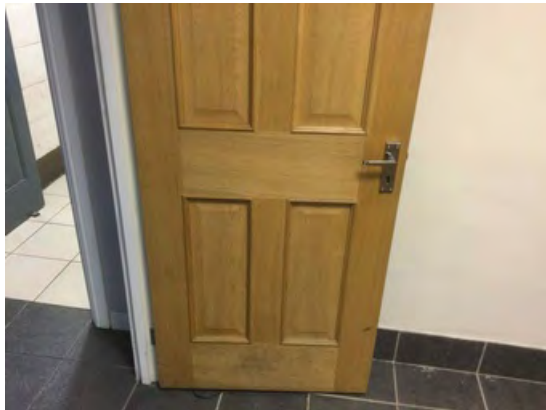
178

Location: Office 6

Condition: Fair

Comments: Entrance door - lightly soiled and marked

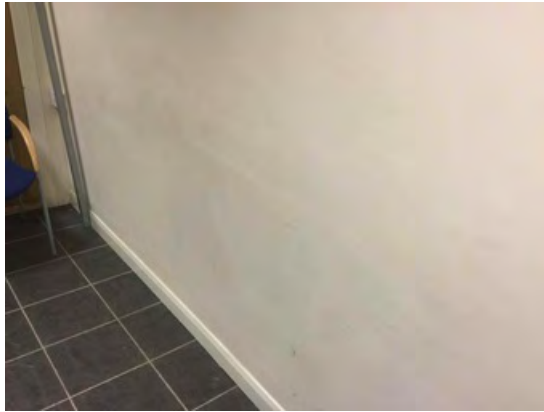
181

Location: Office 6

Decorative Condition: Poor

Comments: Soiled decorations

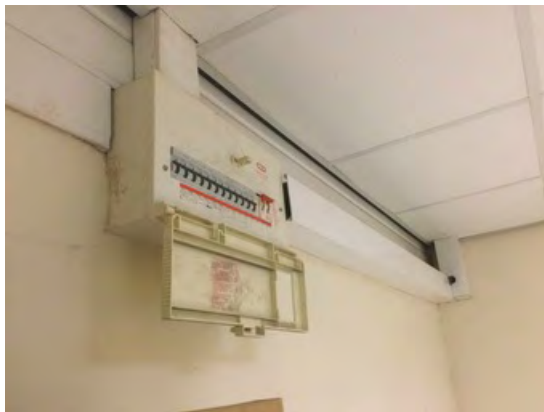
182

Location: Office 6

Comments: Aged and soiled electrical board

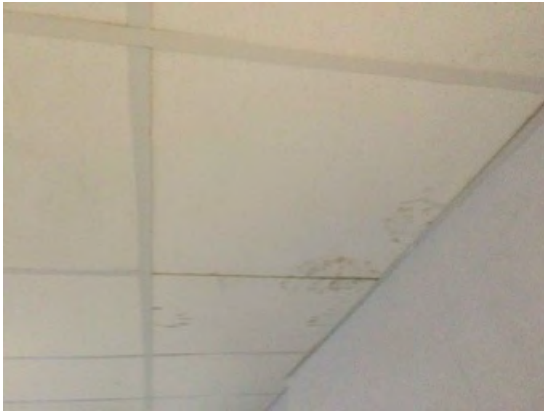
185

Location: Lobby
Condition: Poor
Decorative Condition: N/a
Comments: Soiled tiles

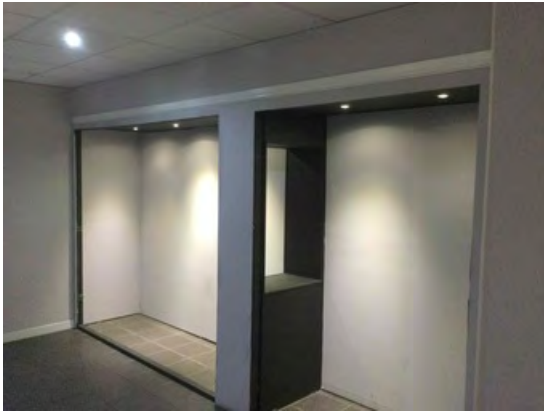
189

Location: Lobby

Comments: Former tenants display fixturing remains

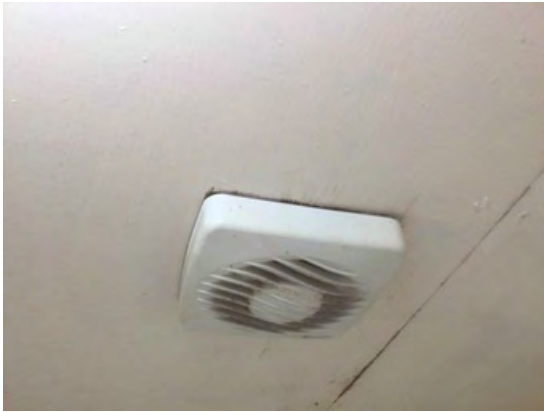
197

Location: Tea room

Condition: Poor

Comments: Defective extractor

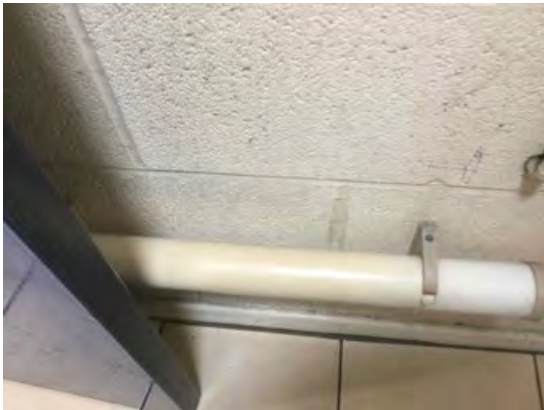
198

Location: Tea room

Comments: Yellowing tube heater

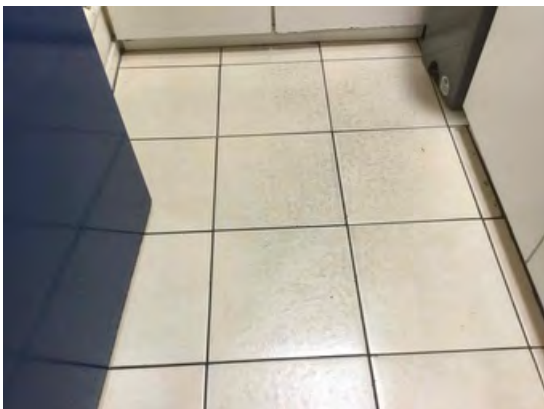
199

Location: Tea room

Condition: Poor

Comments: Soiled and worn floor tiles

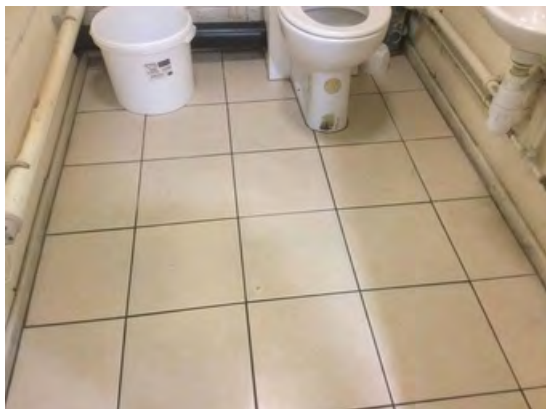
203

Location: Dis WC

Condition: Fair

Comments: Soiled floor tiles

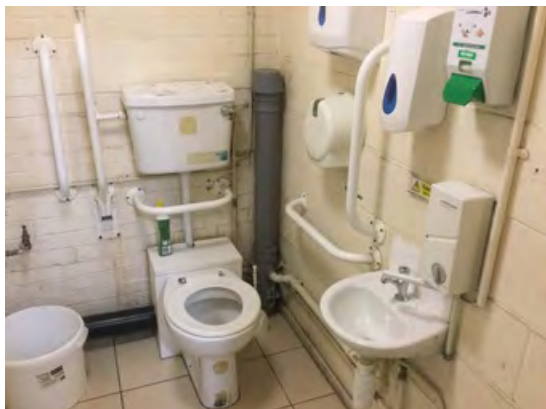
204

Location: Dis WC

Condition: Fair

Comments: Marked and soiled sanitary fittings

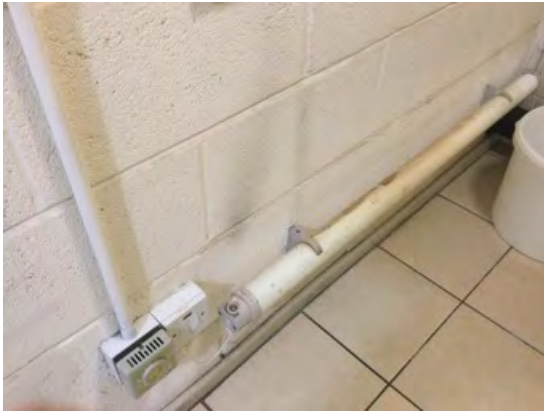
205

Location: Dis WC

Condition: Poor

Comments: Yellowing panel heater

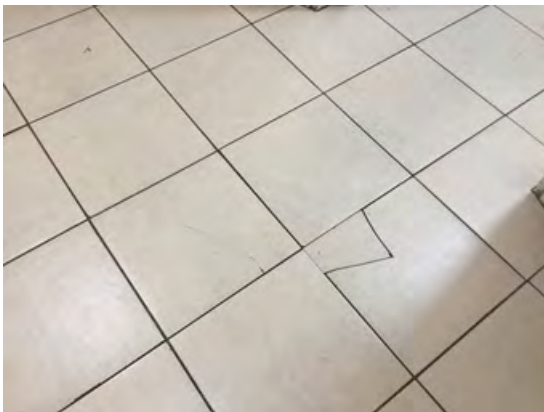
206

Location: Male WC

Condition: Poor

Comments: 2no cracked tiles to the entrance lobby

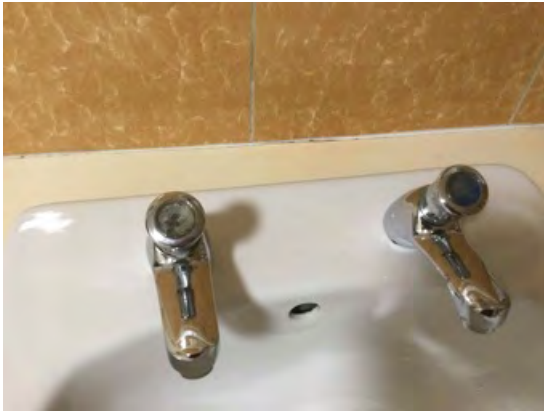
213

Location: Male WC

Condition: Poor

Comments: Decals missing to the taps

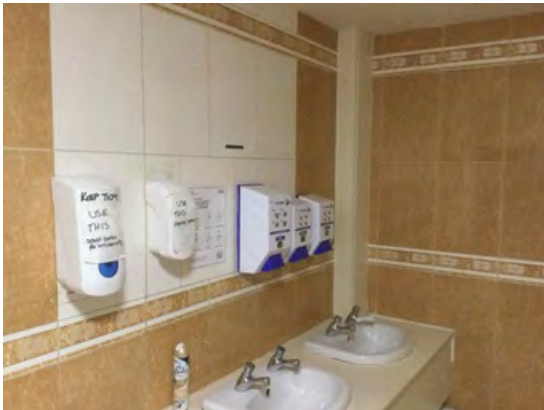
214

Location: Male WC

Condition: Fair

Comments: Tiled finish - fair condition

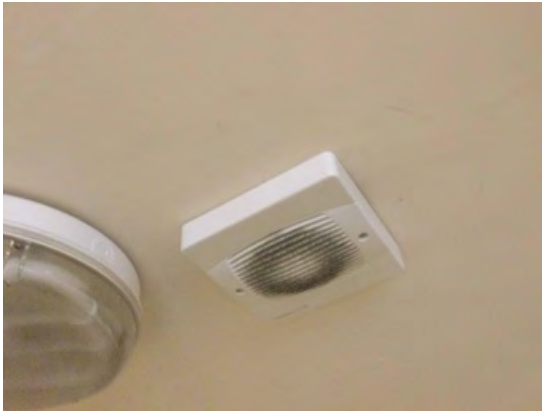
217

Location: Male WC

Condition: N/a

Decorative Condition: N/a

Comments: Noisy and soiled extractors

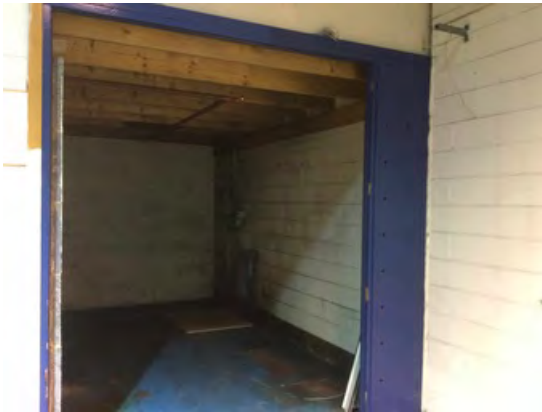
218

Location: Storage area

Condition: Very poor

Decorative Condition: N/a

Comments: Door removed

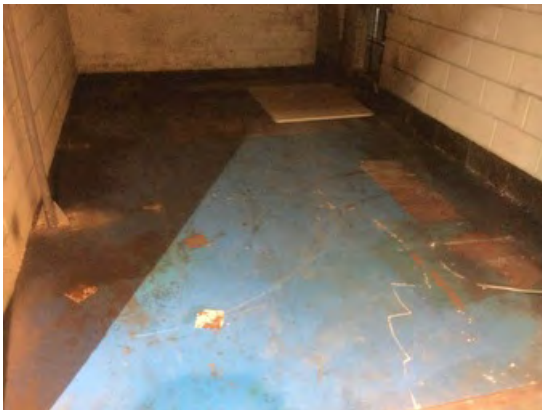
219

Location: Storage area

Condition: Fair

Decorative Condition: Very poor

Comments: Painted screed - soiled, very poor decorative condition

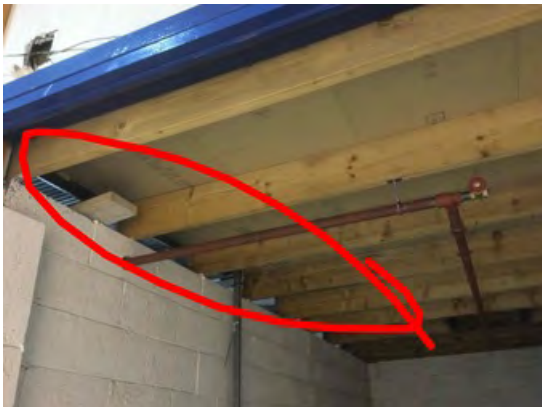
220

Location: Storage area

Condition: Poor

Decorative Condition: N/a

Comments: Exposed timber structure - lack of fire stopping

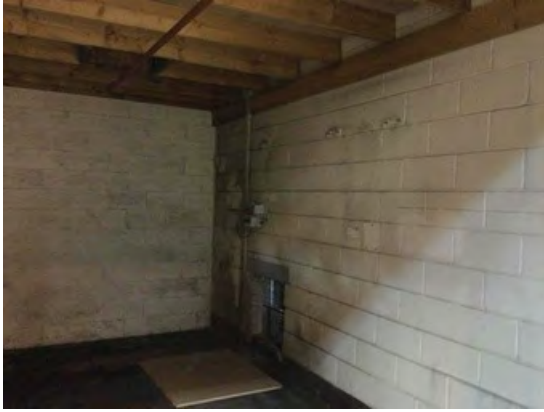
221

Location: Storage area

Condition: N/a

Decorative Condition: Poor

Comments: Very heavy soiling

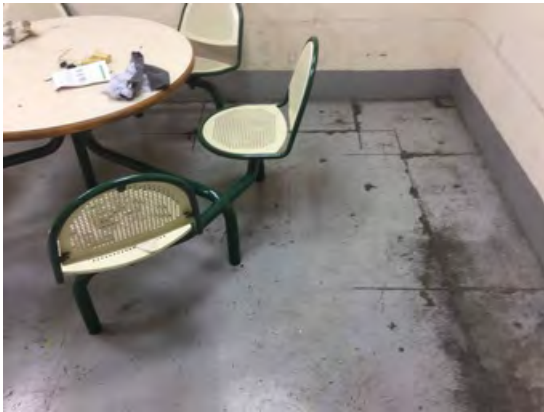
222

Location: Warehouse Kitchen

Condition: Fair

Decorative Condition: Poor

Comments: Pitted screed, worn paintwork
