UNIT 7 GREENHILLS BUSINESS CENTRE - Schedule of Condition

Unit 7 Greenhills Business Ctr, Spennymoor

Inspection Date: 28 March 2023

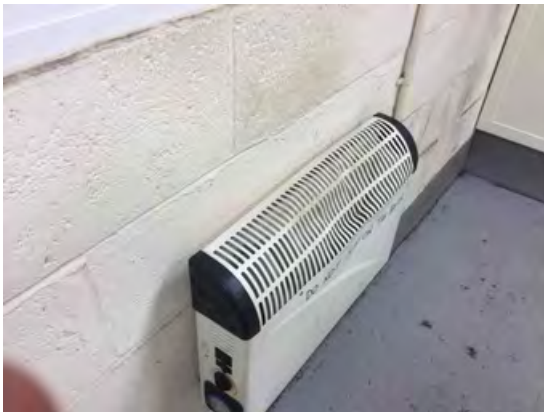
224

Location: Warehouse Kitchen

Condition: Poor

Decorative Condition: N/a

Comments: Indented panel heater

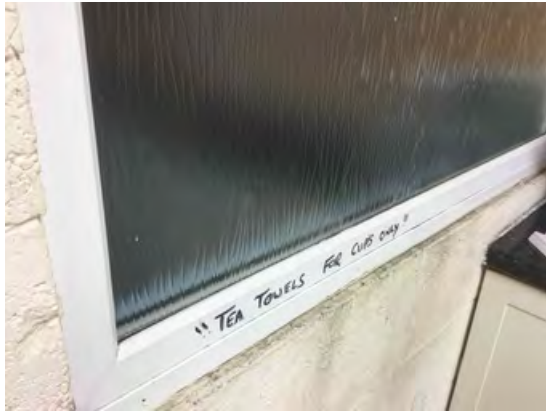
225

Location: Warehouse Kitchen

Condition: N/a

Decorative Condition: N/a

Comments: Window frames marked with permanent marker

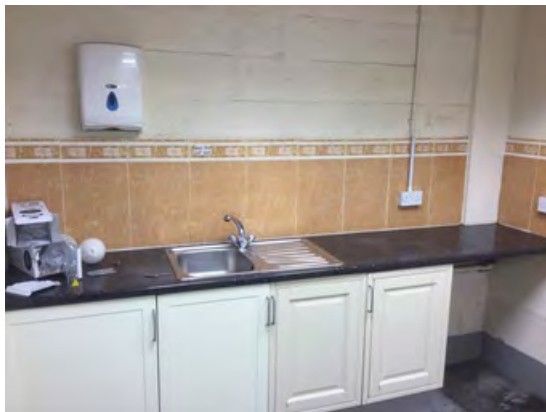
226

Location: Warehouse Kitchen

Condition: Fair

Decorative Condition: N/a

Comments: Fitted kitchen and tiles - fair condition

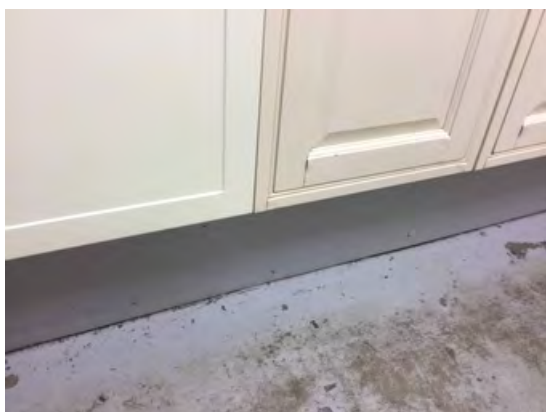
227

Location: Warehouse Kitchen

Condition: Fair

Decorative Condition: N/a

Comments: Soiled plinth, miss-match of doors
